Technical Service Bulletin: TSB260059

Low-Temperature Aftercooler (LTA) Accessory Drive Housing Improvement

- QST30 CM552
- QST30 CM2350 T101

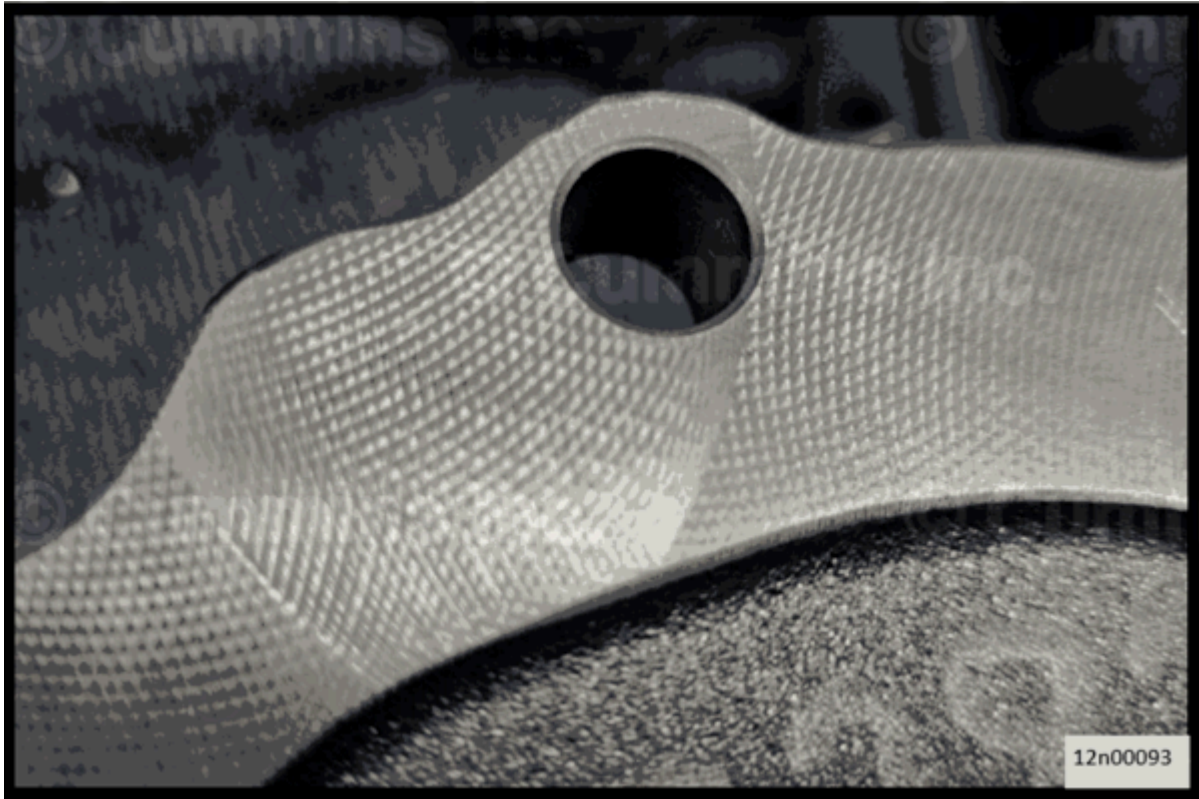
- Lubricating oil leak from joint between offset accessory drive and low temperature aftercooler (LTA) water pump drive.

- Press in place seal installed incorrectly.
- Surface finish of offset accessory drive mating surface machined incorrectly.

Figure 1, Example of Rough Sealing Surface on Accessory Drive

Inspect offset accessory drive and LTA water pump drive for damaged threads and excessively rough sealing surfaces. Replace any damaged components. Replace press in place seal. Verify that press in place seal is fully seated in seal groove.

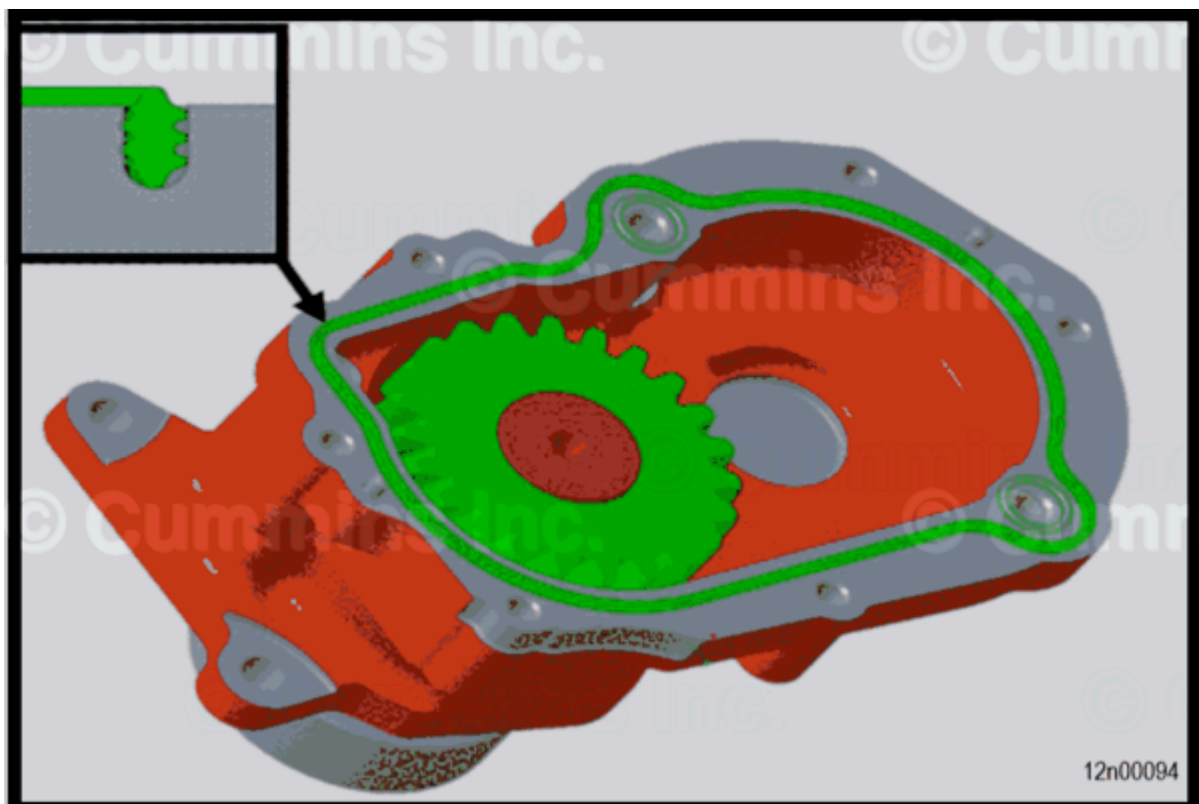
Figure 2, Press in Place Seal Fully Seated in Seal Groove
