Flood Situation Report

Area: 35.180°N 25.470°E (112.7 km²) Flood date: 2026-10-04 Generated: 2026-10-11 06:02 UTC

Flood / debris impact detected

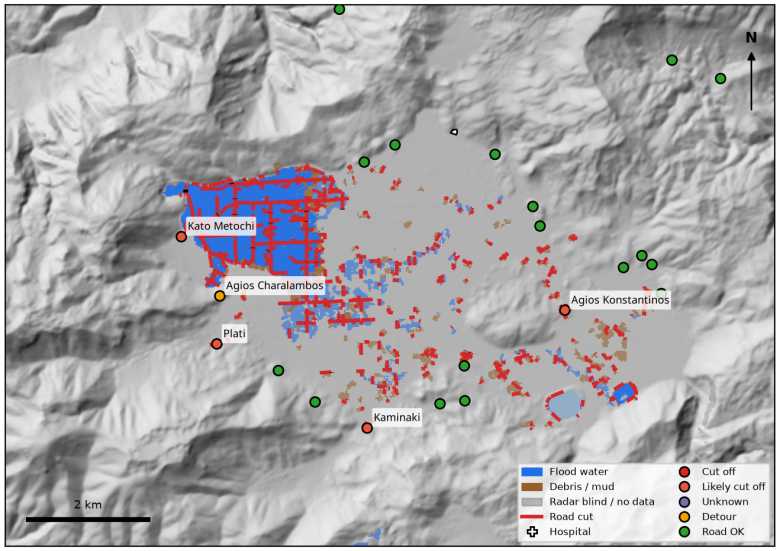
4.86 km²	1.74 km²	4	51.5 km	21	0
Flood water	Debris / mud	Buildings likely hit	Roads affected	Bridges hit	Settlements cut off

#	Settlement	Road access now	Buildings	Nearest hospital (before)	Before	Now
1	Καμινάκι	Likely cut off	213	hospital #3	6.0 km, 10 min	no route
2	Άγιος Κωνσταντίνος	Likely cut off	112	hospital #3	4.0 km, 5 min	no route
3	Πλάτη	Likely cut off	106	hospital #3	6.4 km, 10 min	no route
4	Κάτω Μετόχι	Likely cut off	74	hospital #3	5.6 km, 7 min	no route
5	Άγιος Χαράλαμπος	Long detour	62	hospital #3	5.9 km, 9 min	8.8 km, 18 min

- Περιμετρική Οδός Οροπεδίου: 0.78 km affected, 35.195°N 25.448°E
- Ψυχρό - Άγιος Γεώργιος: 0.26 km affected, 35.166°N 25.466°E
- unnamed tertiary: 0.69 km affected, 35.162°N 25.473°E
- unnamed unclassified: 20.96 km affected, 35.191°N 25.458°E
- + 5 more

- Περιμετρική Οδός Οροπεδίου, 35.192°N 25.432°E
- bridge on unnamed unclassified, 35.187°N 25.441°E
- bridge on unnamed unclassified, 35.194°N 25.441°E
- bridge on unnamed unclassified, 35.188°N 25.448°E
- + 17 more

- Καμινάκι [Likely cut off]: mapped helipad: none within 5 km; flat open ground 0.3 km (35.156°N 25.463°E)
- Άγιος Κωνσταντίνος [Likely cut off]: mapped helipad: none within 5 km; flat open ground 0.5 km (35.178°N 25.498°E)
- Πλάτη [Likely cut off]: mapped helipad: none within 5 km; flat open ground 0.2 km (35.171°N 25.436°E)
- Κάτω Μετόχι [Likely cut off]: mapped helipad: none within 5 km; flat open ground 0.3 km (35.184°N 25.429°E)
