Flood Situation Report

Area: 34.488°N 72.578°E (148.6 km²) Flood date: 2025-08-16 Generated: 2026-10-10 04:06 UTC

Educational prototype generated automatically from satellite data. Not an official emergency map.

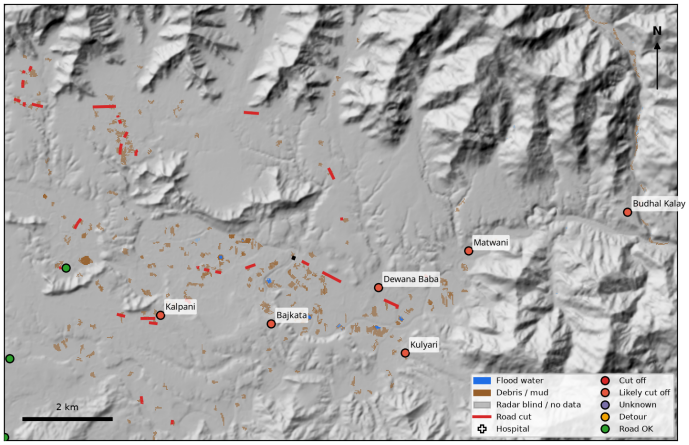
Flood / debris impact detected

0.04 km²	2.36 km²	0	1.9 km	2	0
Flood water	Debris / mud	Buildings likely hit	Roads affected	Bridges hit	Settlements cut off
