Tanggal : 19 Februari 2026
Personil : Tim GAST
Lokasi : Unit 065 Alkylation – 066 WSA
Fungsi Lain : SC JO

SERVICE TEST PURGE NITROGEN UNIT 065-066

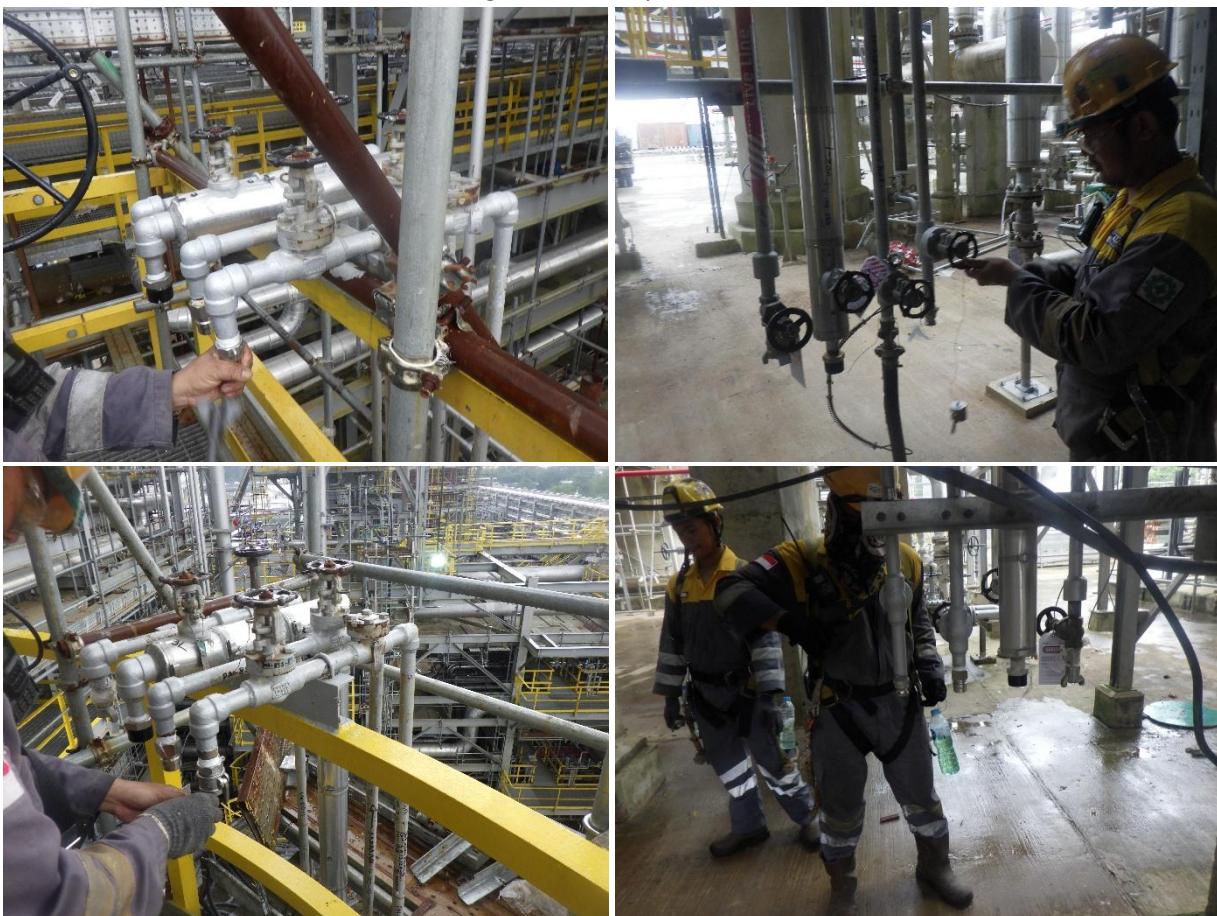
- Service test dilakukan setelah LEL di battery limit dinyatakan aman melalui *thermal camera*
- Semua titik utility station (US) dan non-US telah dicek dan tidak terdapat issue leak/passing

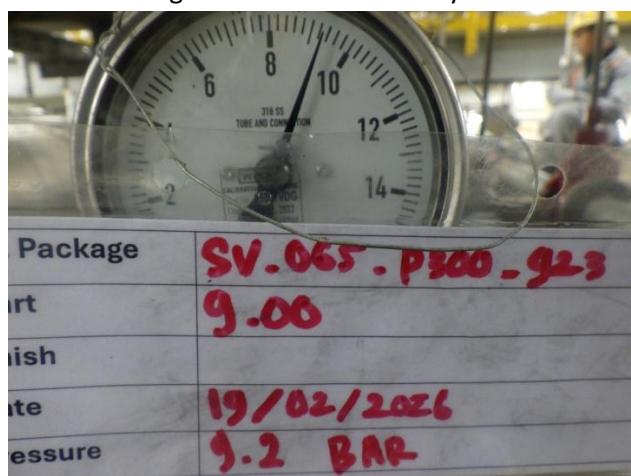
Pengecekan utility station PN
