The Importance of eSlide Macro Images for Primary Diagnosis with Whole Slide Imaging

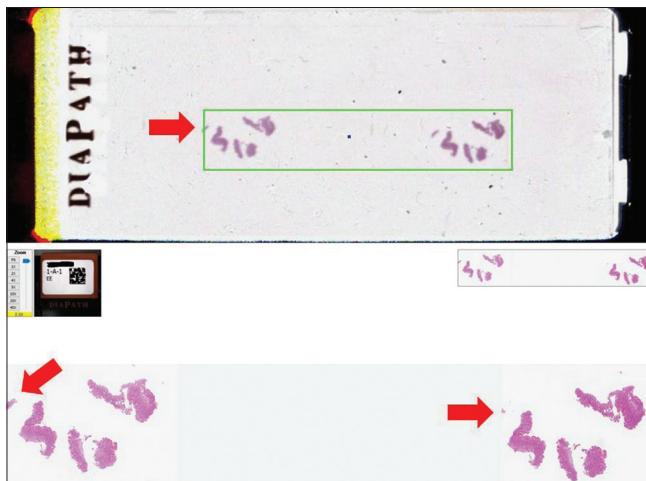
In one case, a H and E-stained glass slide of a gastric biopsy comprising multiple tissue pieces, when scanned at $\times 20$ (Aperio AT2 scanner), was missing a small tissue fragment in the WSI [Figure 1]. The automated tissue finder tool did not detect and therefore initiate complete scanning of this tissue fragment. The missing piece of gastric tissue was readily identified in the accompanying macro image. A similar case was reported in which a glass slide scanned on an Ultra-Fast Scanner (Philips) showed several small tissue fragments in the macro image that were not present in the

Figure 1: Whole slide image missing a tissue fragment. (Top image) Macro image showing a green box placed by the tissue finder tool on the region to be scanned. Arrows indicate the small piece of tissue on the edge that failed to adequately scan. (Bottom image) Thumbnail image showing that the small tissue fragment on the edge of the section was truncated (left part of image, red arrow) or missing (right part of image, red arrow) in the whole slide image

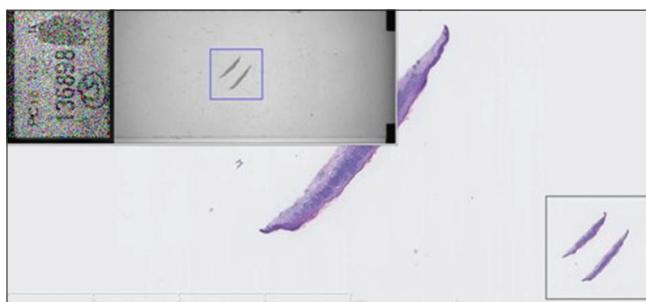
WSI [Figure 2]. Another case was uncovered in which a much larger portion of tissue identifiable in the macro image was missed with scanning (Hamamatsu XR scanner) [Figure 3]. One laboratory reported an incident in which a glass slide of a prostate biopsy scanned using the skip blank stripes mode (Aperio AT2 Turbo scanner) not only skipped blank stripes but also skipped one of the core fragments present on one of two levels of the slide.

Figure 3: A scan error is shown where a slide of a shave biopsy with two portions of tissue, both seen in the macro image, only displayed one of the tissue pieces in the whole slide image

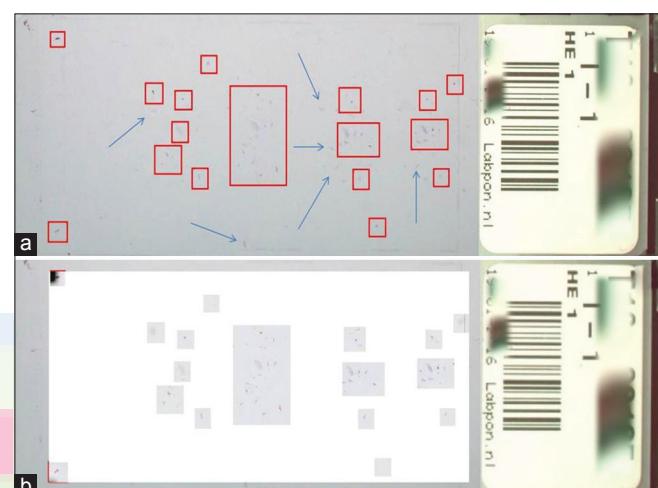
Figure 2: Whole slide image missing tissue fragments. (a) Macro image showing multiple red boxes containing pieces of tissue detected by the tissue finder algorithm, as well as extra tissue fragments (blue arrows) that were not detected. (b) Whole slide image thumbnail showing only those tissue fragments present within selected regions that were scanned

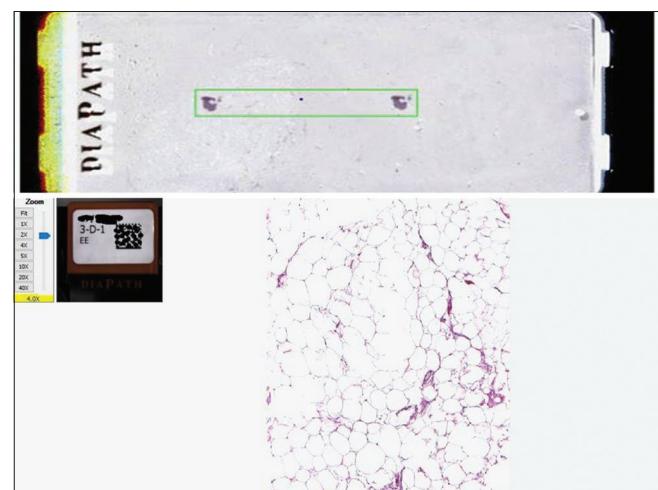
In another case where a glass slide was scanned at $\times 20$ (Aperio AT2 scanner), a mismatch was noted between the macro image and corresponding WSI [Figure 4]. A related mismatched case was identified at another facility involving two cases that were scanned for immunofluorescent analysis (Pannoramic 250, 3DHistech) where the label image and accompanying WSI in one of the cases were incorrectly duplicated [Figure 5]. At a different medical center, when the same H and E-stained glass slide was scanned on different scanners, the WSI was missing an area of tissue [Figure 6], even though the macro image incorporated this region.

Figure 4: Mismatched macro and whole slide image. (Top image) The macro image accurately shows two H&E stained sections of a small fibromuscular tissue biopsy. (Bottom image) The whole slide image in this case unexpectedly shows adipose tissue that was not present on the glass slide

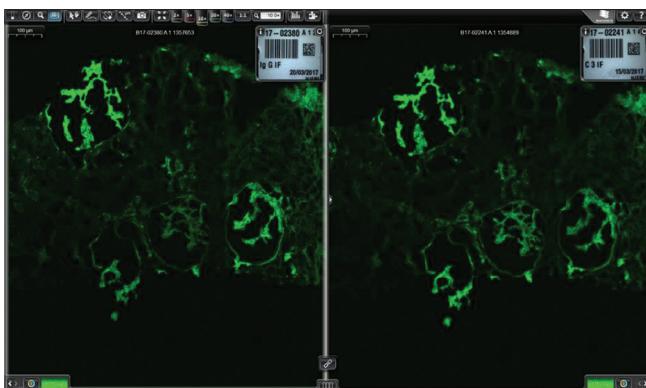
Figure 5: Mismatched label image and whole slide image. (Left) A scanned renal immunofluorescence slide showing the label (IgG stain) correctly associated with the whole slide image. (Right) A scanned slide of a skin biopsy showing the correct label (C3 stain) that is incorrectly associated with the wrong whole slide image from the renal immunofluorescence slide

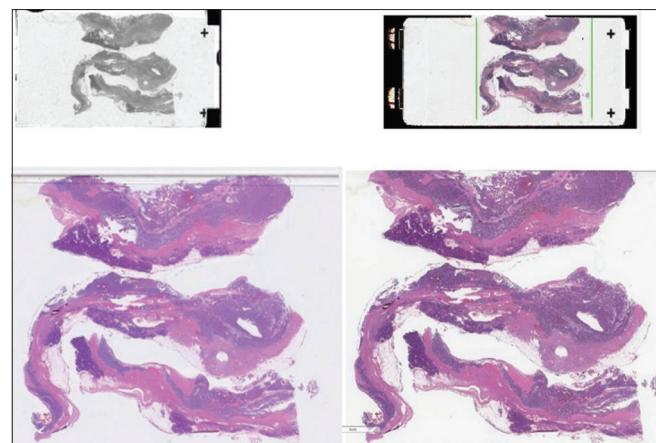
Figure 6: Whole slide image scanners with different scan coverage. An H and E stained slide with several large portions of tissue is shown in which one fragment at the top of the slide extends beyond the coverslip. (Left) The black and white macro image correctly shows all tissue pieces including the portion extending beyond the coverslip; the corresponding whole slide image accurately scanned all of the tissue (Hamamatsu HT2). (Right) The macro image is shown with a green box identifying the tissue region to be scanned, including the tissue extending beyond the coverslip; the corresponding scanned whole slide image is missing part of the tissue near the upper edge of the slide (Aperio AT2)

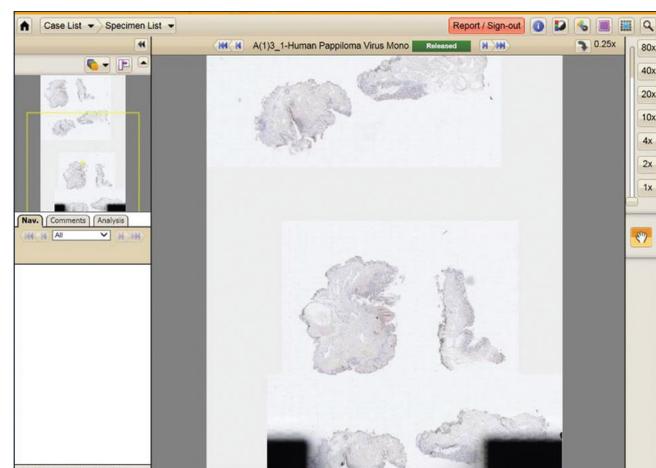
When validating an iScan HT scanner (Roche) for digitization of immunohistochemical slides at an academic medical center, the department of pathology noted that for some of the slides being scanned a portion of the tissue was truncated or entirely missing in the WSI. Inspection of the macro image revealed that this problem arose when there was poor tissue placement on the slide (e.g., when tissue was too close to the slide edge), and as a result, the designated preset box to define the region of interest to be scanned did not include all of the tissue on the slide [Figure 8]. When identified, the error required human intervention by the operator to select a new more inclusive area to be scanned.

Figure 8: Missed tissue during scanning. The small macro image (left) shows that the predefined yellow box in this case does not include all of the tissue. The whole slide image (right) is missing those pieces of tissue located outside the selected region to be scanned
