Building & Field Structural Repairs

Capital Planning Committee · Fall Town Meeting 2026

Article 11: Three CPC Design Projects

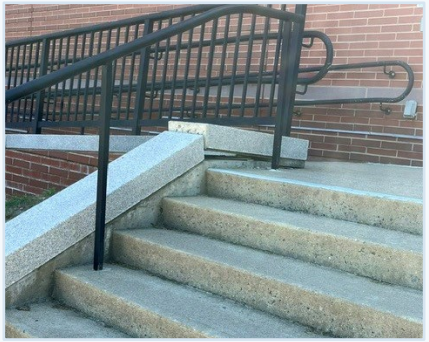
- Mortar and masonry at the stairs and walls are crumbling, in places turning to powder
- Some railings are becoming structurally unsound
- Only ~8 years after the 2015–2018 renovation: too soon for this kind of decay

Broken brick and stone chips under a granite cap

Brick missing beside a granite cap, boards propped underneath

Mortar eroding from the joints of a brick planter wall

Railing posts set through granite caps: a likely path for water

- Outside engineer to find cause:
  - Flashing
  - Water getting in where railings pass through the caps
  - Masonry itself
- Cause will drive design plans + cost estimate
