# FATIGUE FAILURE MODES OF THE GRAIN SIZE TRANSITION ZONE IN A DUAL MICROSTRUCTURE DISK

Tim P. Gabb<sup>1</sup>, Pete T. Kantzos<sup>2</sup>, Bonny Palsa<sup>1</sup>, Jack Telesman<sup>1</sup>, John Gayda<sup>1</sup>, Chantal K. Sudbrack<sup>1</sup> <sup>1</sup>NASA Glenn Research Center; 21000 Brookpark Rd.; Cleveland, OH 44135 <sup>2</sup>Honeywell Engine Systems, 111 South 34th St., Phoenix, AZ 85034

Keywords: dual microstructure, transition zone, fatigue

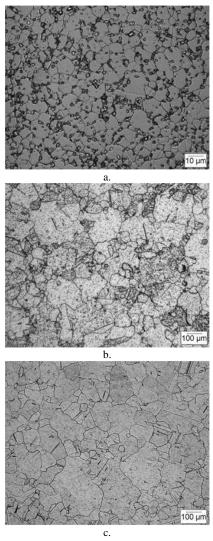
Typical grain microstructures are shown in optical images from etched metallographic sections of LCF specimen sections, Fig. 3. Inner, mid, and outer ring specimens had increasing mean intercept grain diameters of 5.8  $\mu m$ , 38  $\mu m$ , and 55  $\mu m$ , respectively, and had corresponding increasing ALA grain diameters of about 22  $\mu m$ , 410  $\mu m$ , and 413  $\mu m$ , respectively. Because these disks were machined from flat pancake forgings of relatively uniform forging strains, no consistent changes in non-metallic inclusion content or morphology were observed across the fatigue tested locations.

The grain size transition zone was abrupt in this disk, and was usually captured within the gage cross sections of specimens at the mid location. Within this mid location, a bimodal grain size distribution mixing large and small grains was observed. Inner ring specimens also had coarse, undissolved "primary"  $\gamma$  particles widely spaced along grain boundaries and sometimes scattered within grains, Fig. 3. As shown in Fig. 2, the most abrupt region of transition in grain size was located parallel to the loading axis in the gage sections of mid ring specimens. However, this region of grain transition was located normal to the loading axis near the middle of the gage sections in radial specimens. This enabled fatigue loading of the grain size transition plane in the parallel and transverse directions, respectively.

Fig. 3. Grain microstructures for a. inner, b. mid, and c. outer specimen locations.

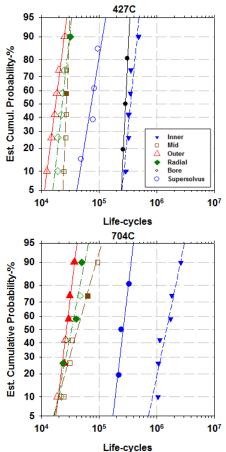
As shown in Fig 4, for tests conducted at both 427 °C and 704 °C, the inner location specimens had significantly higher mean fatigue lives than mid, outer, and radial specimens at both test temperatures. Inner specimens had over 10 x higher mean lives than mid, outer, and radial specimens at 427 °C, and over 50 x higher mean lives at 704 °C. Mid, radial, and then outer specimens ranked in order of decreasing mean fatigue lives at both test temperatures, however the differences in lives between these three locations were relatively modest. Outer samples had lower mean lives than those of mid and radial specimens at a 95 % significance level for tests at 427 °C, but at lower significance levels in tests at 704 °C. Modest scatter in life was observed for each specimen location.

Fig. 4. Comparison of fatigue lives for all uniform gage specimens. Filled symbols indicate internally initiated failures, open symbols indicate surface and near-surface initiated failures.

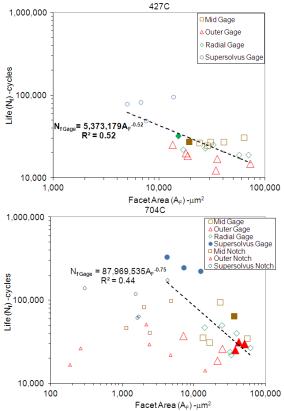
The relationships between the size of the facets initiating failure and fatigue life for DMHT and supersolvus, uniform gage and notch fatigue specimens are shown in Fig. 10. For tests at both 427 °C and 704 °C, uniform gage fatigue specimens removed from the supersolvus disk had smaller facet sizes than those for specimens excised from the DMHT disk. The size of the facets was related to the corresponding fatigue lives. Decreasing facet size correlated with increasing fatigue life for all facet failures in uniform gage specimens at both test temperatures. correlation as indicated by the coefficient of determination was higher at 427 °C than for 704 °C. This appeared related in part to the locations of facet failures. Most facet failures initiated at the surface for tests at 427 °C. However, several specimens failed from internal grain facets at 704 °C, producing longer lives than for surface initiated failures. Such variations in life based on failure location have been observed in other disk superalloys [13, 16]. Facet sizes for uniform gage specimens did not significantly vary between the two testing temperatures.

Facet sizes for notched specimens were smaller than for uniform gage specimens, and did not consistently vary with location. One-way ANOVA evaluations indicated facets causing failure in notched specimens DMHT and supersolvus disks were not significantly different, and did not correlate with fatigue life.

Grouped together, facets of notched gage specimens were significantly smaller than for uniform gage specimens.

Fig. 10. Fatigue life versus facet areas at 427 °C and 704 °C. Regression lines indicate correlation of facet area with uniform gage lives only. Filled symbols indicate internally initiated failures, open symbols indicate surface and near-surface initiated failures.
