Silverline Power infrastructre pvt. ltd.

COMPLIANCE REPORT

Reference: PO No: 04/006390/20200335, Dated: 31/07/2020

Inspection Date: 29.04.2021 & 13.05.2021

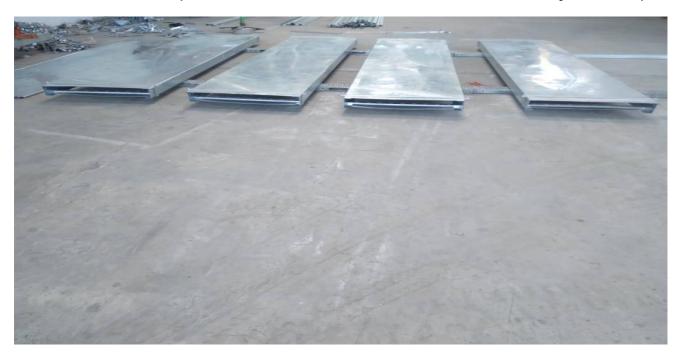
Sr. No.	COMMENTS	OUR COMPLIANCE
3r. No.	a) Visual inspection carried out for ladder and perforated type cable tray lot wise (one sample each from a lot of 100 Nos) found burr in slot corner, bend portion in covers, ladder tray & perforated trays galvanizing lumps etc. observed which needs to be	1) Burrs in Slot Corner are Removed 2) Bends cover are repaired and checked with Fitment with the Cable tray and Clamp. 3) Galvanizing Lumps are removed after fitment no bends is observed from Cable
	rectified before dispatch of material	Tray and Covers.

1) Burrs in Slot Corner are Removed:
