WRAP - Audit Report

Audit #: 10425, Factory: Yorkmars (Cambodia) Garment Mfg Co. Ltd, Address Line 1: Preytea Village, Sangkat Choam Chao, Khan Porsenchey,, City: Phnom Penh, Country: Cambodia, Approval Status: Completed

Audit Report

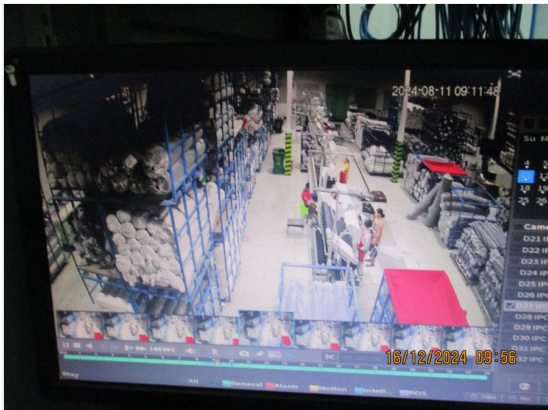
CCTV screenshot of production floor weekly rest day photo 1 (List rest day date)

Weekly rest working on Aug 11, 2024

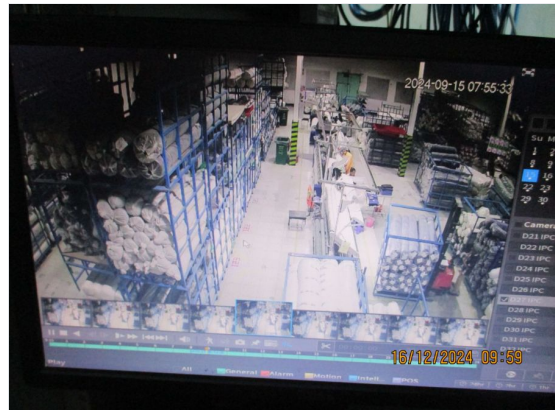
CCTV screenshot of production floor weekly rest day photo 2 (List rest day date)

Weekly rest working on Sept 15, 2024

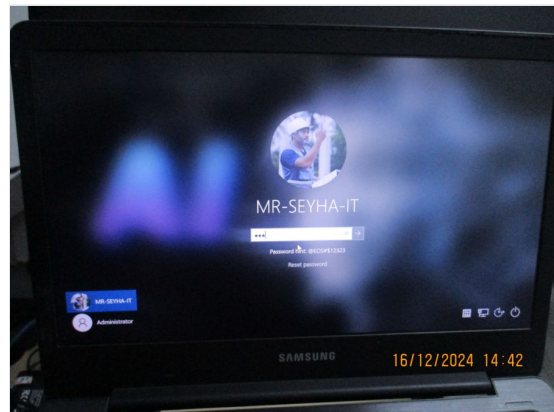
Password log in was required.

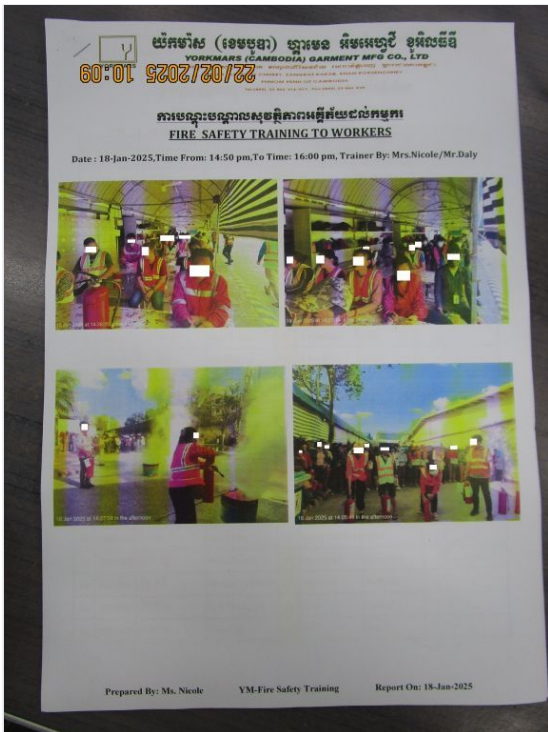
8.20&8.40-Observed exit aisles were partially blocked by tables, machines, chairs and material at sewing section and packing section

As per site observation, worker and management interview, it was noted that 7 out of 30 observed exit aisles were partially blocked by tables, machines, chairs and material at sewing section and packing section.

Proof of NC# 8.20&8.40c: The emergency exit aisles at packing section freely accessible during working time.

Based on site observation, it was noted that the emergency exit aisles and workplace were not block and freely accessible during working. In addition, the facility has provided fire safety awareness training to employees on January 18, 2025.
