ASBESTOS RISK ASSESSMENT

DATE: SEPTEMBER 2020

OUR REFERENCE:
J169642

ALEXANDER DISTRICT HEALTH
ALEXANDER DISTRICT HOSPITAL
24 COOPER STREET, ALEXANDRA VIC 3714

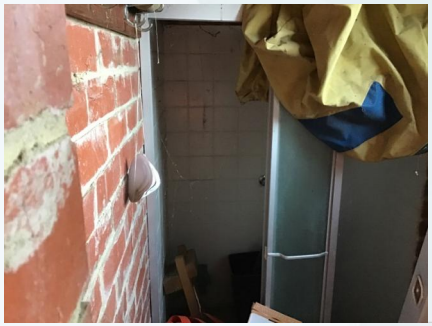
6	Mortuary Room Ceiling - Flat Cement Sheeting	Asbestos	Not Sampled Height Restricted	Presumed Positive	J169642-001-Photo008	10 m²	Good	Non Friable	Low	Low	Not Labelled	07/09/2025	P4	Confirm status, label, maintain in current condition and incorporate into an AMP. Remove by licensed asbestos contractor prior to demolition or refurbishment.	
7	Mortuary Room Wall - Rendered Masonry	Asbestos	J169642-001-003	Negative											
8	Shower Room Shower Cubicle - Flat Cement Sheeting - Behind ceramic tile	Asbestos	Not Sampled Restricted Access	Presumed Positive	J169642-001-Photo007	4 m²	Good	Non Friable	Low	Low	Not Labelled	07/09/2025	P4	Confirm status, label, maintain in current condition and incorporate into an AMP. Remove by licensed asbestos contractor prior to demolition or refurbishment.	
9	Shower Room Shower Cubicle - Flat Cement Sheeting - Beneath shower tray	Asbestos	Not Sampled Restricted Access	Presumed Positive	J169642-001-Photo004	1 m²	Good	Non Friable	Low	Low	Not Labelled	07/09/2025	P4	Confirm status, label, maintain in current condition and incorporate into an AMP. Remove by licensed asbestos contractor prior to demolition or refurbishment.

ITEM NO.: **6**
PHOTO NO.: **J169642-001-PHOTO008**
RESULT: **ASBESTOS - PRESUMED POSITIVE**
BUILDING/LEVEL: **MORTUARY BUILDINGS - GROUND LEVEL**
ROOM/LOCATION: **MORTUARY ROOM**
FEATURE/MATERIAL: **CEILING - FLAT CEMENT SHEETING**
SAMPLE NO.: **NOT SAMPLED HEIGHT RESTRICTED**

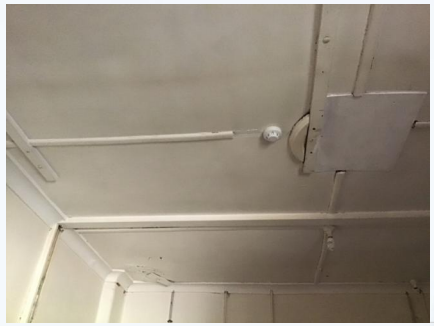
52	Reception Safe - Insulation - Safe	Asbestos	Not Sampled Restricted Access	Presumed Positive	J169642-001-Photo033	1 Unit/s	Good	Friable	Low	Low	Not Labelled	07/09/2021	P3	Confirm status, label, maintain in current condition and incorporate into an AMP. Remove by licensed asbestos contractor prior to demolition or refurbishment.	
53	South Store Room Ceiling - Flat Cement Sheeting - Painted white	Asbestos	Not Sampled Height Restricted	Presumed Positive	J169642-001-Photo048	10 m²	Good	Non Friable	Low	Low	Not Labelled	07/09/2025	P4	Confirm status, label, maintain in current condition and incorporate into an AMP. Remove by licensed asbestos contractor prior to demolition or refurbishment.	
54	Store Offices Ceiling - Flat Cement Sheeting - Painted white	Asbestos	Not Sampled Height Restricted	Presumed Positive	J169642-001-Photo019	8 m²	Good	Non Friable	Low	Low	Not Labelled	07/09/2025	P4	Confirm status, label, maintain in current condition and incorporate into an AMP. Remove by licensed asbestos contractor prior to demolition or refurbishment.

ITEM NO.: **52**
PHOTO NO.: **J169642-001-PHOTO033**
RESULT: **ASBESTOS - PRESUMED POSITIVE**
BUILDING/LEVEL: **MAIN HOSPITAL BUILDING - GROUND LEVEL**
ROOM/LOCATION: **RECEPTION**
FEATURE/MATERIAL: **SAFE - INSULATION - SAFE**
SAMPLE NO.: **NOT SAMPLED RESTRICTED ACCESS**
