PREPARED FOR

Project Address: 18398 131st Trail N, Jupiter Farms, FL

PROJECT — TWO PARTS

B) Replacement of the termite-damaged floor structure (2 main beams + 7 joists) with structural aluminum members. Like-for-like appearance and layout, equal or greater strength.

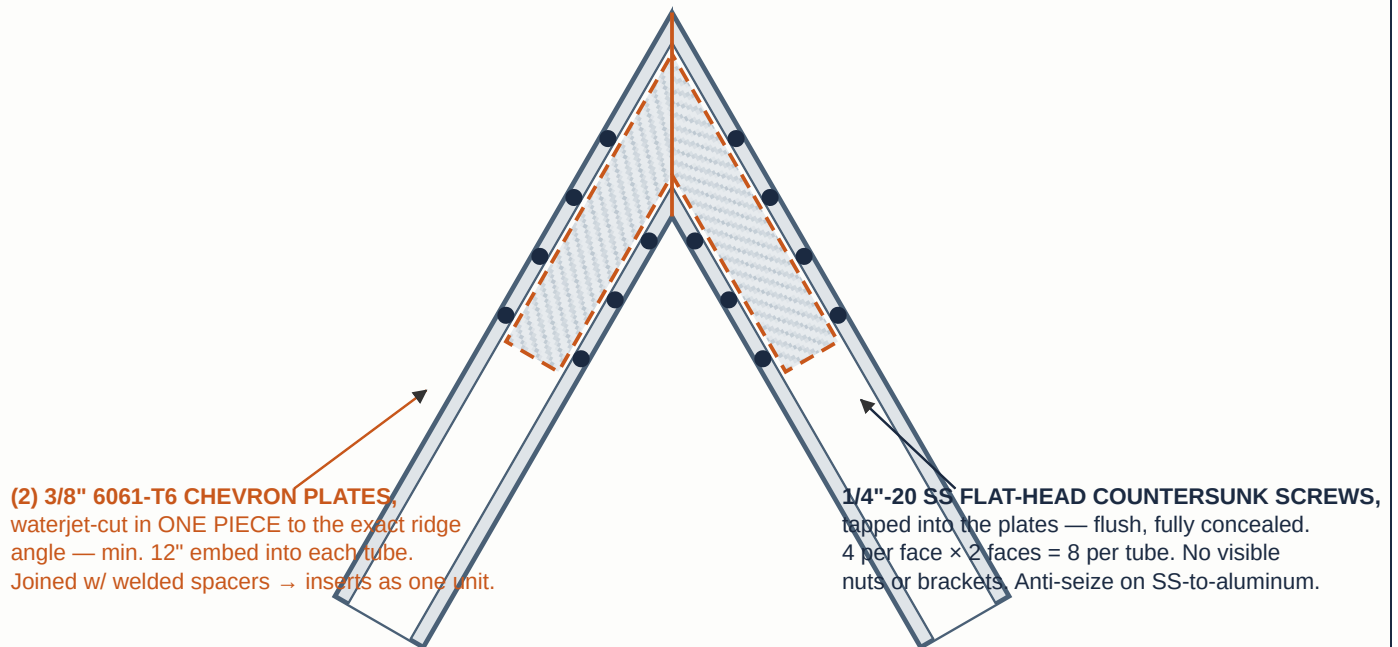
DWG-3 · RIDGE JOINT — MITER-CUT TUBES W/ CONCEALED ONE-PIECE CHEVRON PLATES (N.T.S.)

TUBES MITER-CUT & BUTTED TIGHT — HAIRLINE JOINT, WOOD-TONE SEALANT

Joint capacity ≈ 8,000 lb per member (8 screws @ ~1,000 lb) — far above loads previously carried by the timber. 1/4" weep hole at each tube low point.

Bolted concealed joint keeps the 6061-T6 tubes at full strength (no weld heat-affected zone at the ridge). Field angle verified before plates are cut.

- 5. Fabrication:** Miter-cut members at the field-verified ridge angle. Fabricate two (2) concealed internal chevron-plate inserts: 3/8" 6061-T6 plates waterjet/plasma-cut in one piece to the exact ridge angle, joined with welded spacers, pre-drilled and tapped — each insert slides into both tubes as a single unit (see DWG-3). Welds per AWS D1.2.

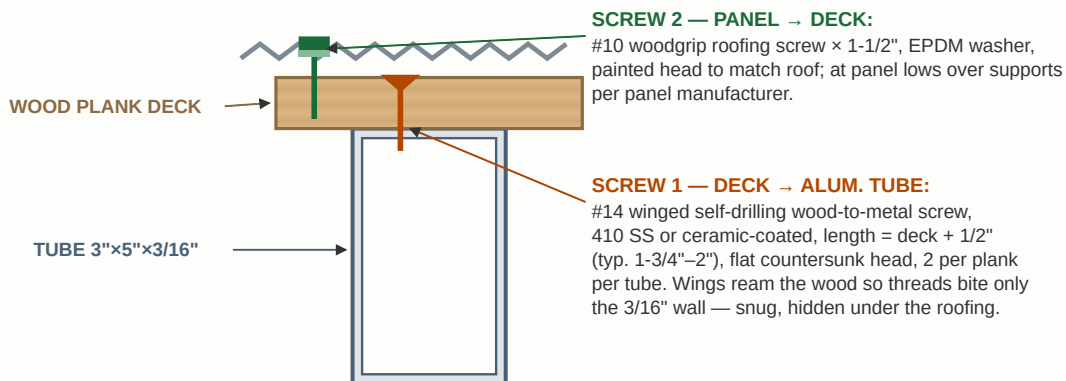
DWG-4 · GABLE FRONT VIEW — ROOF BUILD-UP, EAVE END CAPS & FASTENING (N.T.S.)

Deck planks and metal roof panel re-installed over the new aluminum members; all fasteners selected for aluminum compatibility.

8. **Roof deck & metal panel:** Re-install wood plank decking over the new members with #14 winged self-drilling wood-to-metal screws (410 SS or ceramic-coated, concealed under roofing), and metal roof panel with #10 woodgrip screws with EPDM washers; drip edge at eaves and ridge cap at the peak (see DWG-4).

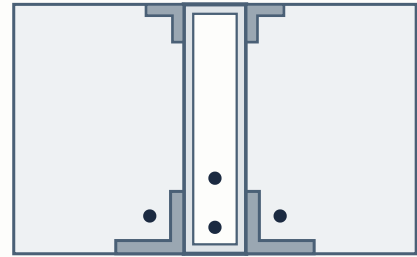
JOIST SEAT AT GIRDER (section)

3"x3"x1/4" ALUM. ANGLE SEATS
thru-bolted w/ SS hardware + top clip —
replaces the corroded sheet-metal hangers.
Nothing for termites to eat.

5. **Fabrication:** Weld and drill aluminum angle seats and top clips (3"×3"×1/4") for every joist-to-girder connection — far stronger than the sheet-metal hangers being removed, and nothing for termites to eat. Welds per AWS D1.2.
