HIM overheat

Wednesday, February 9, 2022 10:41 AM

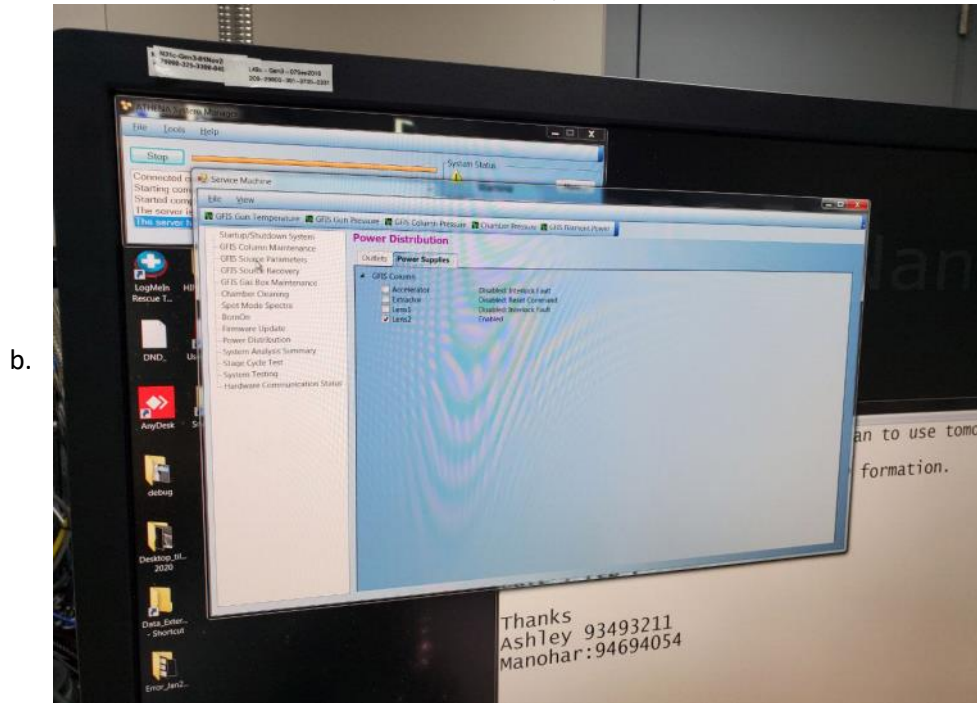
Gun temperature too high bc LN2 exhausted
