## PRO PCB ISSUES 2022-04-06

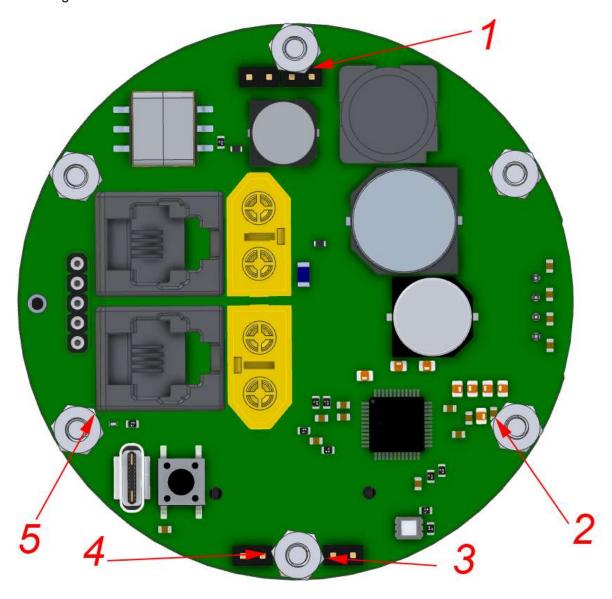
- 0) The bottom PCB has a slightly larger diameter than the top PCB? Why?
- 1) Connector overlaps the hex standoff
- 2) Component overlaps hex standoff
- 3) Component overlaps hex standoff
- 4) Component overlaps hex standoff
- 5) Component almost overlaps hex standoff (move the two black connectors slightly closer together.

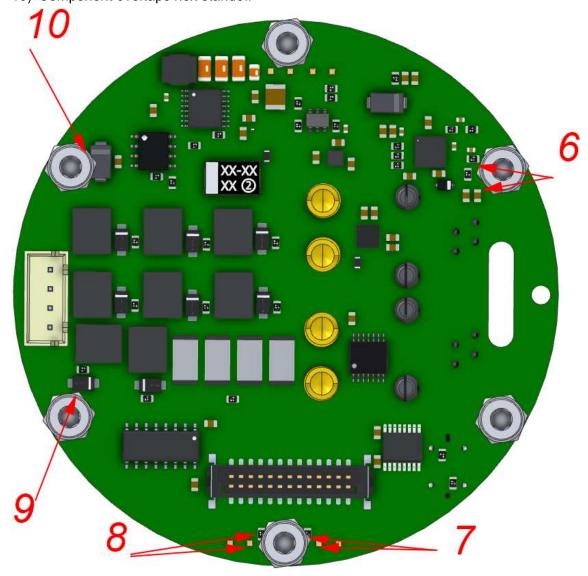
- 6) Component overlaps hex standoff
- 7) Component overlaps hex standoff
- 8) Component overlaps hex standoff
- 9) Component overlaps hex standoff
- 10) Component overlaps hex standoff

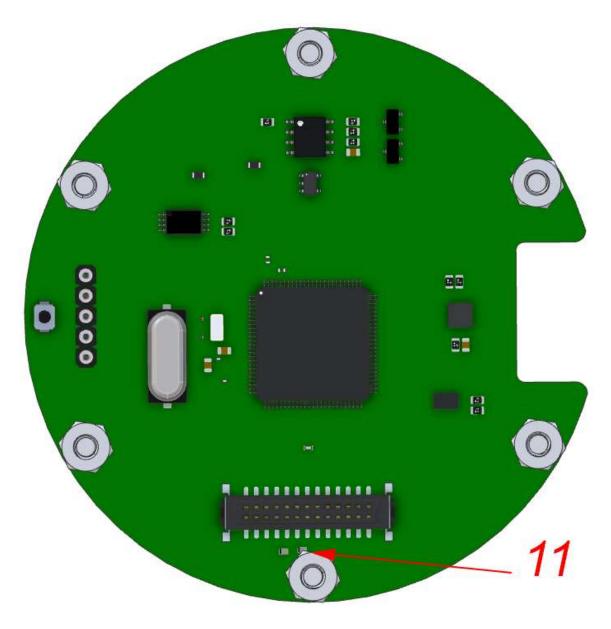
11) Component overlaps hex standoff
