To : MV Aballe /JR Dacalano**February 14, 2023****Thru : RB Nazareno****From : JRH Marquez/ IT Salenga, Jr.****Subject: SMC RMI Key Performance Metrics, Projects and Activities.**

Submitting for your appreciation a compilation of Key Performance Indicators (January, 2023) as agreed and stipulated in our maintenance agreement, as follows:

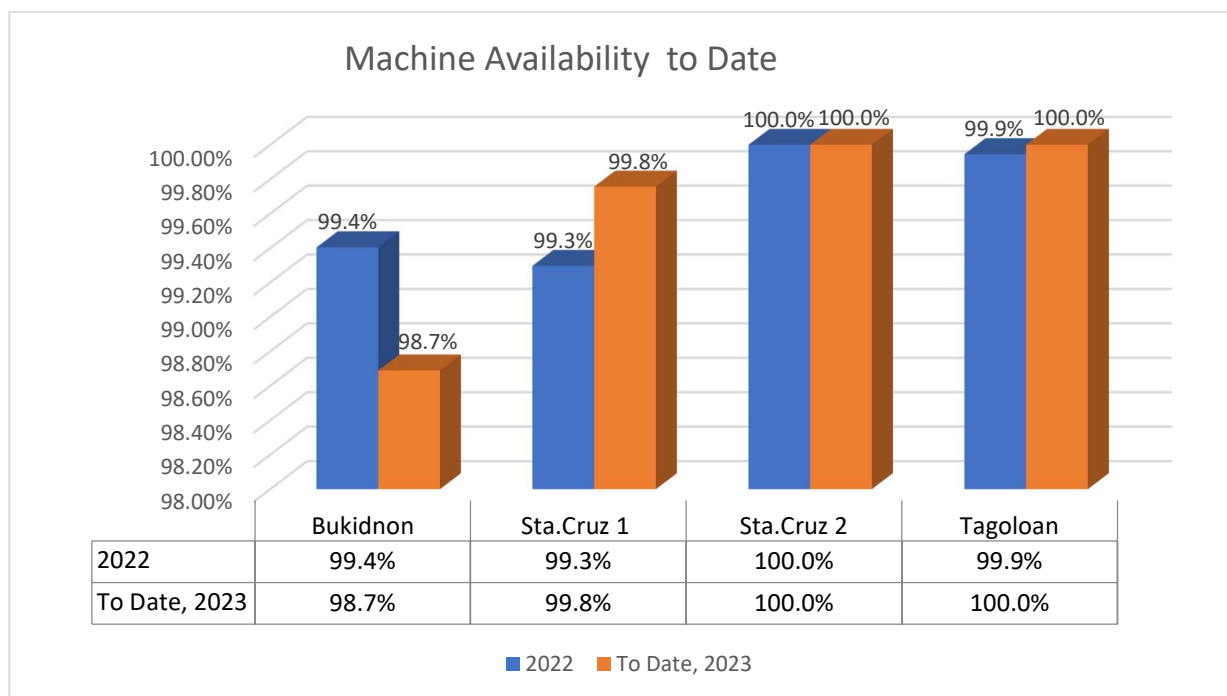
To date, Sta. Cruz 2 and Tagoloan plants got 100.00% machine availability, followed by Sta. Cruz 1 at 99.8%, while Bukidnon got the lowest at 98.7%.

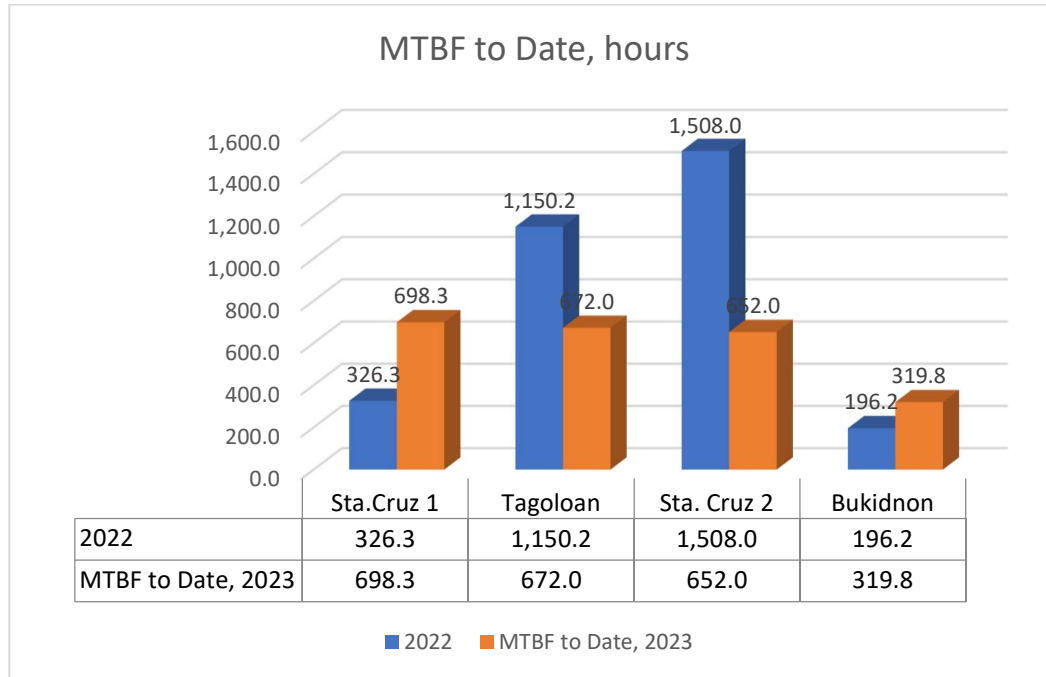
To date, the plant with longest time before a machine failed was Sta. Cruz 1 at 698.3 hours, followed by Tagoloan with 672.0 hours and Sta. Cruz at 652.0 hours, while Bukidnon got the lowest at 319.8 hours.

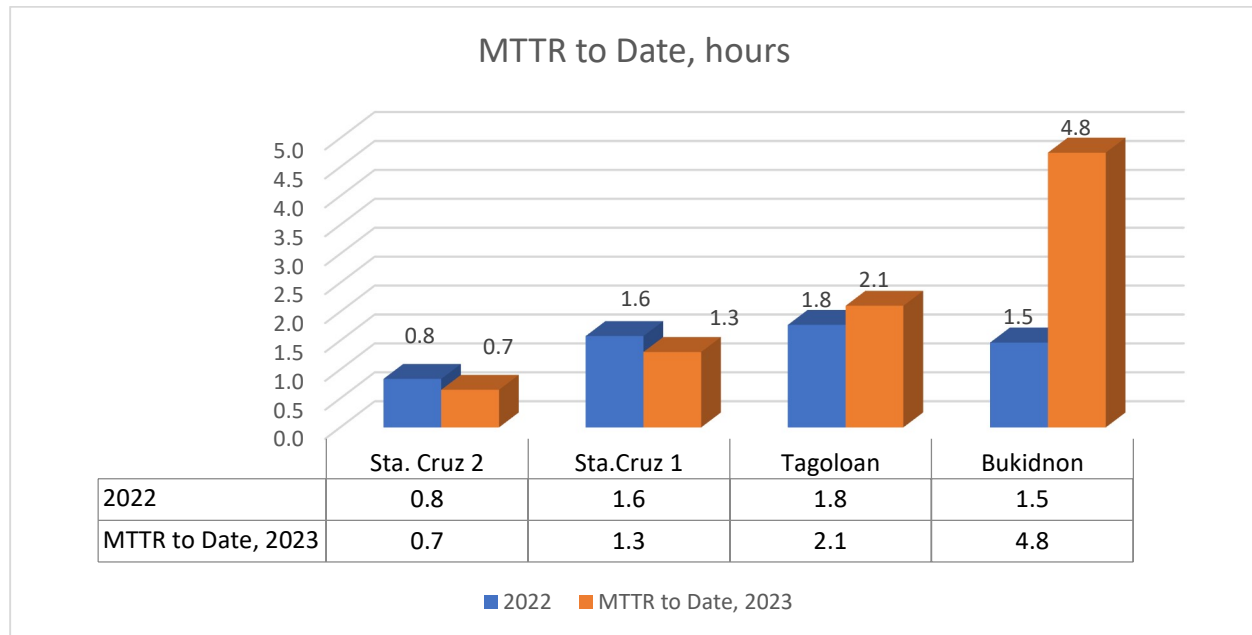
The plant with shortest repair time is Sta. Cruz 2 at 0.7 hour, followed by Sta. Cruz 1 at 1.6 hours, and Tagoloan at 2.1 hours, while Bukidnon got the longest hour at 4.8 hours.
