## Home Inspection Report

**1952 Camargo Drive, San Jose**

**Esteban Vasquez**  
June 17, 2022

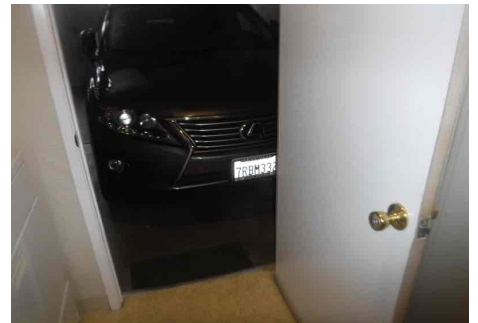
Photo 10

1. The door between the garage and the house did not have an automatic closing mechanism. The door between the garage and the interior of the house should be fitted with an automatic closing mechanism. This will reduce the potential of toxic automobile gases entering the house and serves as a fire break. (See Illustration 3G) (See Photo 10)
2. Personal storage was blocking access to the interior of the garage. Therefore, the area is considered inaccessible and was not fully inspected. With access and an opportunity for complete inspection, conditions in need of attention may be discovered. Ideally, the personal belongings should be removed so the area may be inspected. (See Photo 8) (See Photo 9)
3. The uneven walkway section(s) at the left side present a trip hazard. This condition should be corrected for improved safety. (See Photo 6)

- ! 1. The door between the garage and the house did not have an automatic closing mechanism. The door between the garage and the interior of the house should be fitted with an automatic closing mechanism. This will reduce the potential of toxic automobile gases entering the house and serves as a fire break. (See Illustration 3G) (See Photo 10)
