高通RF技术期刊2016-03-31

Qualcomm Technologies, Inc.

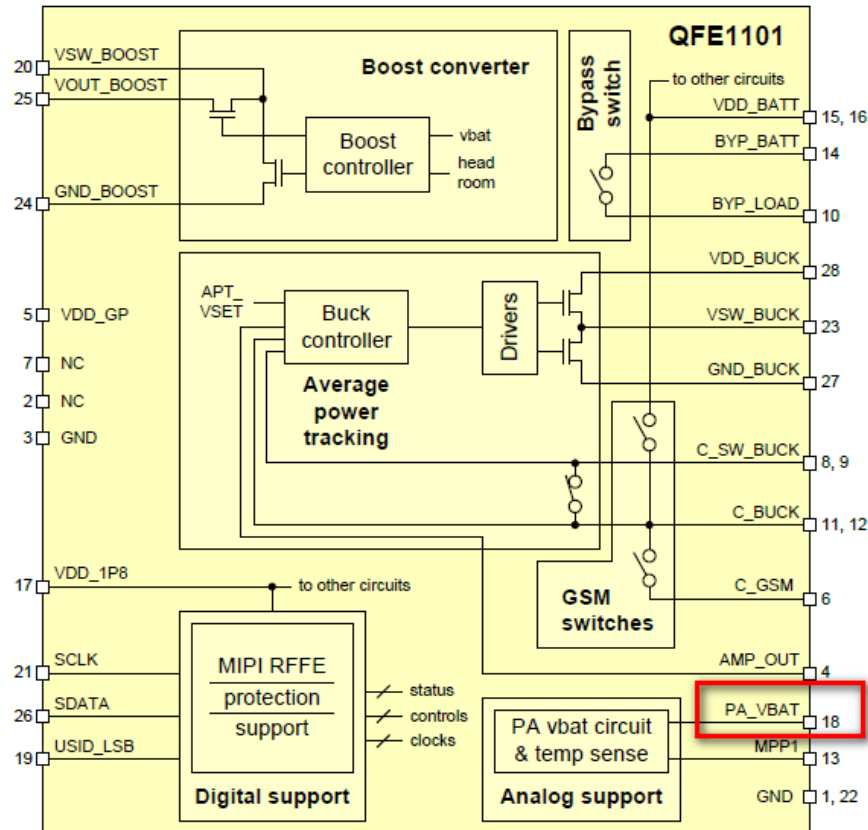
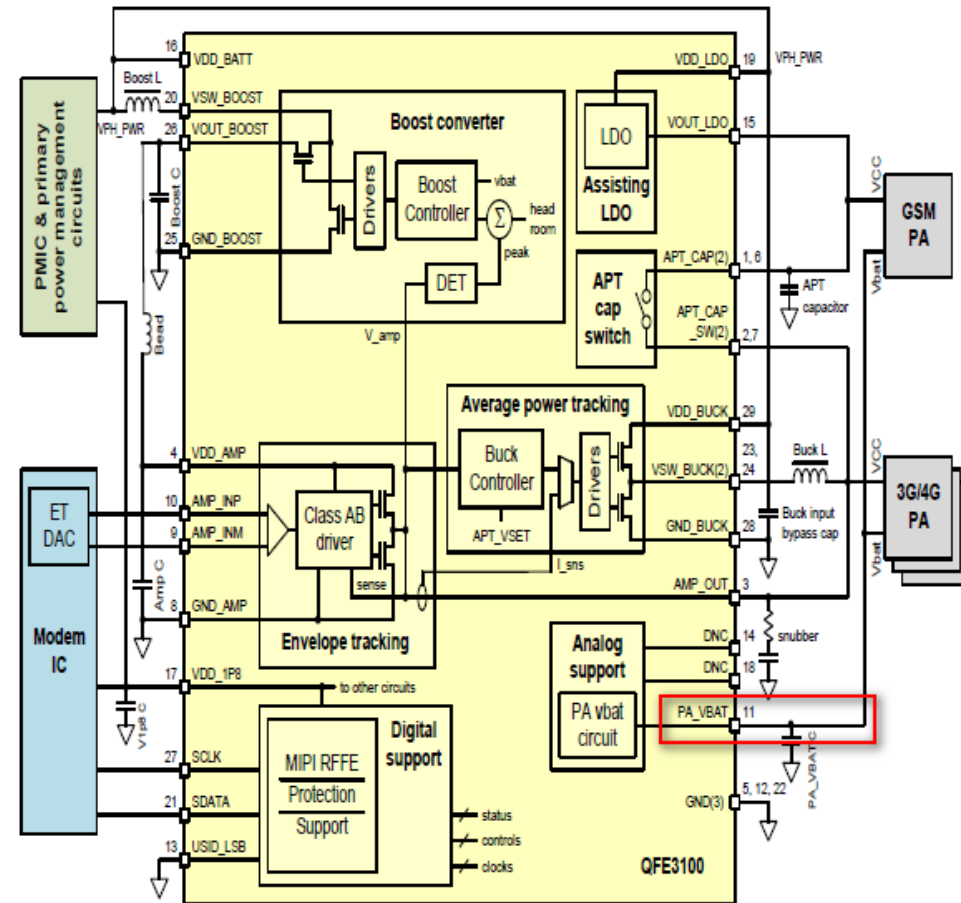
How to power VBATT of PA with QFE3100

- **Platform:** All+QFE3100
- **适用平台：** All+QFE3100
- **Description:** Normally, VBATT pin is used to power APT/ET PA bias, when QFE1100/1101 powers ET PA, VBATT is also powered from QFE1100 PA_VBAT. For some TDD HB PA Modules, for example, sky77807, internal switch is also powered by VBATT. If using PA_VBAT of QFE1100 to power VBATT of PA, PA_VBAT will be pulled down at standby/sleep mode, that cause TDD RX path to be switched off. So such PA is not recommended to be powered from PA_VBAT of QFE1100. But for QFE3100, how to power VBATT pin of PA?
- **问题描述：** APT和ET PA的偏置电路供电一般是VBATT pin，在用QFE1100/1101给PA供电时，VBATT pin用QFE1100/1101的PA_VBAT输出来供。但对于有些TDD HB PA Module，比如SKY77807，内部TX/RX Switch也是用该pin脚供电。那么如果用QFE1100的PA_VBAT供电，且手机处于standby/sleep模式的时候，QFE1100的PA_VBAT电压是被拉低的，就会导致TDD的RX通路断开而工作不正常，因而对于这种PA不建议用QFE1100/1101的PA_VBAT供电。那用QFE3100如何给PA的VBATT供电呢？

- **Reply:** (1)For QFE3100, PA_VBATT can be always on even in standby/sleep mode. It's different to QFE1100. (2)For APT only PA, VBATT pin can be powered with both VPH_PWR and PA_VBAT of QFE3100. (3)For ET PA , if phone works within 3.0V-4.5V and will shutdown below 3.0V, VBATT pin of PA can be powered from VPH_PWR; if phone still can work below 3.0V, VBATT pin of PA is required to be powered from PA_VBAT of QFE3100 , not VPH_PWR, because QFE3100 can make sure VBATT to stay within 3.0V-4.5V and work normally.
- **问题回复：**（ 1 ）QFE3100不同于QFE1100/1101，它的PA_VBATT输出可以一直是高电压，甚至在standby/sleep 模式也可以是常高。（ 2 ）对于APT only的PA，VBATT pin既可以用VPH_PWR供电，也可以用QFE3100的PA_VBAT供电。（ 3 ）对于ET PA，如果手机电池电压工作在3.0V-4.5V，3.0V以下手机会自动关机，那么VBATT除了可以用QFE3100的PA_VBAT供电，也可以接VPH_PWR供电。如果3.0V以下手机仍然可以工作，给ET PA仍然需要用QFE3100的PA_VBAT供电，不建议用VPH_PWR供电，因为QFE3100可以确保VBATT上的电压处于3.0v-4.5v，以保证ET在低电池电压下仍可以正常工作。
