高通RF技术期刊2015-12-30

Qualcomm Technologies, Inc.

1. GSM ORFS modulation issue
2. LTE B13 spurious emission issue for VZW supplementary testing
3. Baseband modem power supply for CA/non-CA design

1. TA.2.0 ICI-CA RFC Customization
2. CDMA 1x RC1 TX gating failure due to wrong MIPI PA_ON register address setting
3. How to debug WCDMA RSCP variation issues via RF AGC logs
4. Common Issues About GSM Tx Timing

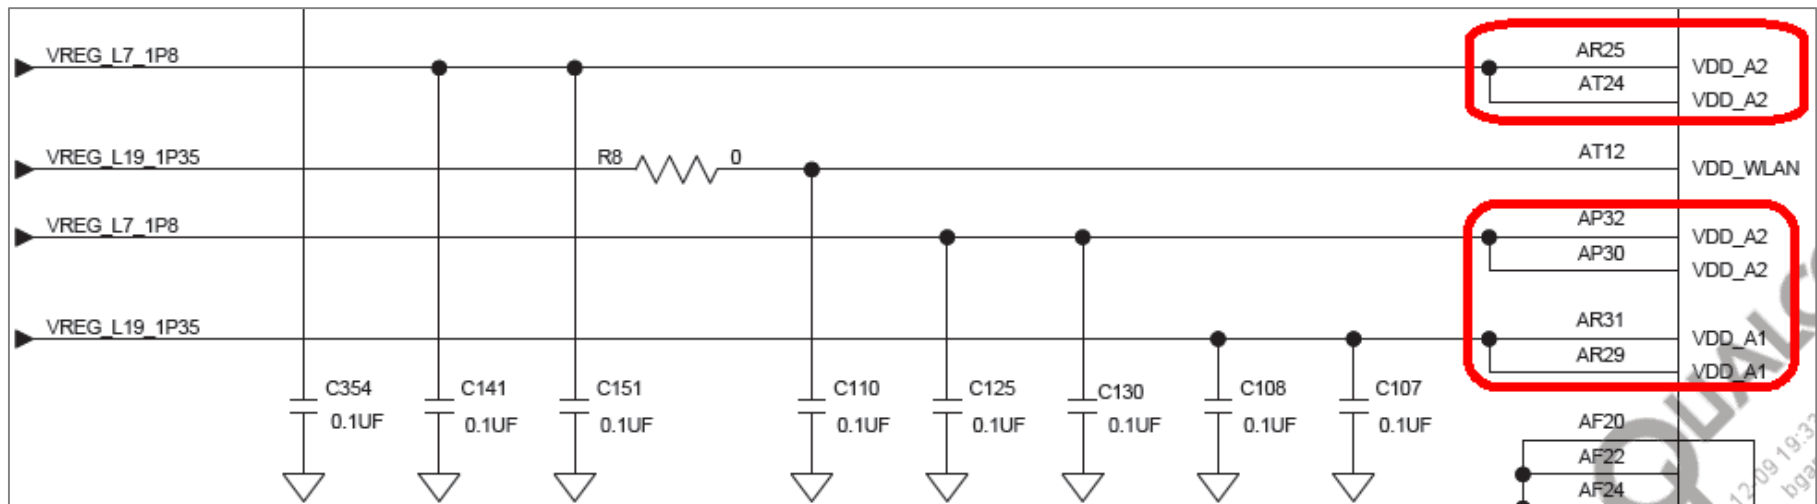
Baseband modem power supply for CA/non-CA design

- Modem供电pin脚:

- AR25(Tx_DAC0),AT24(Tx_DAC1),AR31/AP32(Rx_CH0/1),AR29/AP30(Rx_CH2/3)

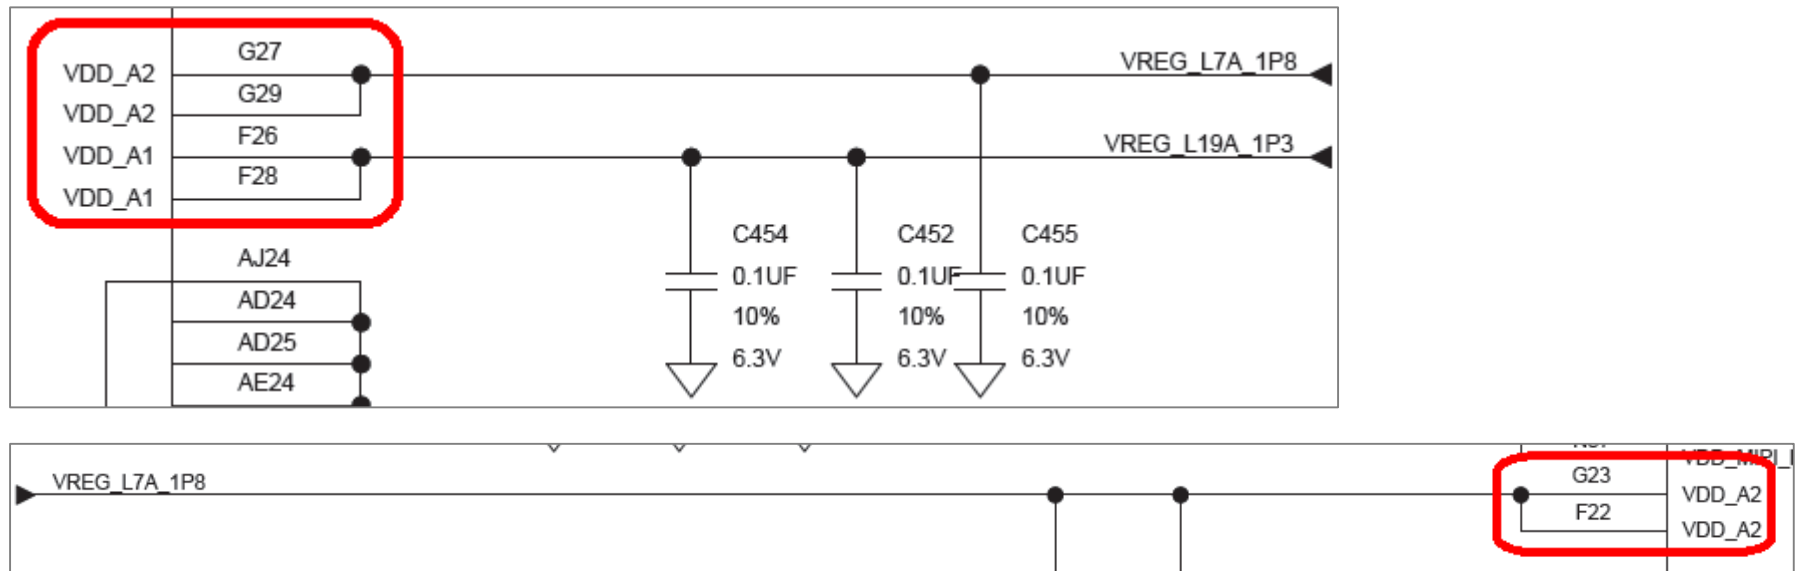
Baseband modem power supply for CA/non-CA design

- Modem供电pin脚:

- G23(Tx_DAC0),F22(Tx_DAC1),G27/F26(Rx_CH0/1),G29/F28(Rx_CH2/3)

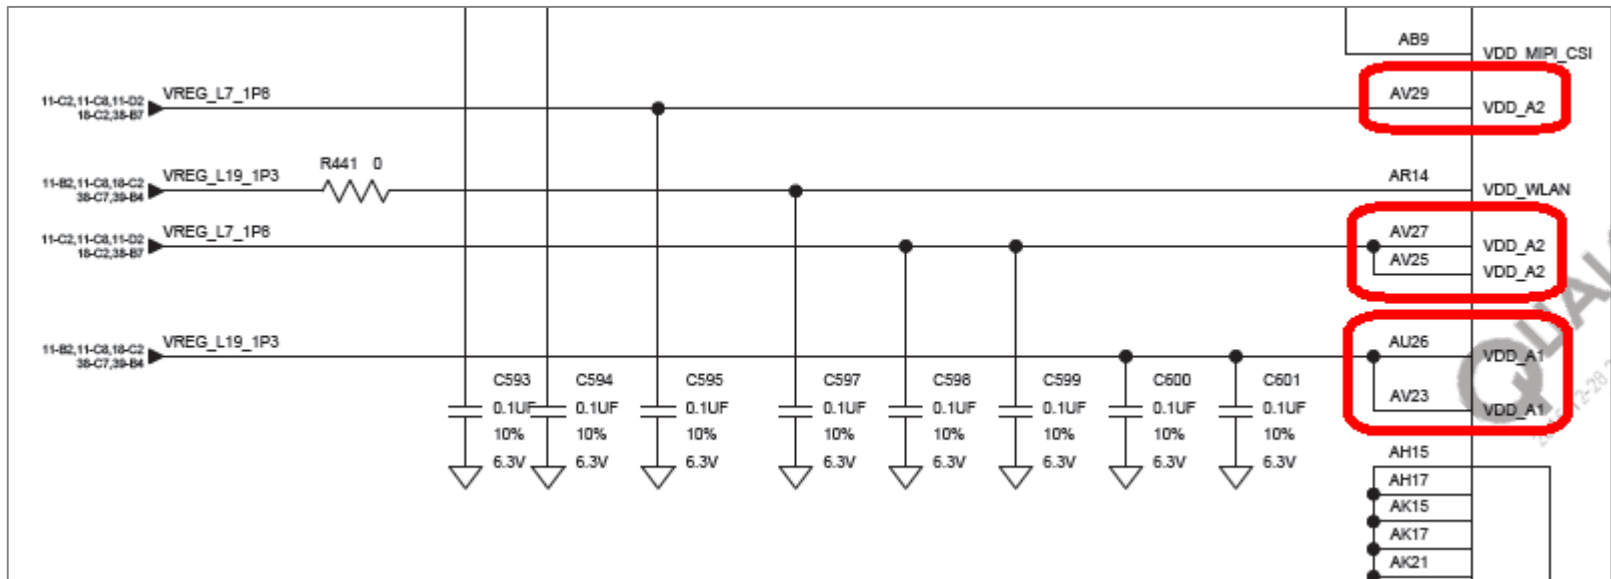
Baseband modem power supply for CA/non-CA design

- Modem power pins: AV29(Tx_DAC0),AU26/AV27(Rx_CH0/1),AV23/AV25(Rx_CH2/3)
- Modem供电pin脚: AV29(Tx_DAC0),AU26/AV27(Rx_CH0/1),AV23/AV25(Rx_CH2/3)
