Remediation Guideline
Defect ID: ST4-473

Asset: 716 Rejects Bin
Location: West side compression beam

Purpose: This document outlines the governance framework, procedures, and compliance requirements for the Replace of the Steel Beam (Defect ID: ST4-473) on 716 Rejects Bin located at West side compression beam. The repair process addresses structural damage caused by continuous mining operations and degradation over time, ensuring compliance with Australian Standards.

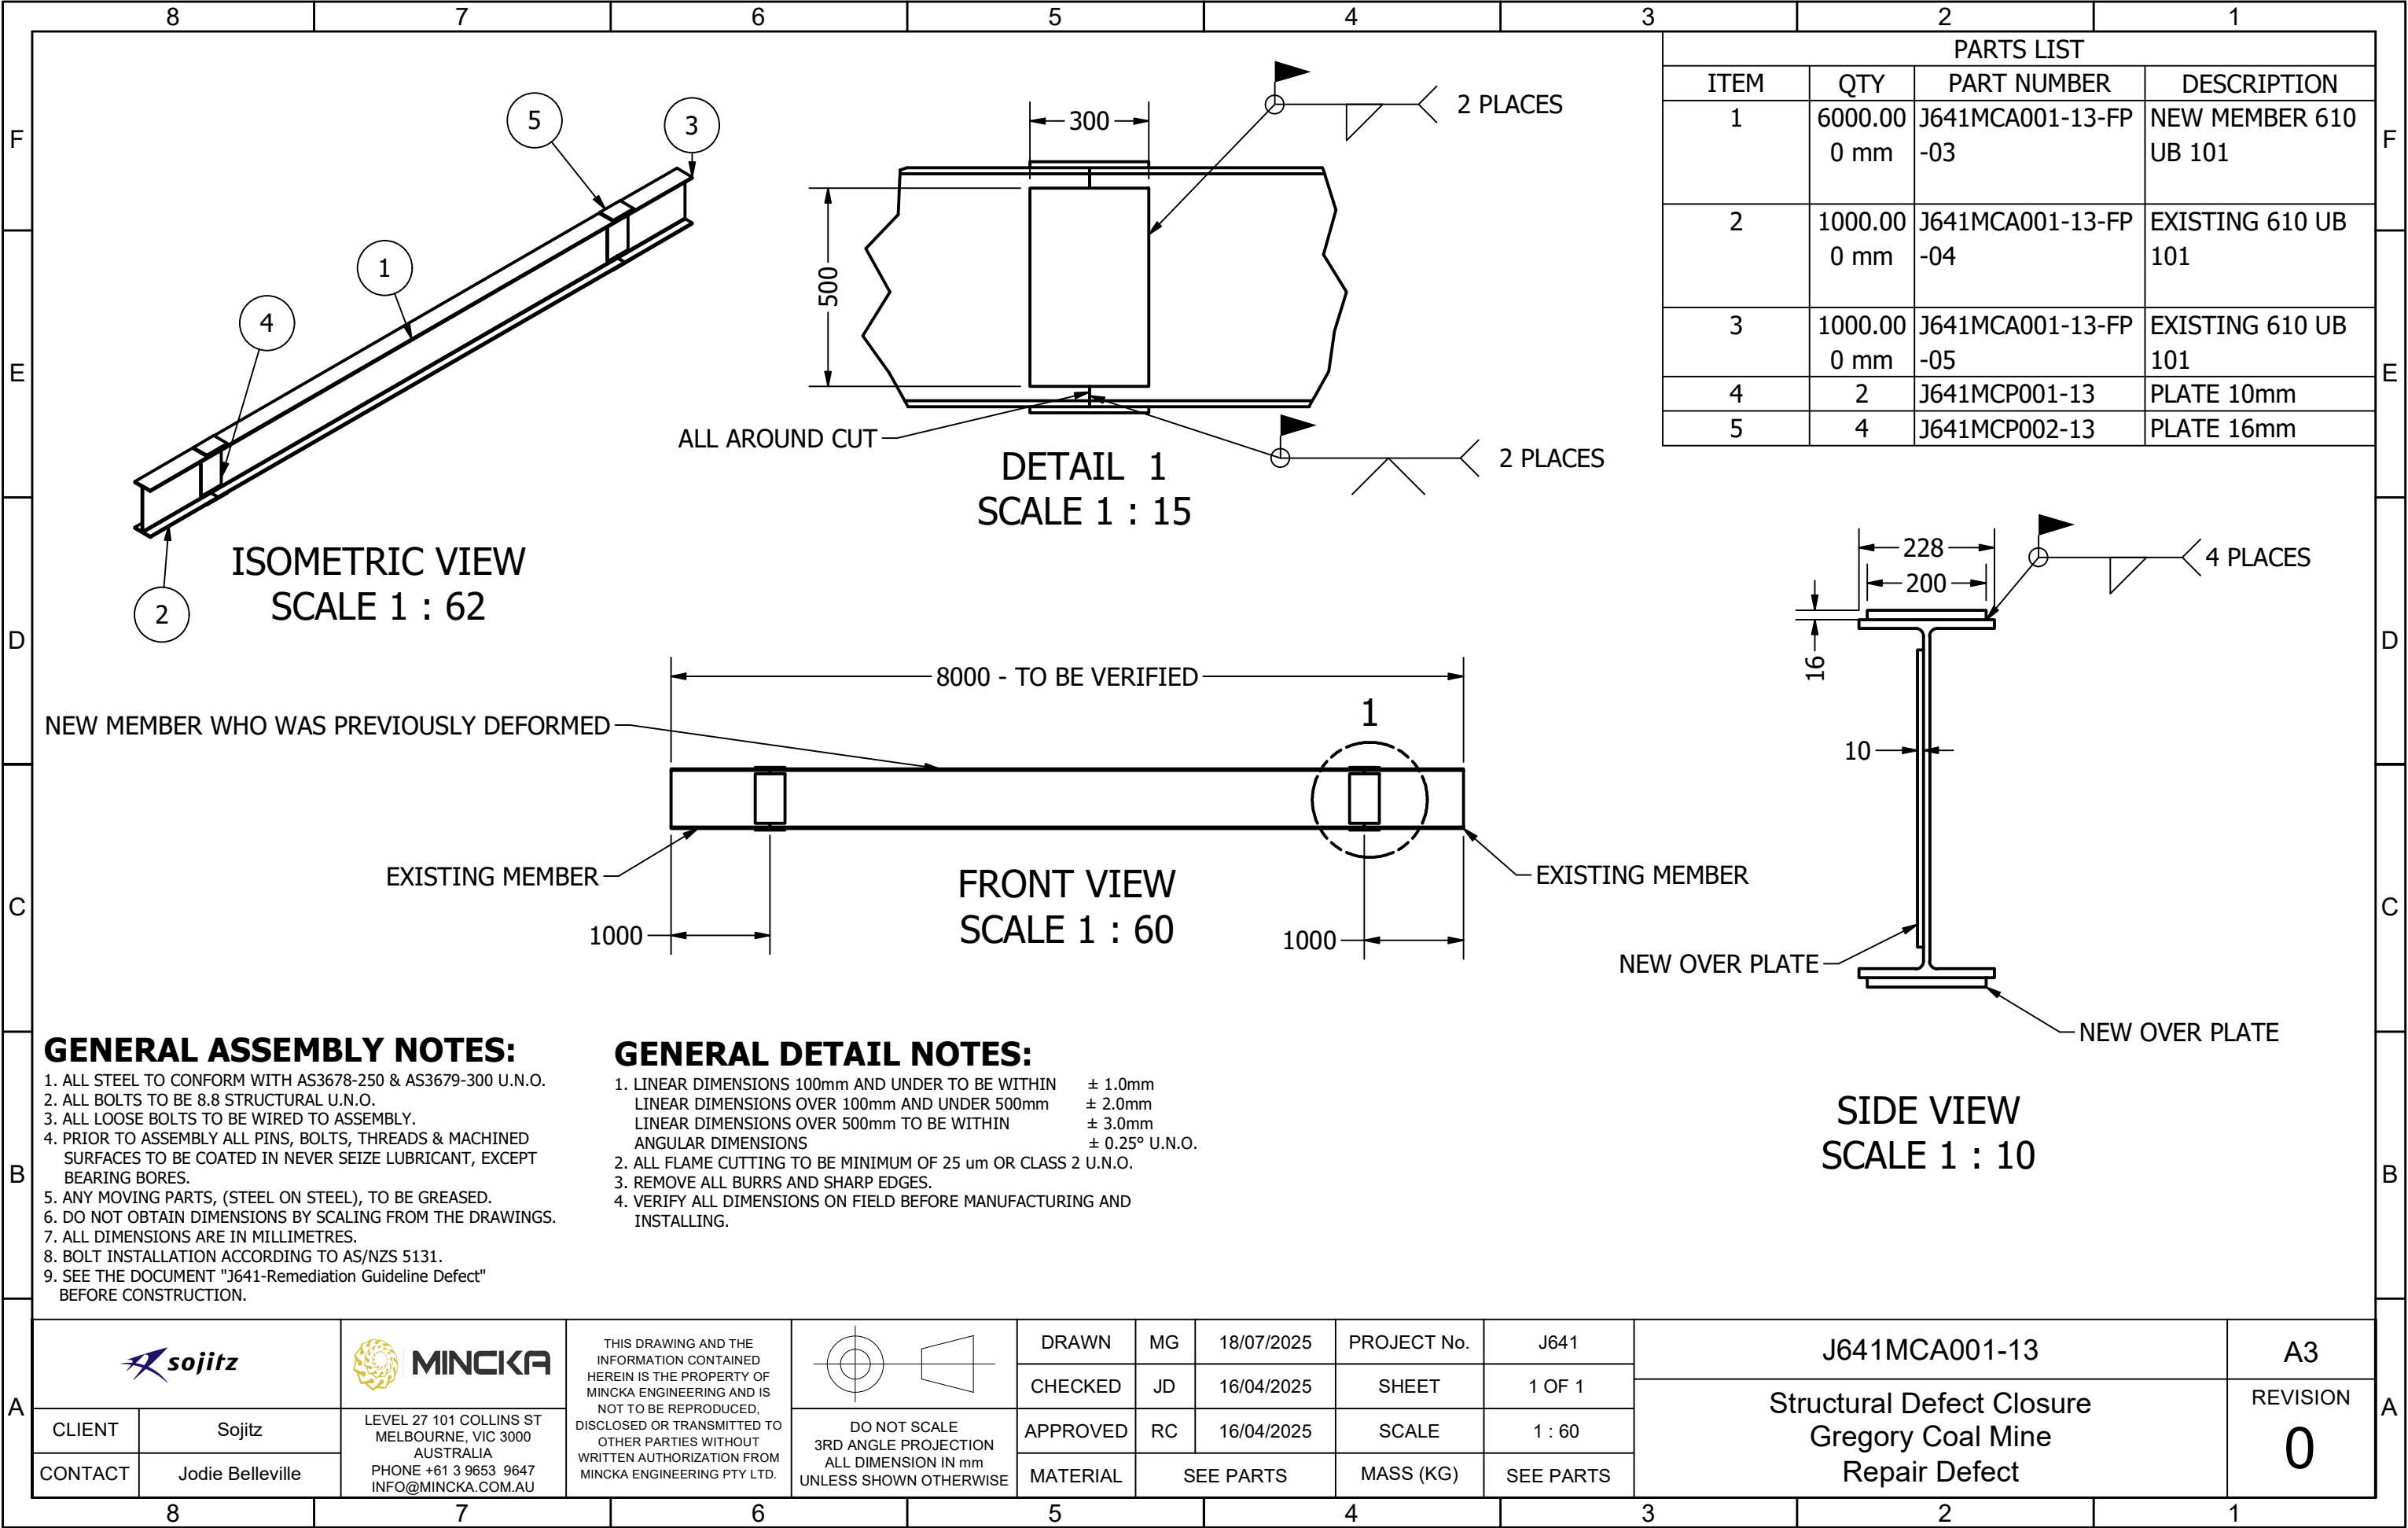
Permanent deformation was identified, likely caused by a mechanical impact or an excessive load. This deformation significantly reduces the structural element's stability, increasing its susceptibility to buckling.

Isolate the area around the damaged beam and apply necessary signage and barriers to ensure safety.

Carefully detach any connected elements or fixtures from the damaged beam using appropriate tools, ensuring no additional stress is placed on the structure.

Clean the installation area, removing any debris, rust, or old paint using wire brushes and scrapers to prepare for the new installation.

Apply a rust inhibitor to the cleaned surfaces to prevent future corrosion, ensuring compatibility with the existing steel structure.

Apply a protective coating to the new beam and any exposed steel surfaces, following the site-specific corrosion protection system.
