Multimedia Power Debugging Case Studies Overview

80-NT616-1 C

- Customer is reporting 720p video playback power is high for an APQ8084-based product
- Determine customer use case power consumption
 - Use case mentioned is a QTI standard use case
 - Customer measured power consumption using QTC77
 - Customer device power consumption is high using the QTI standard dashboard use case
 - Root cause of power difference must be determined

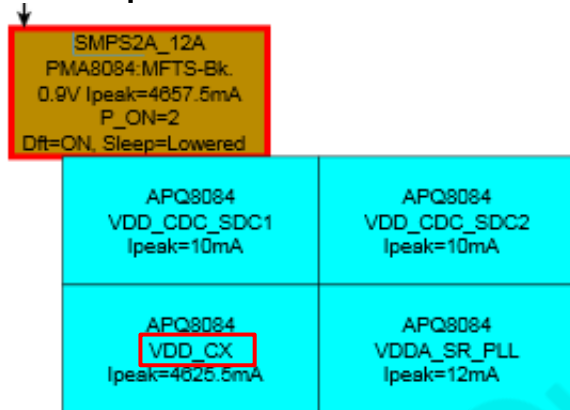
Identifying Power Rails Using a Power Tree

- SMPS2A powers CX rail

- SMPS2 is VDD_CORE (CX) rail source
- SMPS4 powers the LPDDR, EMMC, etc.
 - BIMC manages the clock for DDR, hence look for BIMC power consumption to know DDR consumption

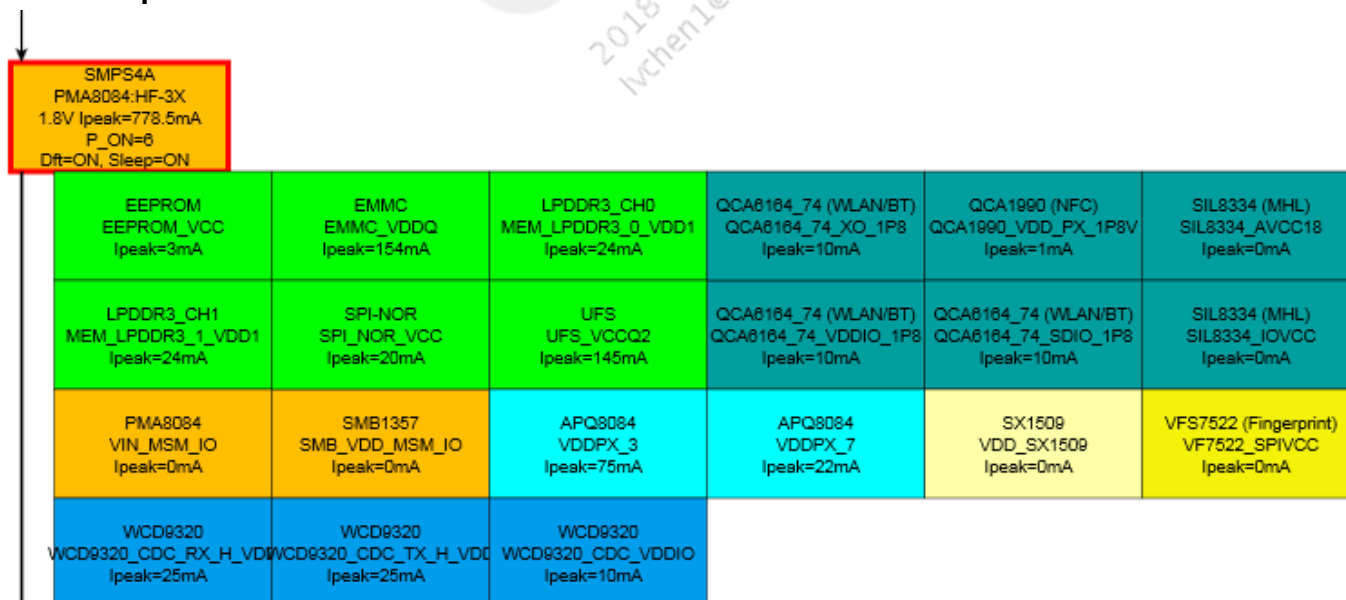
- SMPS4A powers audio codec and DDR

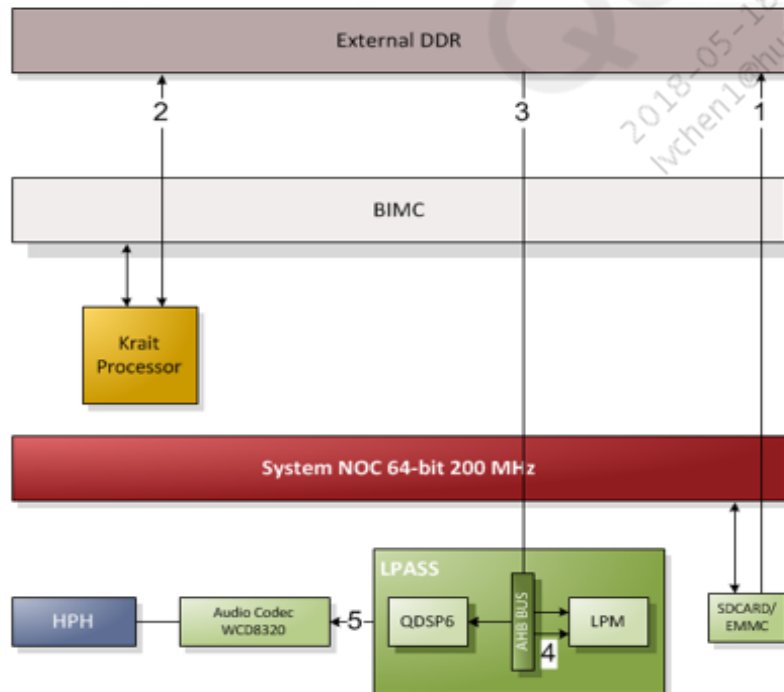
Why LPASS in Video Playback?

- The diagram shows that LPASS is involved in audio processing during video playback.
- LPASS requests DDR bandwidth and can influence BIMC frequency.
- The customer issue was isolated to audio processing and does not exist when video clips without audio are used.
- LPASS/audio bandwidth voting code must be checked to see LPASS bandwidth voting.

1. CPU reads 1 MB of data from the SDCARD/EMMC to the DDR.
2. CPU parses the data and puts it in the DDR.
3. LPASS sets up DM-Lite to transfer 32 KB of bit stream from the DDR to LPM.
4. LPASS performs decoding and postprocessing and puts a PCM sample into LPM.
5. LPASS sets up the DMA to render the PCM sample to the audio codec.

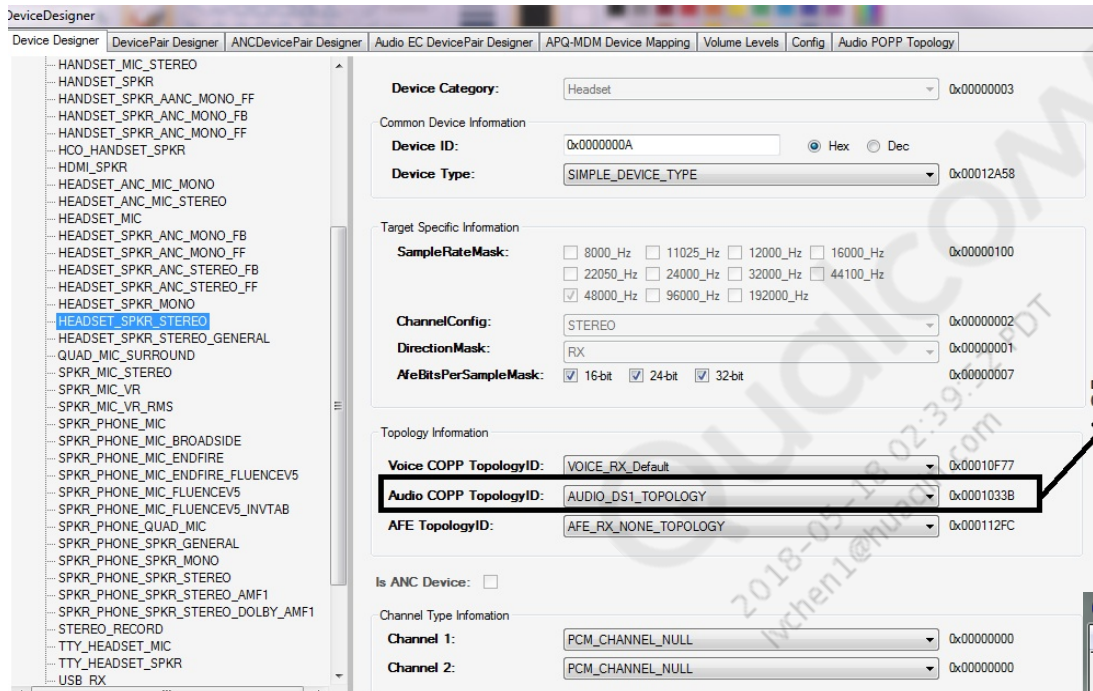
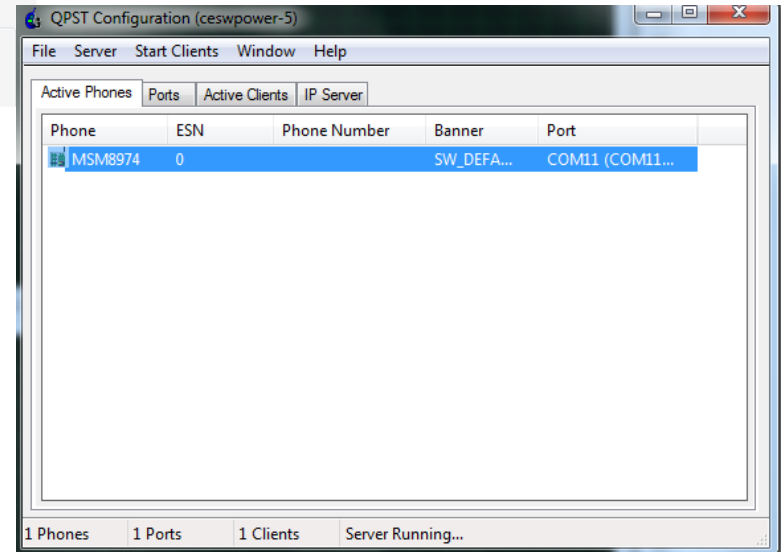
Using QACT and QPST to Change ACDB Files

- High current consumption for audio can be caused by postprocessing methodologies employed by customers.
- In this case, the customer had Dolby enabled. Disable Dolby using the QACT and QPST tools and note the power difference. For details on these tools, see:
 - QACT – *Installer, Qualcomm Audio Calibration Tool 5.0 Release 00000 (72-NT688-1)*
 - QPST – *Installer, QPST 2.7 Version 00424 (72-V1400-160)*
