Qualcomm Technologies, Inc.

PM660

Device Revision Guide

80-P7905-4 Rev. F

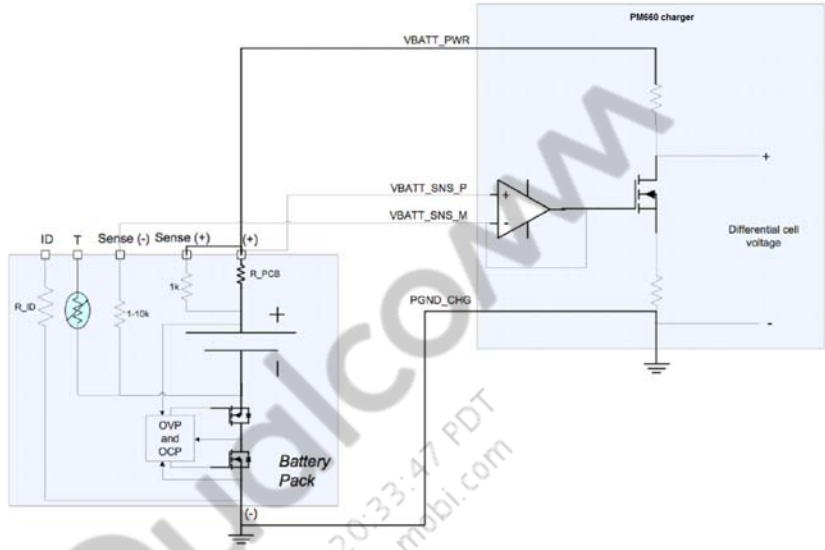
Issue 5-3 Battery continues to discharge when protection FETs open with in battery pack differential sensing

<p>Description</p>	<p>PM660 has the ability to differentially sense at the battery connector or internal to the battery pack and charge a battery. Example implementations are shown below for in battery pack differential battery voltage sensing:</p> <ul style="list-style-type: none"> ■ Typical 6-pin differential battery pack:

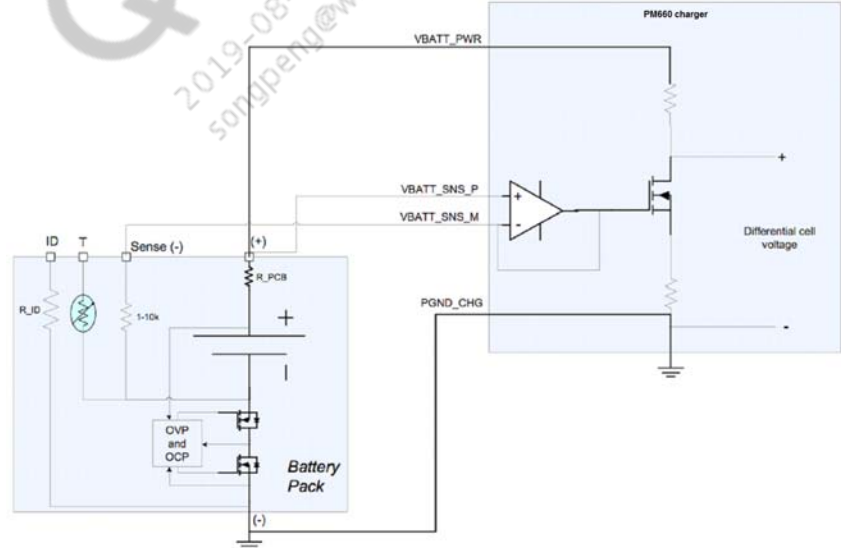
<ul style="list-style-type: none"> ■ Typical 5-pin differential battery pack:
