# TECHNICAL AUDIT REPORT

Location of intervention: Wind farm "  
Source de Sèves », 50490 ? Vaudrimesnil.

Mission completed on 11/12/2024

Mission type: Technical audit of a wind farm.

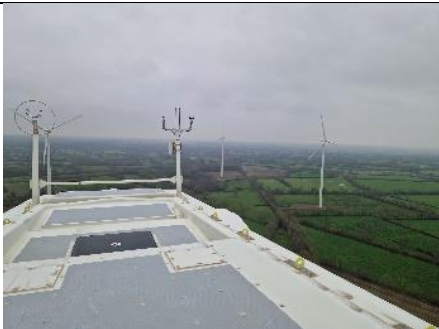
weather mast	in a degraded state	<p>with a rust trace on the part connecting the 2 meteorological masts.</p> <p>Comment from EDPR: EDPR will verify how to manage this issue</p>
