TECHNICAL AUDIT REPORT

Location of intervention: Wind farm «
Source de Sèves », 50490 – Vaudrimesnil.

Intervention No .: H0270241200000000329 **Nature
of the mission :** Technical audit of a wind power plant.

VDN 2 audited turbine

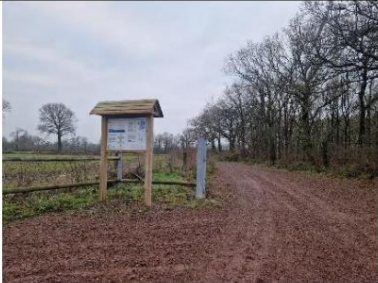
Description	State	Observations	Images
Access	Presence of the ICPE sign at the entrance to the access.	Normal state	No defects were found during the audit.

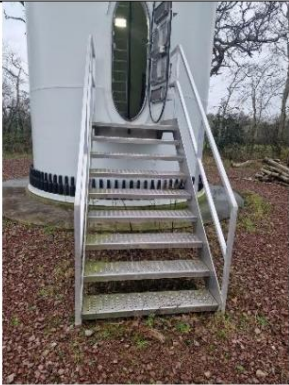
Status of the access path.	Normal state	No defects were found during of the audit.	
	State of conservation of the access staircase, conservation, bolts.	Normal state	No defects were found during of the audit.

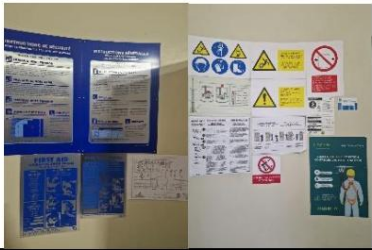
Status and presence of mandatory displays.	Normal state	No defects were found during of the audit.

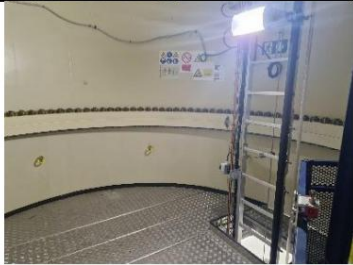
Section 2	State of cleanliness	Normal state	No defects were found during of the audit.

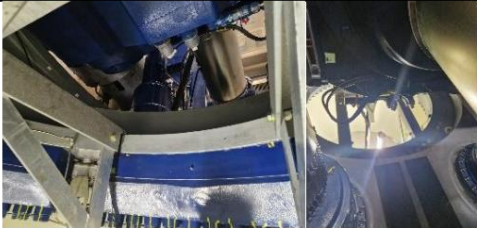
Lighting	Normal state	No defects were found during the audit.	
	Access	Normal state	No defects were found during the audit.

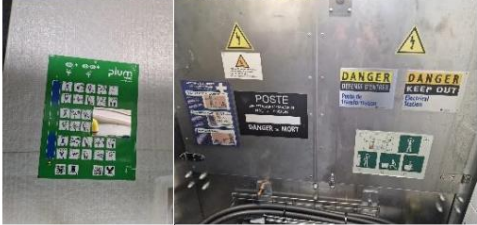
Display	Normal state	No defects were found during the audit.

Nacelle	Evacuator - ResQ	Degraded state	The box is slightly damaged, dirty <i>EDPR Comment: EDPR will look to change the box.</i>

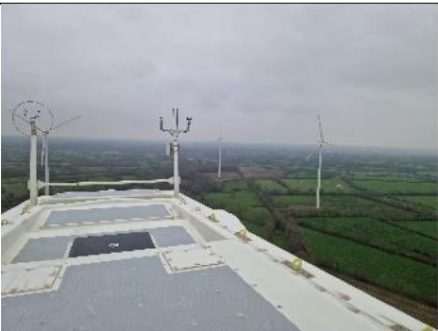
Weather mast	Degraded state	<p>Trace of rust on the part connecting the 2 weather masts.</p> <p><i>EDPR Comment: EDPR will check how to handle this issue.</i></p>

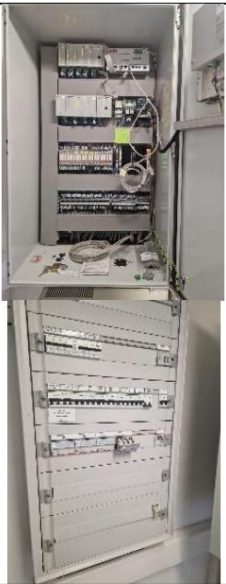
Interior	Condition of electrical cabinets (exterior/ interior).	Normal state	No defects were found during the audit.
