# TECHNICAL AUDIT REPORT

Location of intervention: Wind farm "  
Source of Sèves, 50490 ? Vaudrimesnil.

Case number: 2412H0270000001 Intervention number: H0270241200000000329  
Nature of the mission: Technical audit of a wind farm.

Identification:	VDN 2
Manufacturer:	Siemens Gamesa
Model:	SG97 T120
Power (W):	2 MW
Tower height (m):	120 m
Rotor (m):	97 m
Maintainer:	SGRE

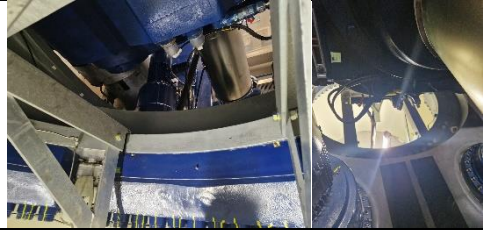
No defects were found during the audit. Access	Normal condition		
		Normal state	No defects were found during the audit.

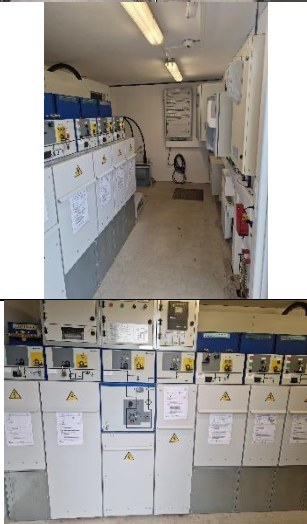
Condition of HT cell preservation (obstacles, interlocking, ?).	Normal condition	No defect was found during the audit.
