VEDANTA LIMITED

PRELIMINARY REPORT FOR IN LINE INSPECTION RUN

**14 INCH RD TO RT WATER INJECTION PIPELINE,
10.64 km**

SUBCONTRACT NO- PF-109943-R-24-189

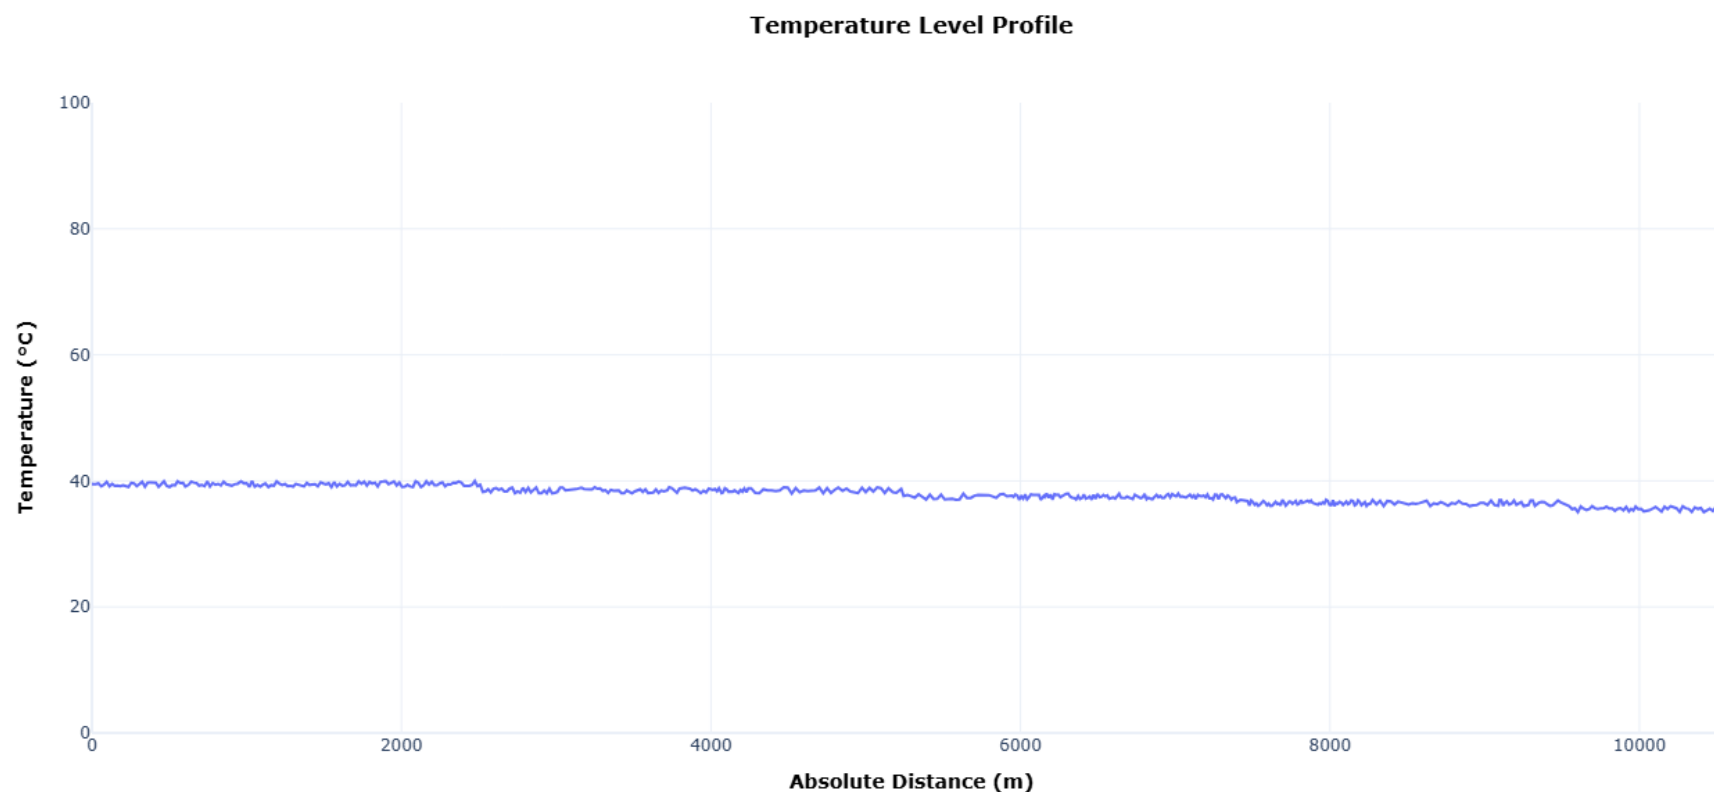
3.3 Temperature Profile EGP Tool

Total Inspection duration time	3 Hour 7 Minutes
Average Speed	0.9 m/s
Average Temperature	38° C
Maximum Pressure	70.3 Kg/cm ²

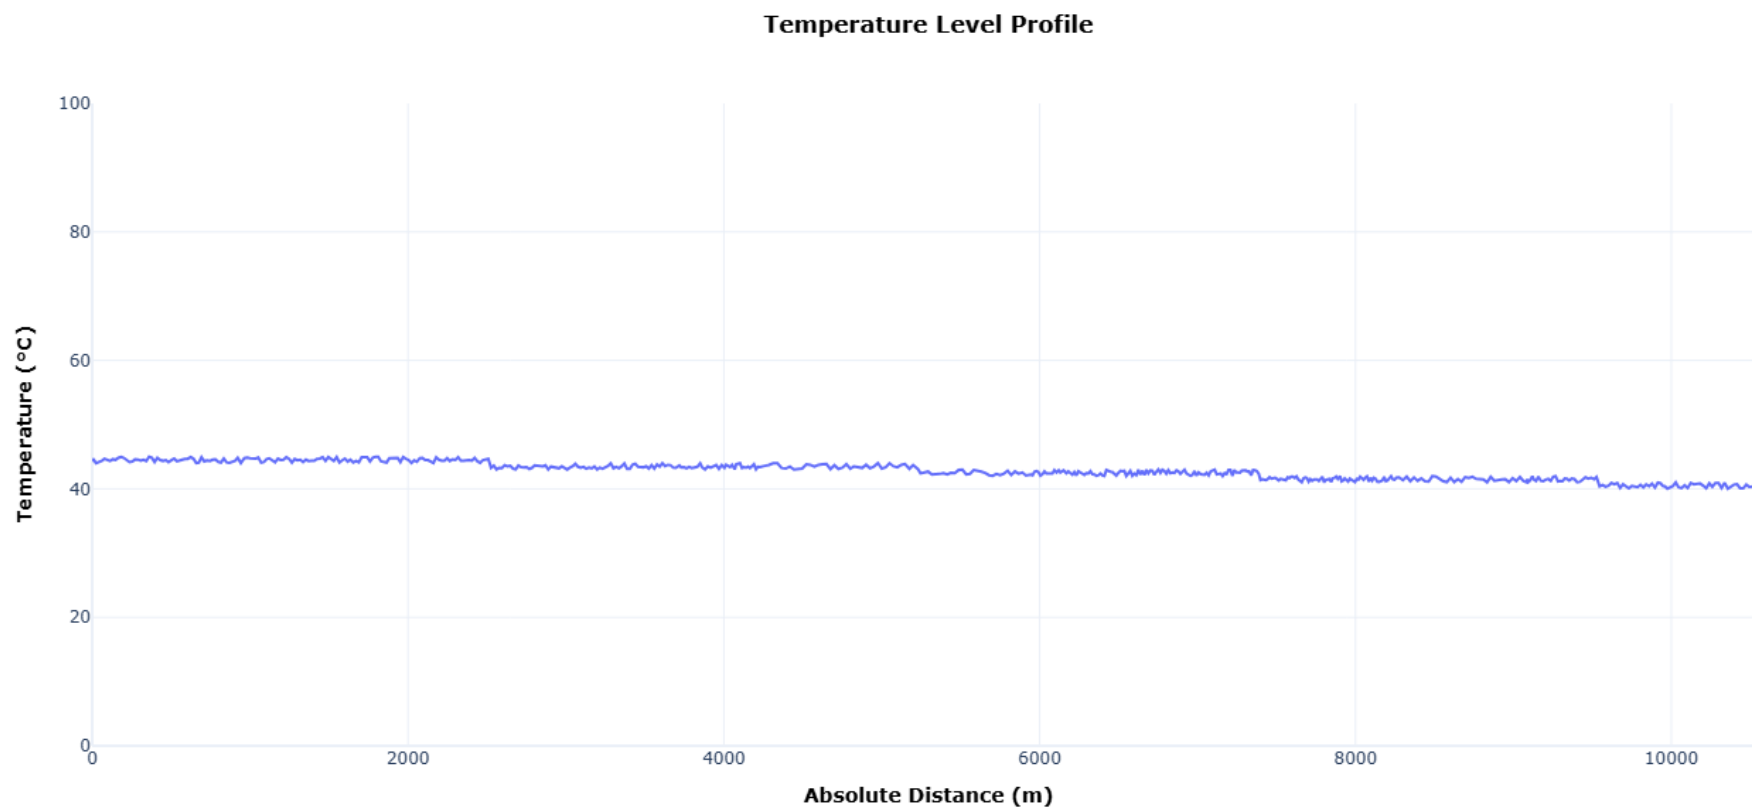
3.7 Temperature Profile MFL Tool Run #2

Total Inspection duration time	3 Hour 42 Minutes
Average Speed	0.8 m/s
Average Temperature	42° C
Maximum Pressure	70.2 Kg/cm ²

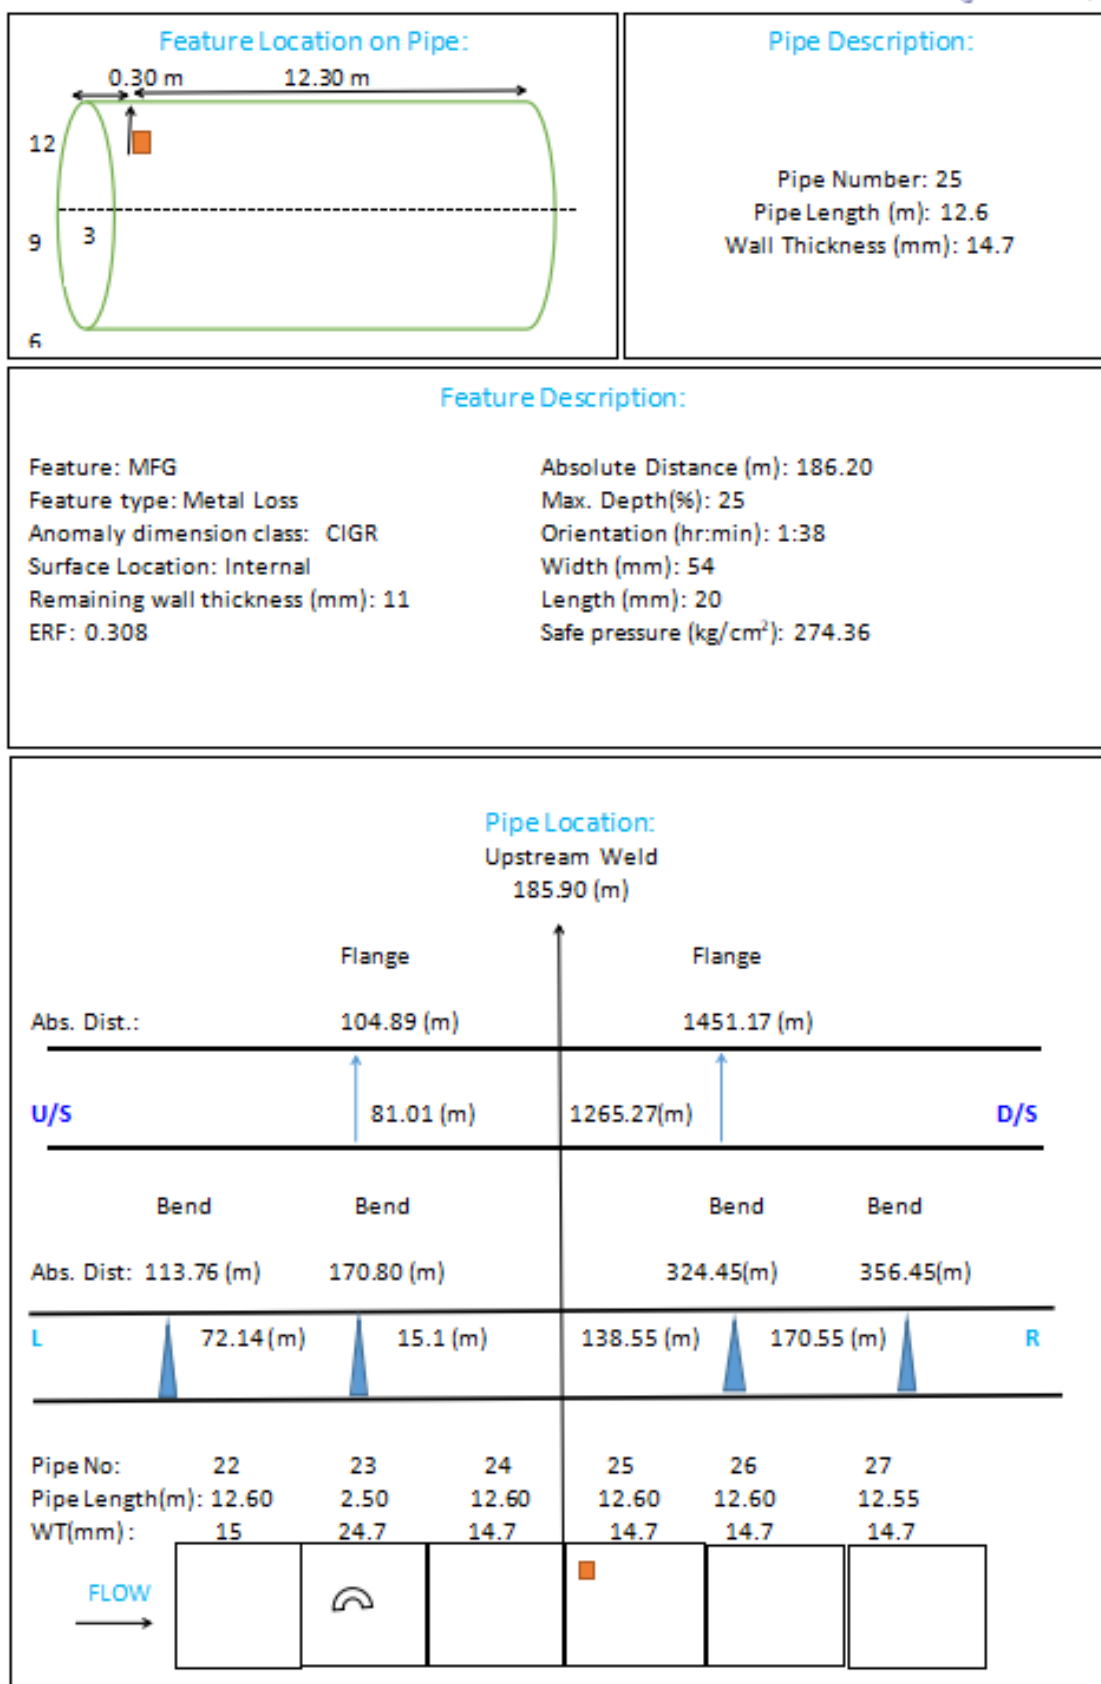
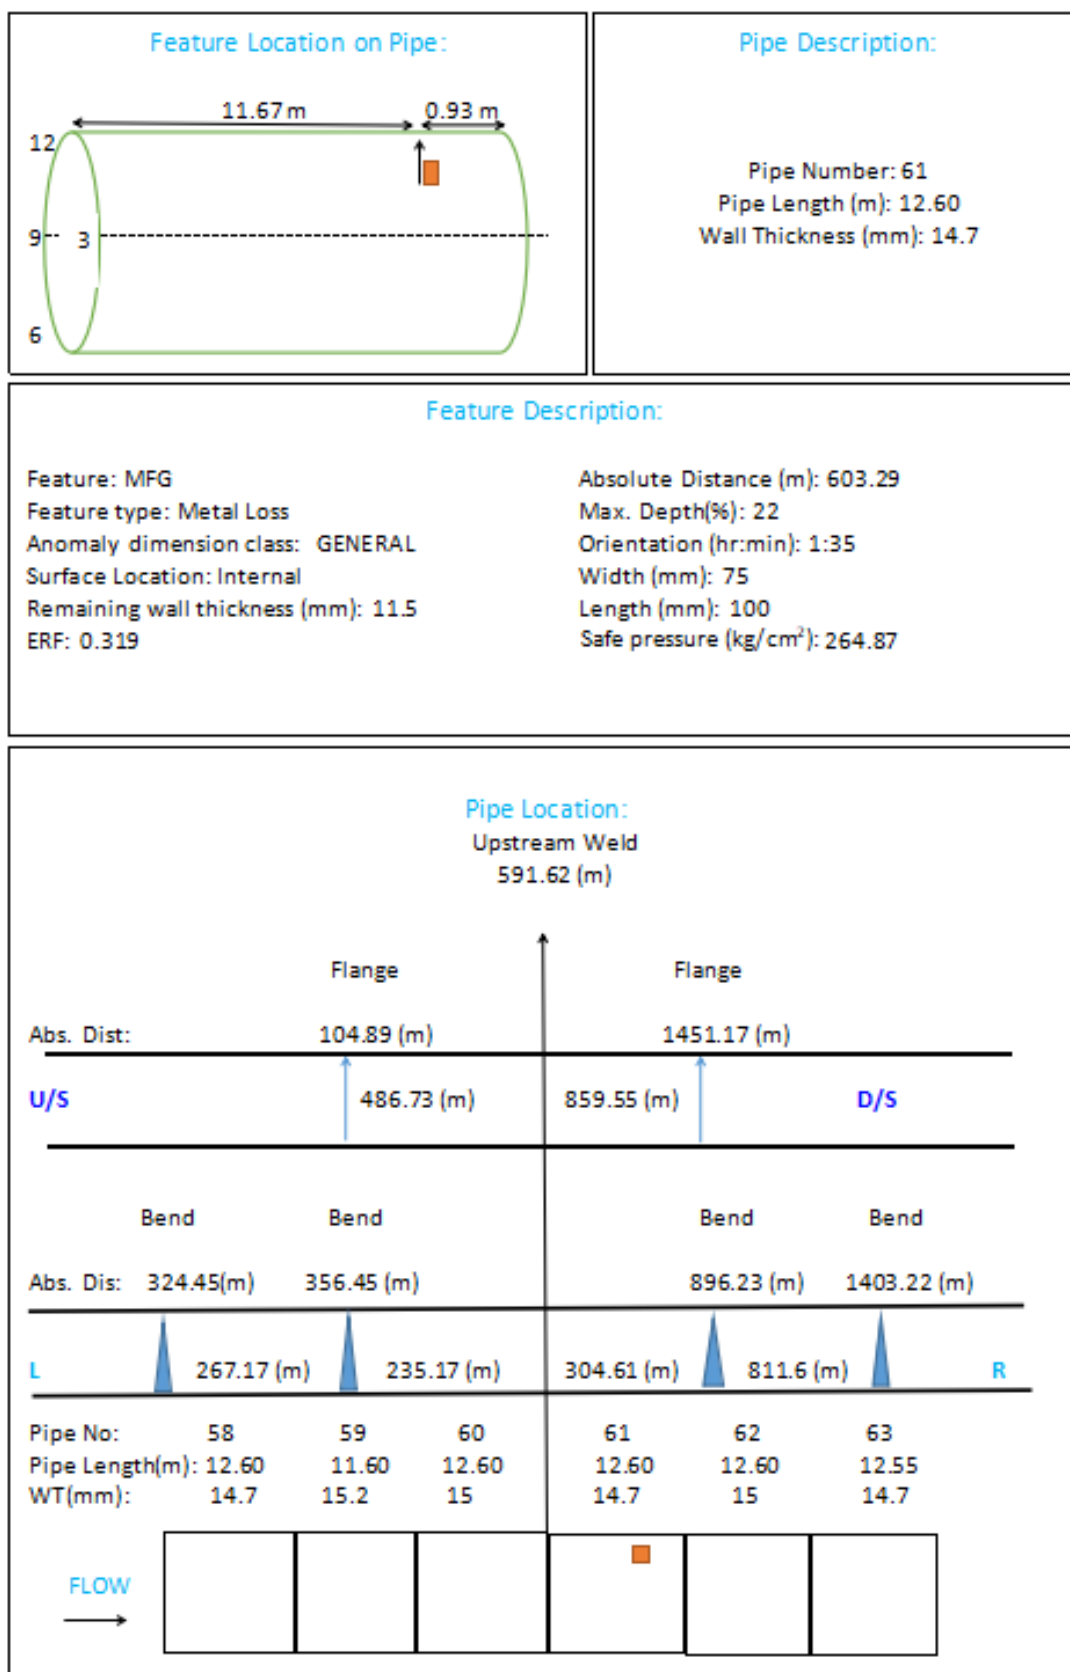
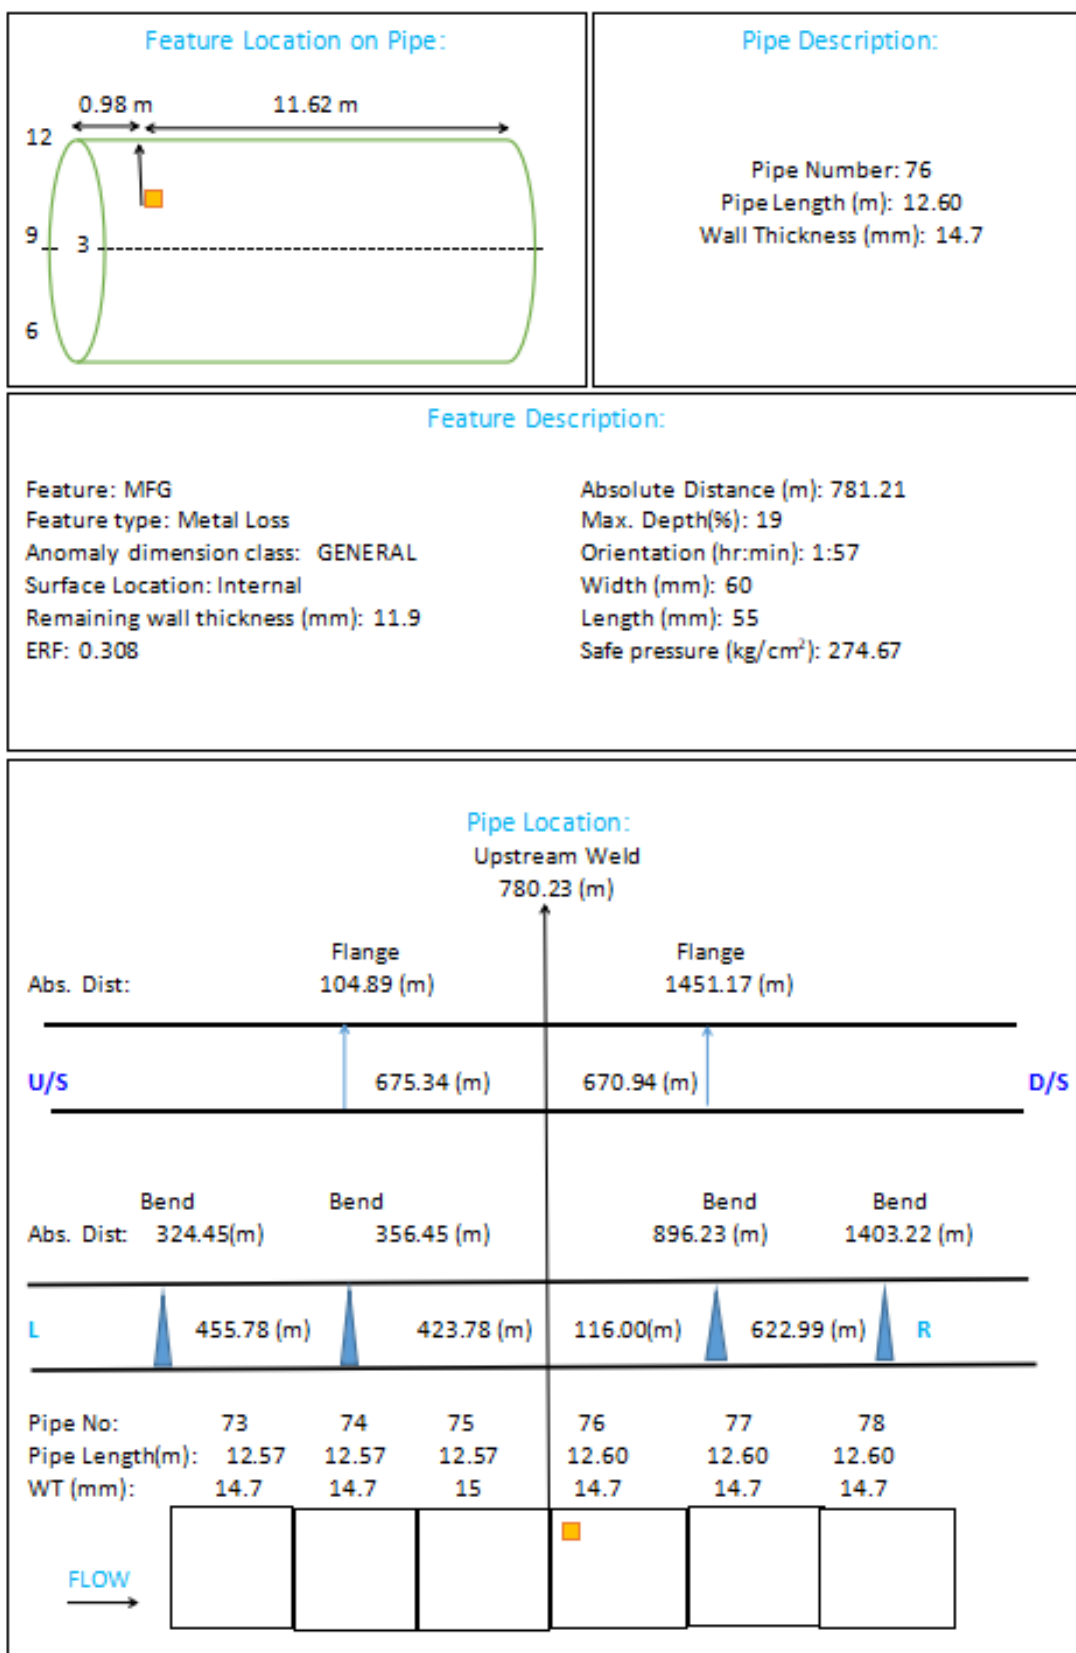
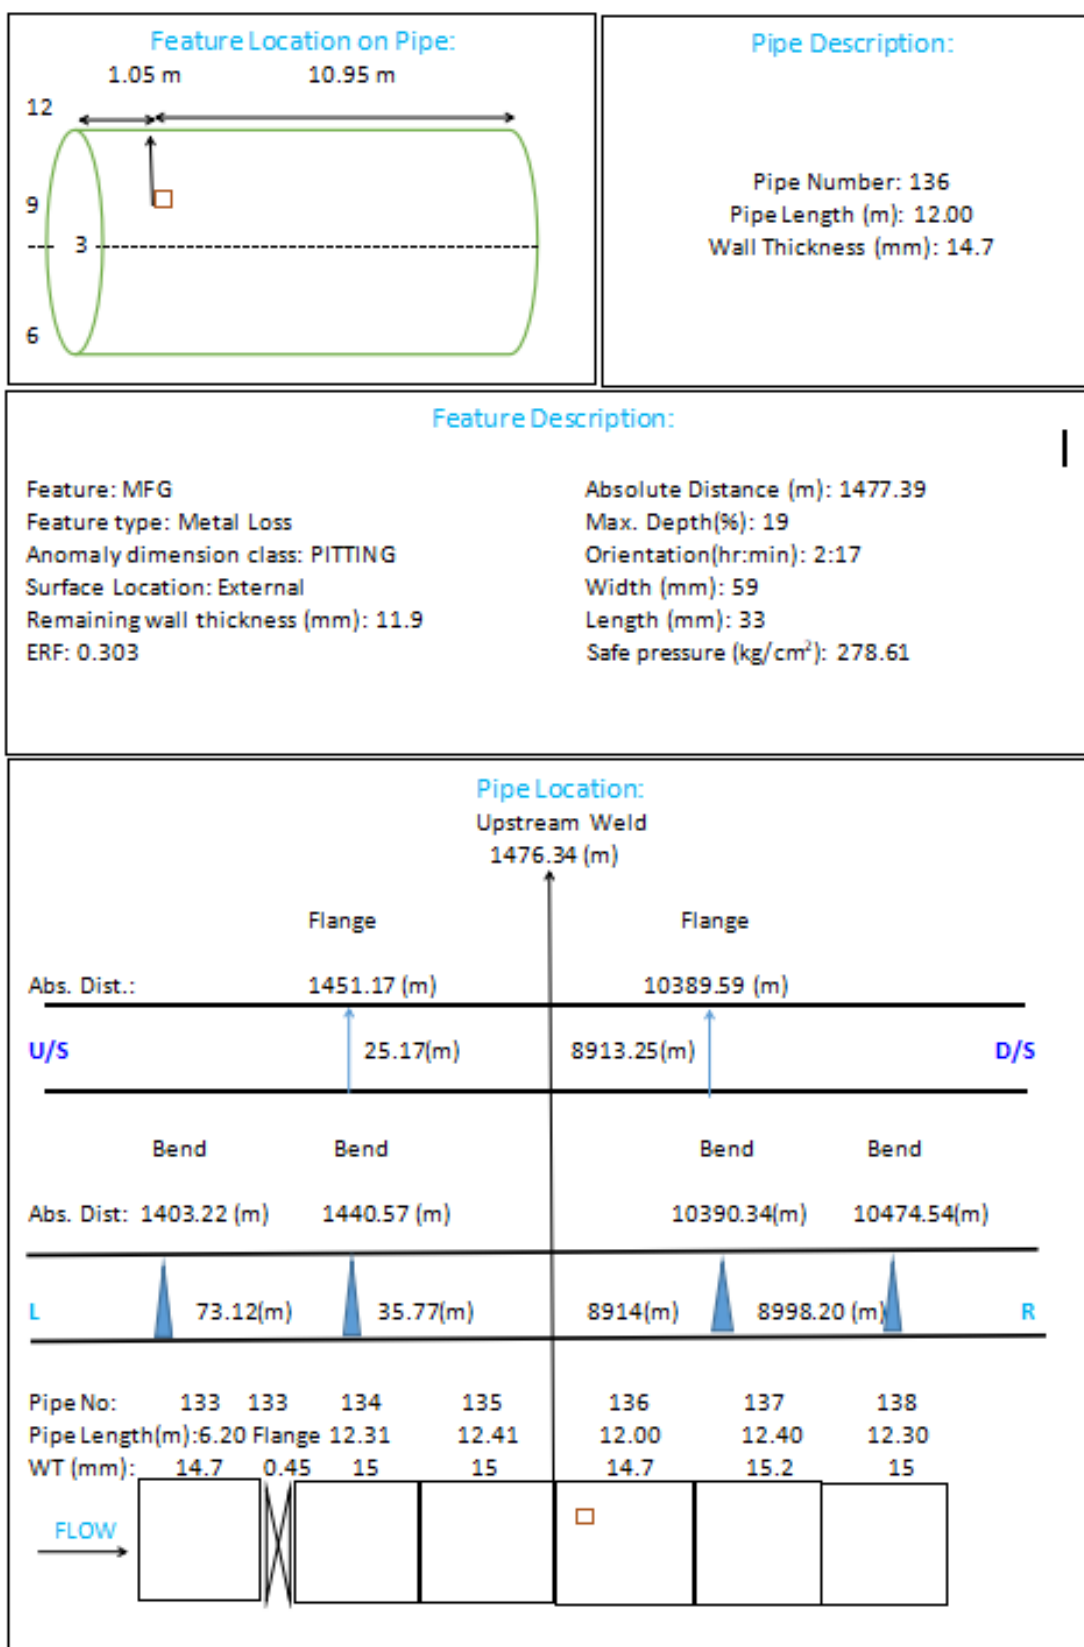
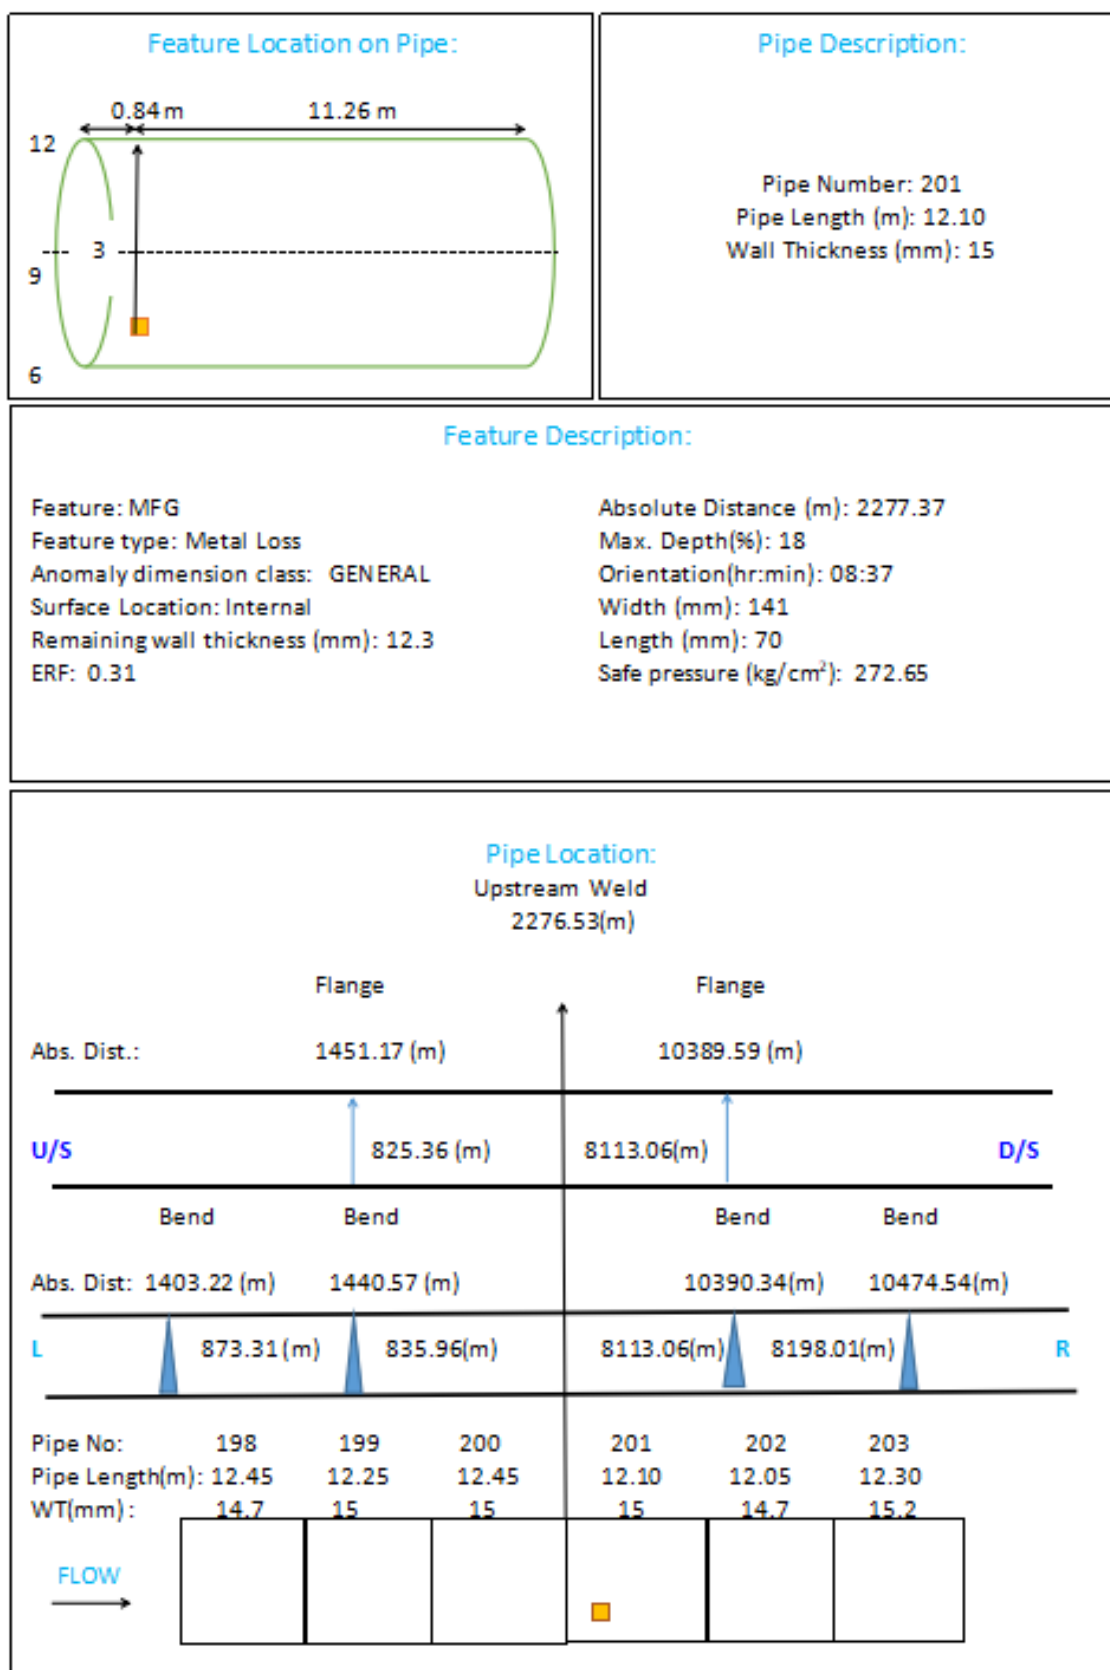
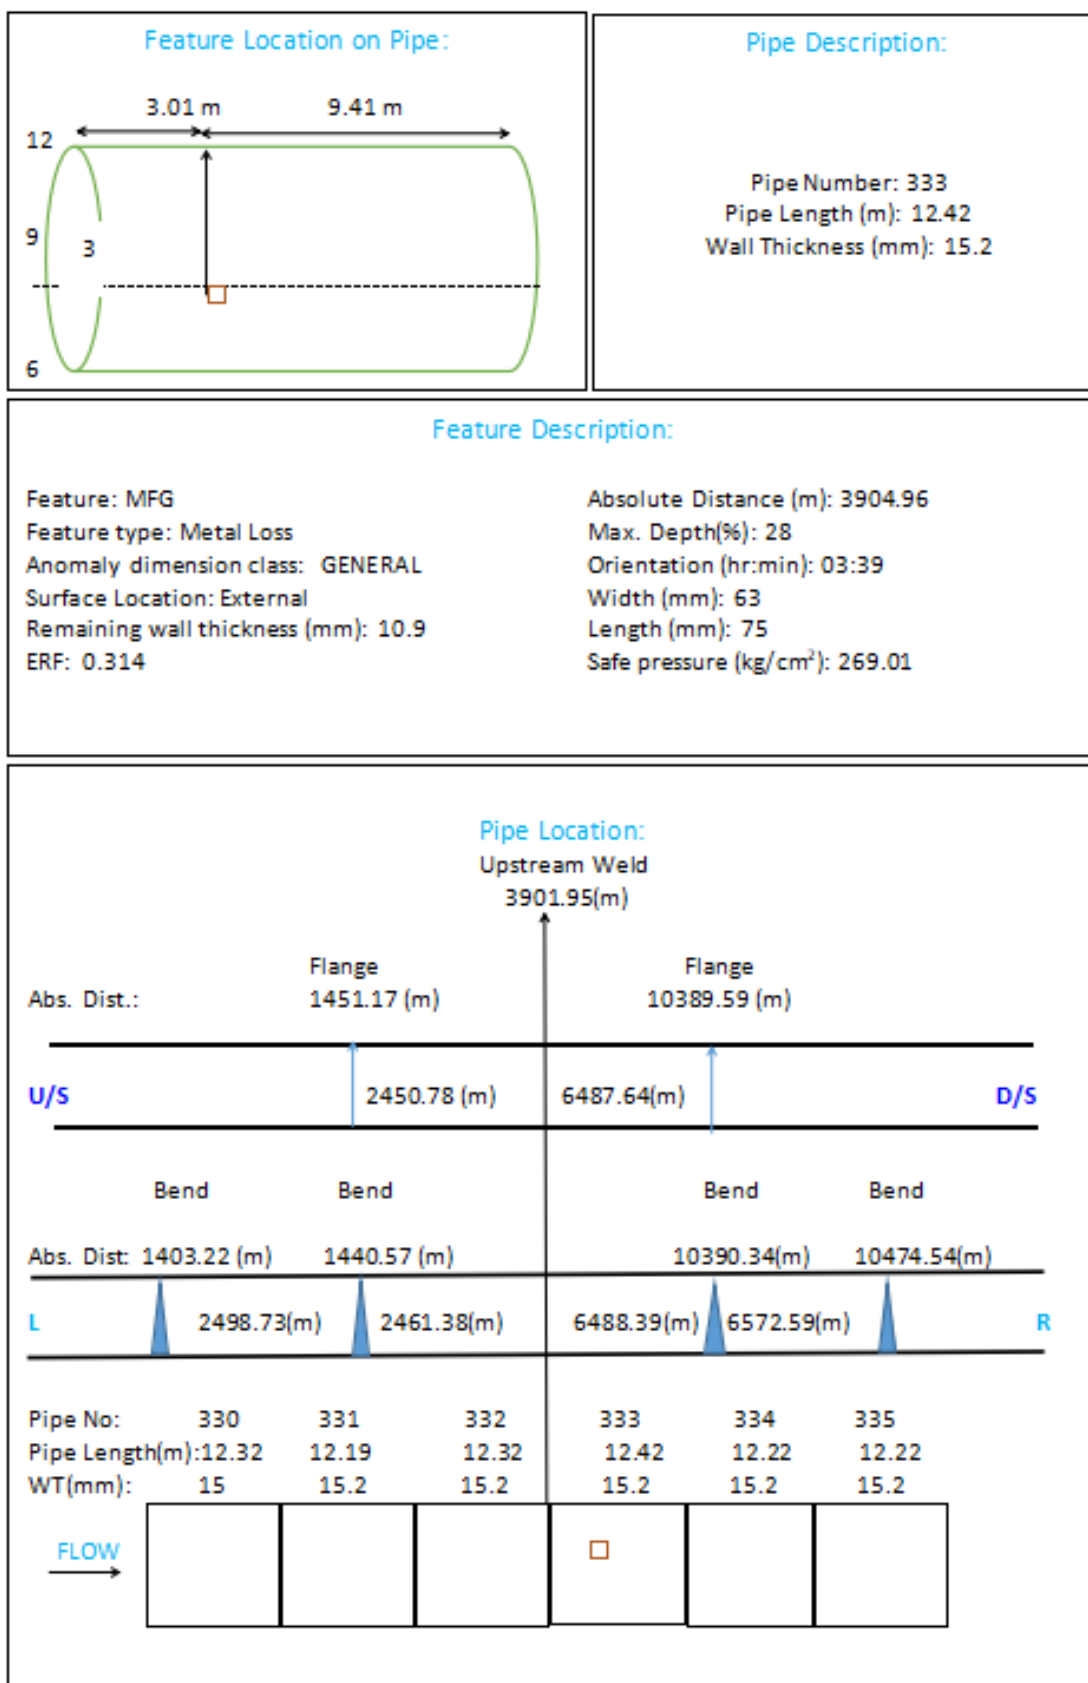
This section provides information that will enable the reference joint to be located for excavation. Wherever possible, the position of the metal loss feature is related to reference points that can easily be identified and located from the surface. There is a schematic diagram giving details of 3 pipe spools upstream and downstream of the reference joint.
