SERVICE BULLETIN
SUMMARY

TITLE: AIR CONDITIONING - DISTRIBUTION - INSPECTION OF DRAIN PIPES**MODIFICATIONS**

SERVICE BULLETIN No.: A320-21-1174

A318/A319/A320/A321

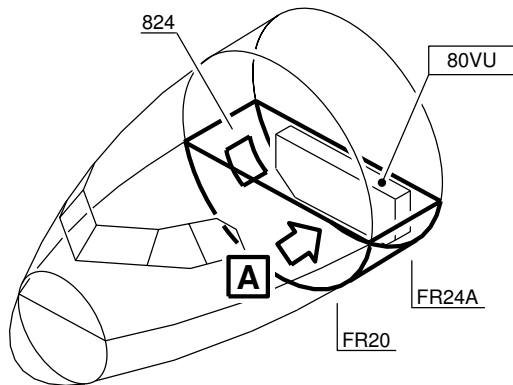
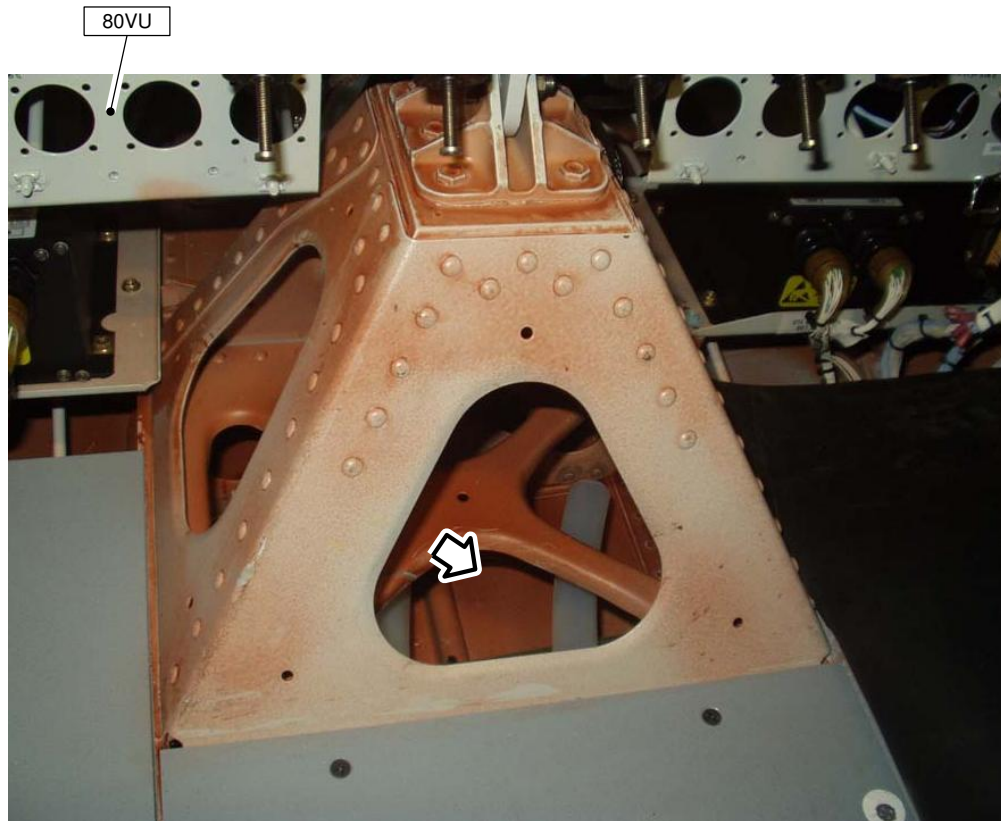
Air filter drain pipe and cabin floor grid drain pipe have been found too short during Final Assembly Line Inspection. Following a new issue of drainage system installation drawing, drain pipe length after the last clamp moved from 1.9685 in. (50 mm) to 4.7244 in. (120 mm). The modification of that dimension is linked to windmilling modification which moves the 80VU support pyramid forward. However on some aircraft having had this windmilling modification the length of the drain pipes after the last clamp remained with 1.9685 in. (50 mm); This defect can lead to dripping of drainage liquid on electrical wires (routes 1M, 2M, 1S, 2S)

- (a) Loosen the 5 or/and 7 clamps shown on details B and C Refer to [Fig. A-FACAA](#)
- (b) Pull on the drain pipe(s) to get the suitable length of 4.7244 in. (120 mm)
- (c) Tighten the 5 or/and 7 clamps.
