737

Service Bulletin

Number: 737-24-1165
Original Issue: April 28, 2005
Revision 2: April 29, 2015
ATA System: 2434

SUBJECT: ELECTRICAL POWER - Standby Power System - Removal and Replacement of the Static Inverter Module

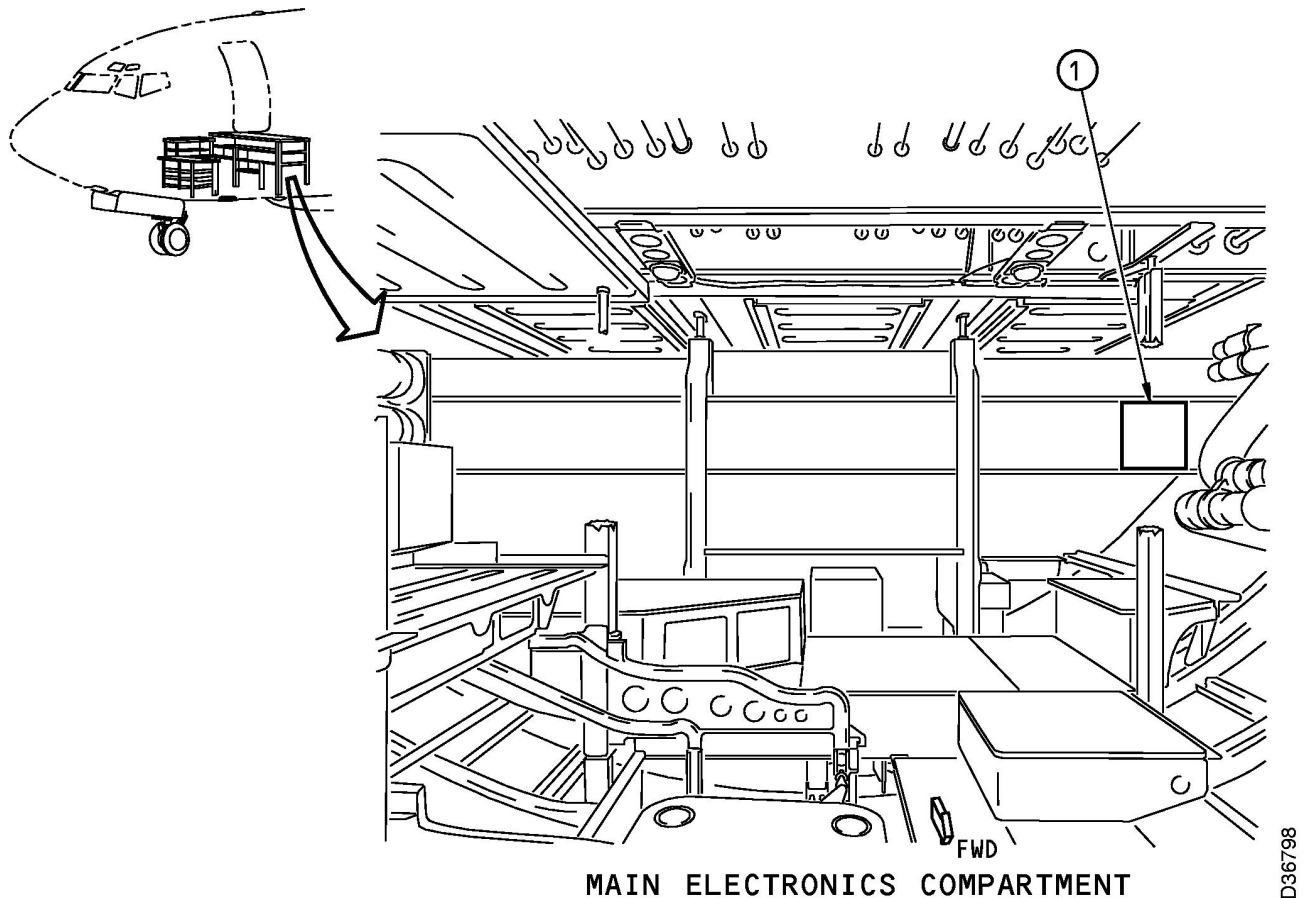
**FIGURE 1: REMOVAL OF THE STATIC INVERTER
(SHEET 1 OF 1)**

Boeing and Federal Aviation Administration (FAA) received reports that the static inverters can become too hot on many Boeing airplanes. In one incident, the pilots made an emergency landing after smoke got into the flight and the passenger compartments. After the emergency landing, the source of the smoke was found to be from a fire in the static inverter. Many Boeing airplane models have the same type of static inverter with the static inverter installed on the incident airplane. This change will prevent a possible unwanted smoke and fire conditions caused by a resistor in the static inverter.

3. In the main electronic equipment compartment, remove the static inverter from the E2-2 electronics shelf in accordance with FIGURE 1.

STEP	TASK	PART NAME	IDENTIFICATION	QTY	MORE DATA
1	Remove	Static Inverter	S282T004-10 (Supplier Part Number: 1-002-0102-1000) or S282T004-20 (Supplier Part Number: 1-002-0102-2062)	1	(a)
(a) From the E2-2 electronics shelf. Refer to 737-600/700/800/900 AMM 20-10-07 and 737-600/700/800/900 AMM 24-34-21 as an accepted procedure.
