S.B. No. A320-21-1023 REV.

TITLE : AIR CONDITIONING - IMPROVED ADIRU DRAINAGE.

SERVICE BULLETIN No. : A320-21-1023

TITLE : AIR CONDITIONING - IMPROVE ADIRU DRAINAGE

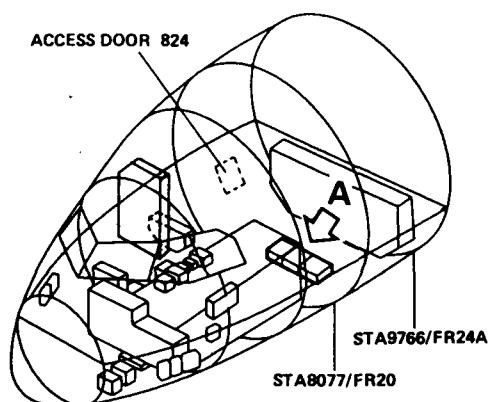
Water was found on the lower plate of the ADIRUs support. This water comes from the avionics equipment ventilation system in ground configuration during rainy weather (air taken from outside the aircraft) and can collect under the ADIRUs, sometimes leading to ADIRU malfunctions.

Therefore, this Service Bulletin recommends drilling 2 holes in the lower plate of the ADIRUs support.
