S.B. No. A320-21-1015  
Mod. No. 21224/P01532

TITLE : AIR CONDITIONING - AVIONICS EQUIPMENT VENTILATION - REDUCE  
LEVEL OF VIBRATION AT WALL HEAT EXCHANGER.

SERVICE BULLETIN

MODIFICATION No. 21224/P01532

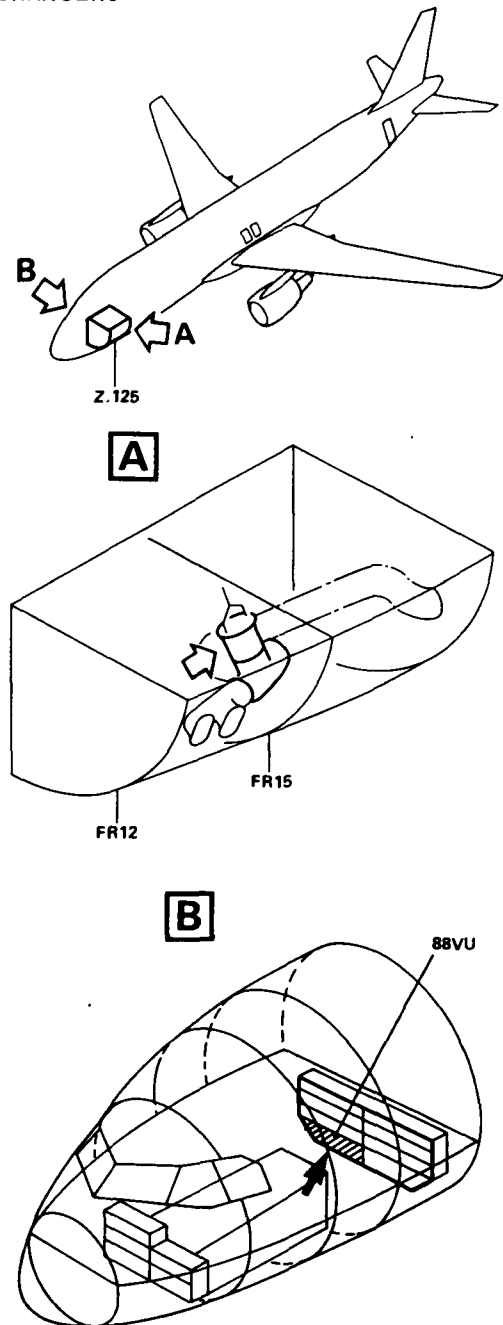
A new definition of the avionics  
ventilation system enables the air  
flow to be reduced, at the level of  
the heat exchanger, while still  
maintaining a satisfactory airflow  
at the level of the equipment. This  
new definition reduces the cockpit and  
cabin noise levels in flight.

This Service Bulletin proposes the  
modification of the Avionics Equipment  
Ventilation Computer (A.E.V.C.), as per  
the instructions given in the CROUZET  
Service Bulletin No. 87292325-21-001,  
as well as the deletion of the diaphragm  
associated with the SKIN EXCHANGER OUTLET  
BY PASS valve.
