SERVICE BULLETIN
SUMMARY

ATA SYSTEM: 21

**TITLE: AIR CONDITIONING - AVIONICS EQUIPMENT VENTILATION -
OPTIMIZE VENTILATION OF T3CAS INSTALLED IN 82VU**

MODIFICATION No.: 152526K15298

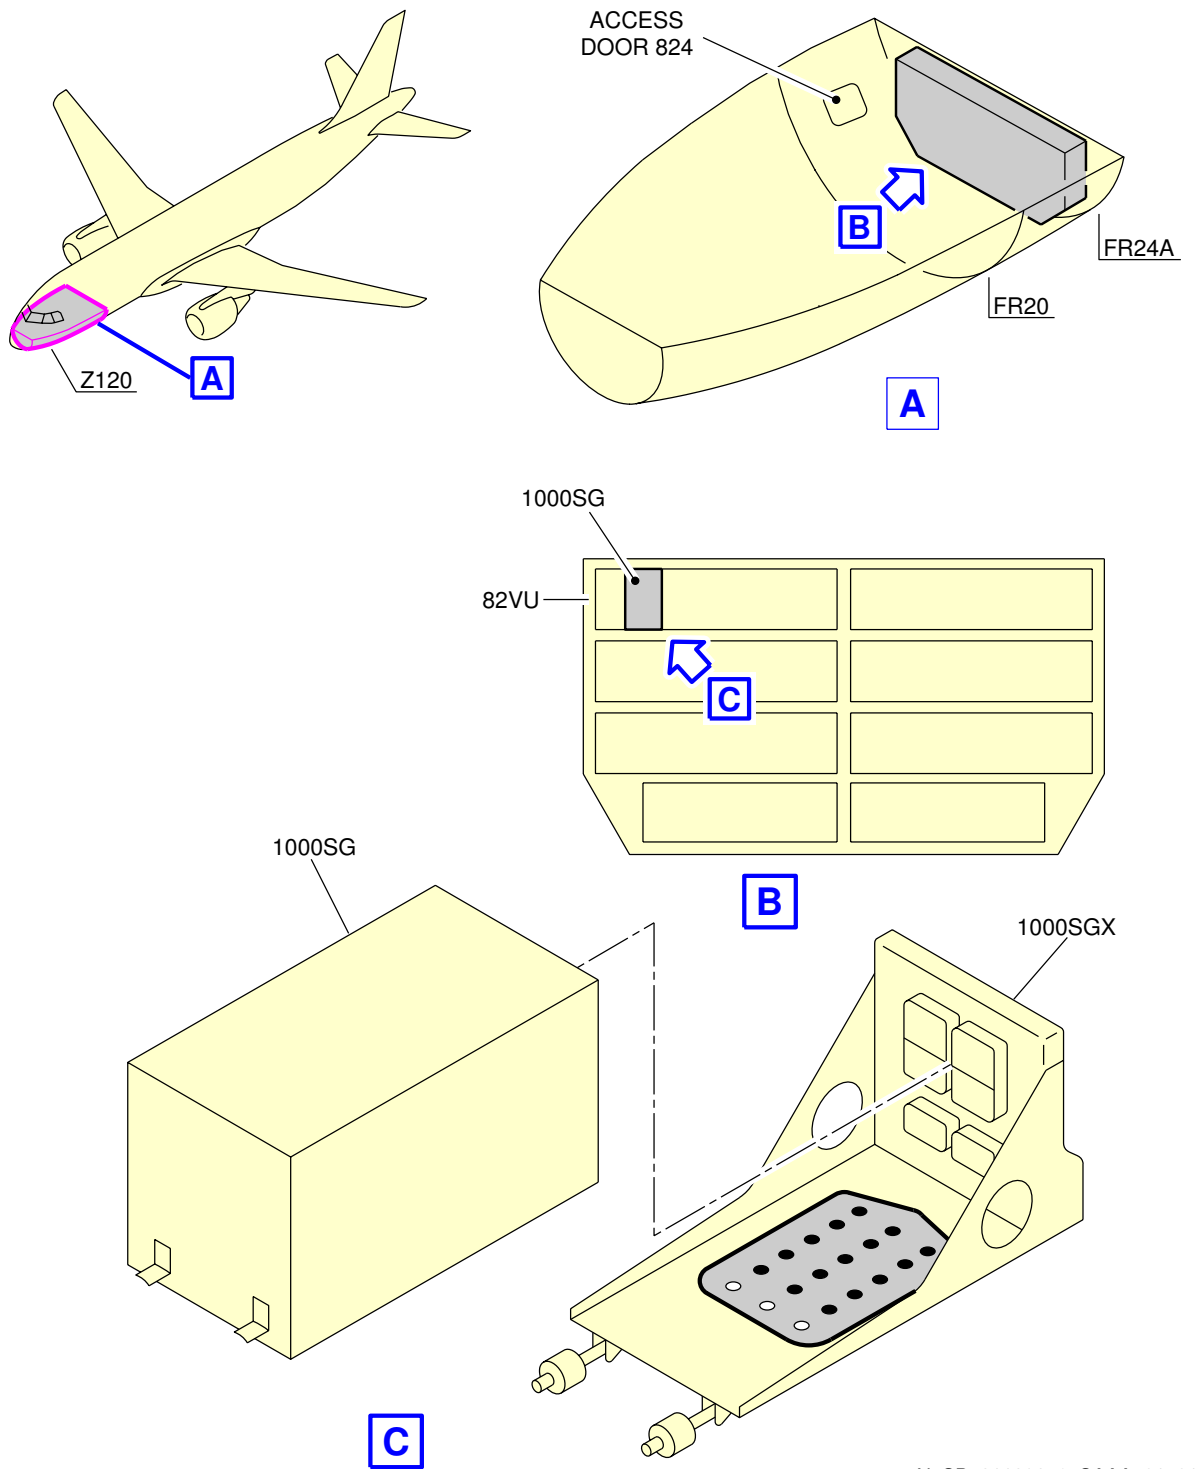
Figure A-GSAAA - Sheet 01

Investigations have shown, that the T3CAS computer is not sufficiently cooled by air. The reason for the insufficient air cooling is the non optimized position of the open ventilation holes.

To improve the airflow, it is necessary to adjust the ventilation hole plugs on the rack into an optimized position.

This Service Bulletin details the work necessary to optimize the ventilation hole plugs.
