SERVICE BULLETIN

TITLE : AIR CONDITIONING - INTRODUCE SOME IMPROVEMENTS TO AVOID WATER
CONDENSATION IN THE COCKPIT.

SERVICE BULLETIN No. : A320-21-1902

REVISION No. : 1 - Feb 18/92

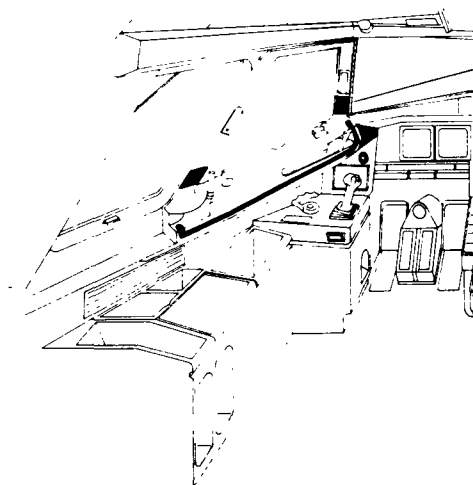
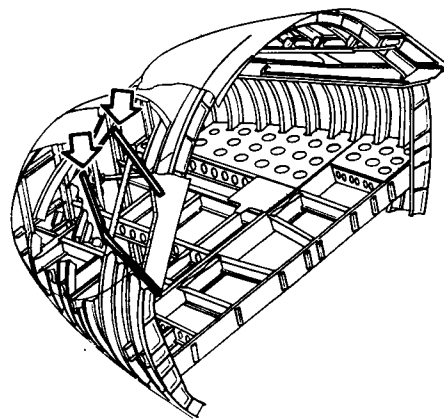
Operators report damage and nuisance due to condensed water ; several locations have been identified mainly on the front panel and side walls of the cockpit. This is experienced during long flights (4 hours and more).

This Service Bulletin proposes to apply adhesive foam on left lining in cockpit and to seal gaps on lower and upper left lateral frames in the cockpit, for an evaluation for 3 months on one AIR MALTA aircraft and on one CONAIR A/S aircraft.
