TITLE : AIR CONDITIONING ELECTRICAL INSTALLATION - PROVIDE PROTECTIONS  
AGAINST WATER CONTAMINATION OF ELECTRICAL HARNESS.

MODIFICATION No. 24291P3789

This page transmits Revision No. 1 of Service Bulletin No. A320-21-1097.  
No more work is necessary to do this Revision.

SERVICE BULLETIN No. : A320-21-1097

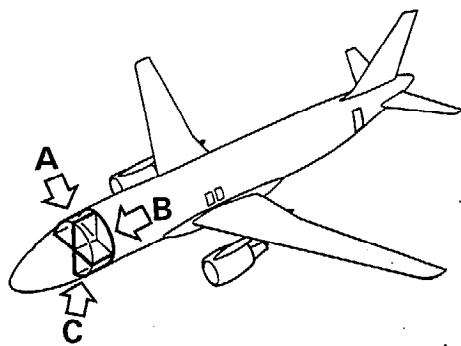
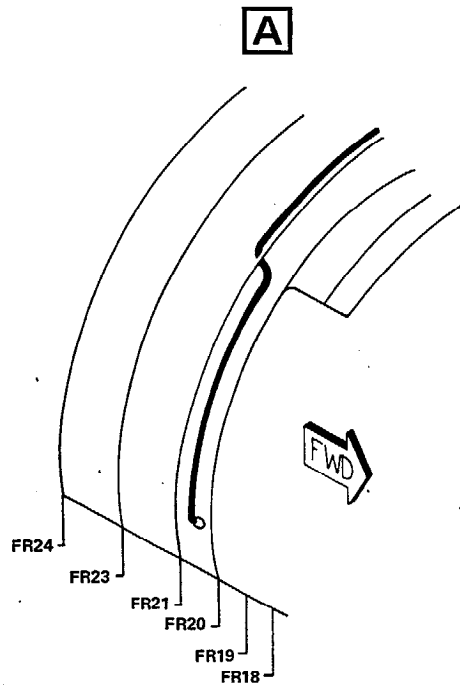
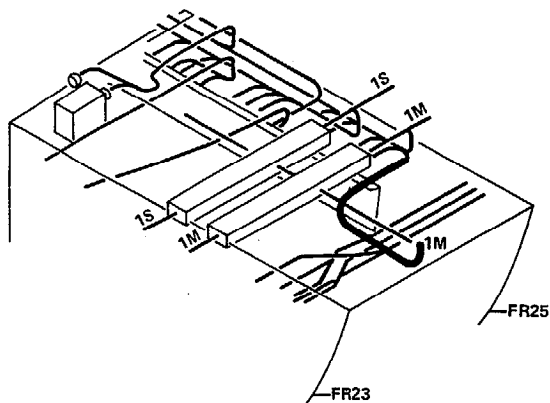
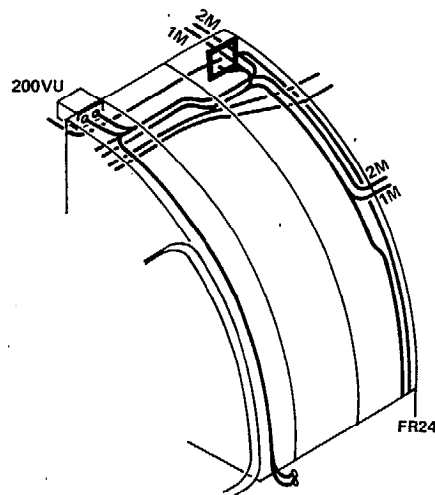
Operators have reported electrical connector damage in the forward  
galley area due to water condensation ingress between FR21 and FR24.
