A318/A319/A320/A321

TITLE : AIR CONDITIONING - INSTALL IMPROVED CLAMP ON BELLOWS AT PACK OUTLET AND
BETWEEN PACK OUTLET CHECK VALVE AND MIXER UNIT.

MODIFICATION No. : 35038K9698

SERVICE BULLETIN No. : A320-21-1155

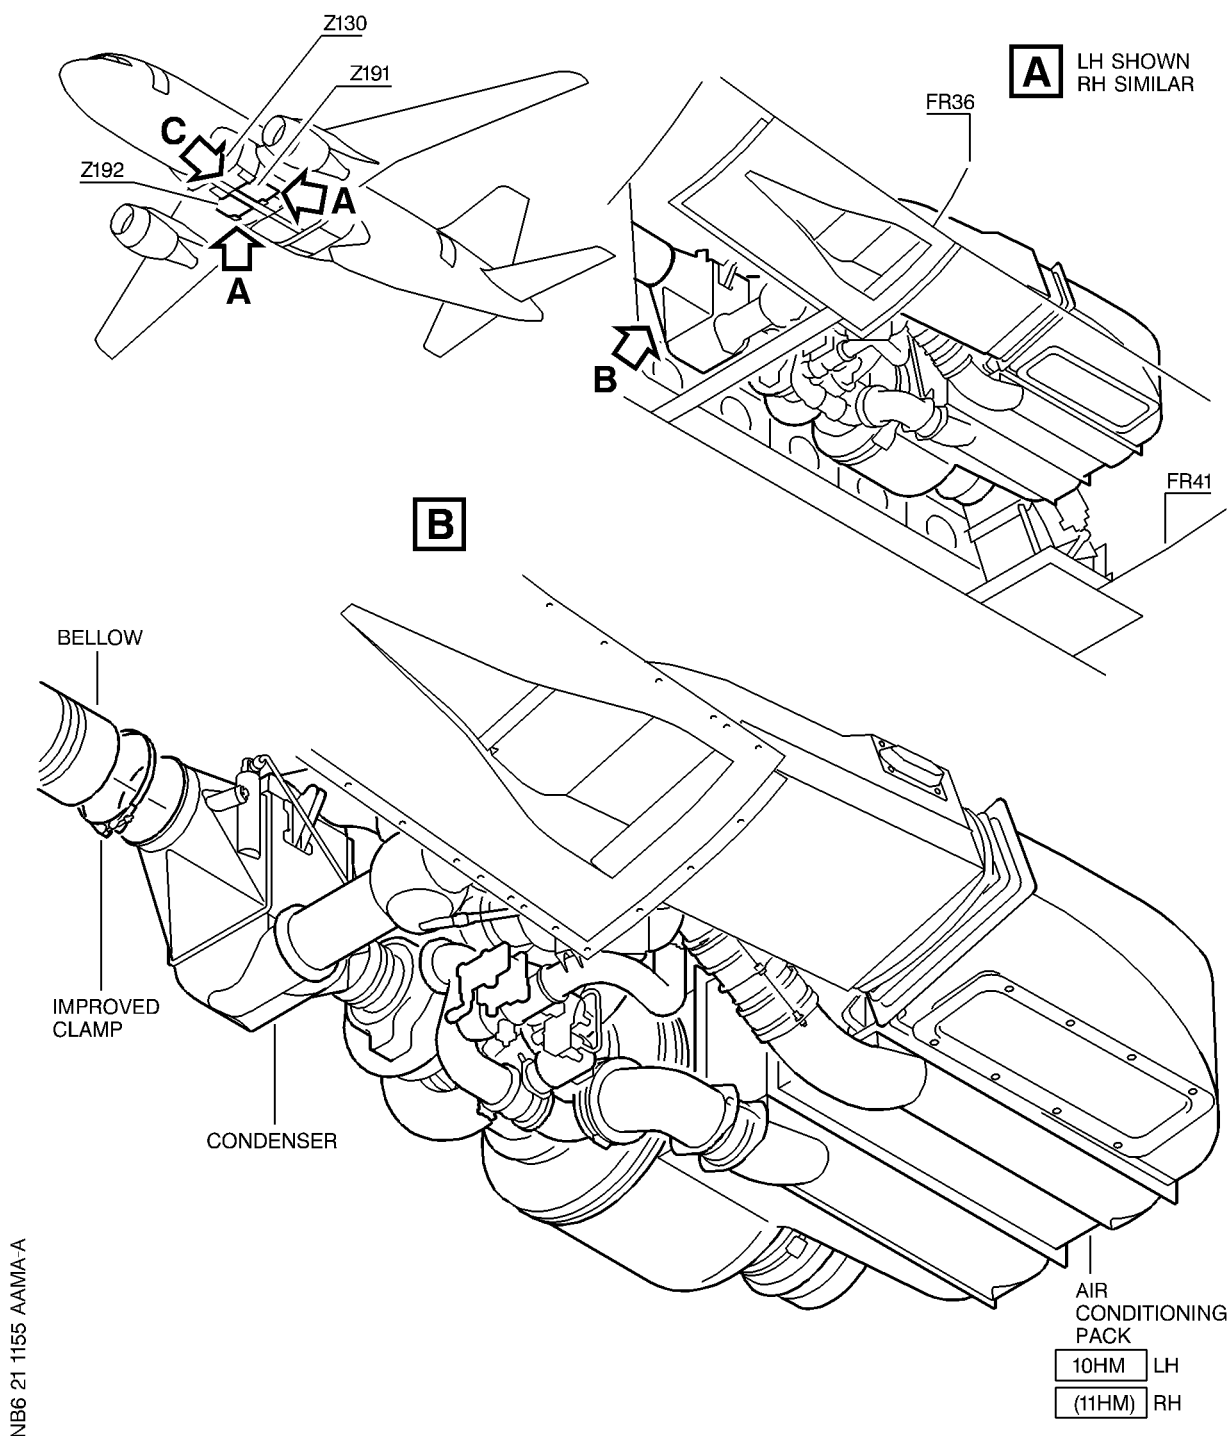
Operators have reported some cases of rupture of the quick-disconnect clamps used for the bellows which connect the condensers of the air conditioning packs with the outlet ducts and the pack outlet check-valves with the mixer unit. As a result of these clamp ruptures the bellows come completely off, the pack air blows into the pack bay, the pack outlet valve closes and the aircraft is supplied only with pack air from the remaining pack. In one case a depressurization of the cabin was reported as the result of a failed pack outlet-valve flap-position or broken flap due to heavy oscillation of flap.

This Service Bulletin details the procedure to replace the affected clamps by improved clamps. The improvement consists in spot-welded, corrosion-resistant steel clamps instead of riveted aluminium clamps.
