TITLE : AIR CONDITIONING - PRESSURIZATION CONTROL - MODIFICATION OF PIN
PROGRAMMING TO DISABLE USE OF EXTERNAL MODE (RETRO SOLUTION)

MODIFICATION No. : 32221K7821

SERVICE BULLETIN No. : A320-21-1138

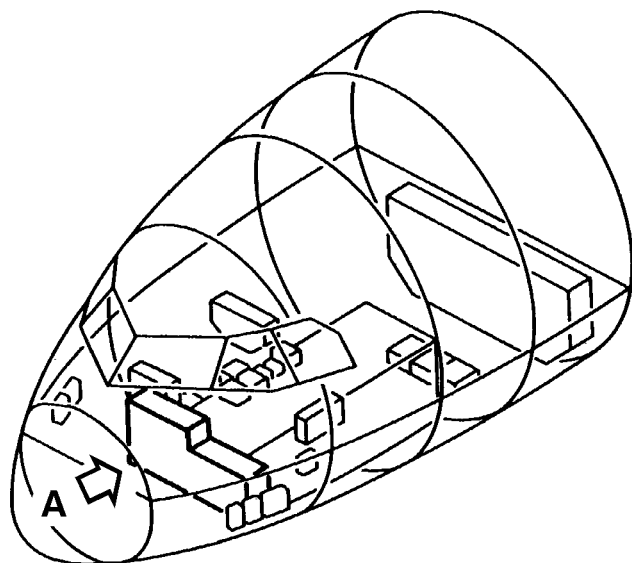
90VU

This Service Bulletin details the procedure to change the pin programming by modification of the wiring in shelf 95VU and shelf 96VU in order to deactivate the external mode function of the CPC.
