**TITLE: AIR CONDITIONING - CONDITIONED SERVICE AIR SYSTEM (CSAS) -
INSTALLATION OF IMPROVED CSAS CONTROL UNIT (CCU)**

This page transmits Revision No.01 of Service Bulletin No.A320-21-1196

SERVICE BULLETIN No.: A320-21-1196

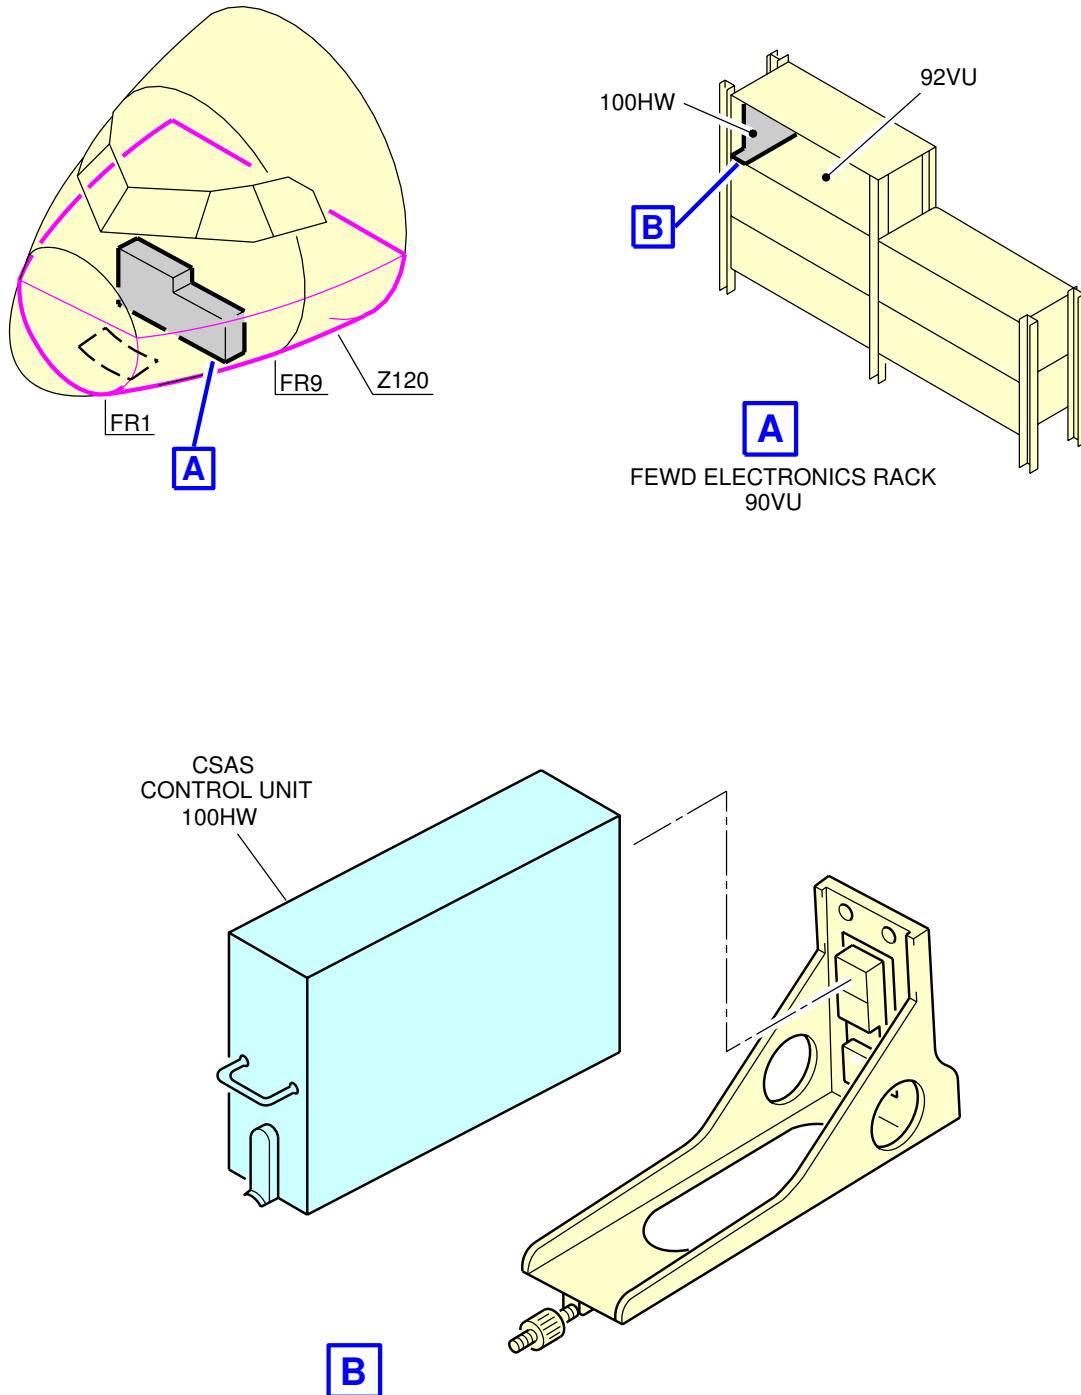
Figure A-GSAAA - Sheet 01

In-Service experience has identified some deviations in the Conditioned Service Air System (CSAS) software PN 3959A0000K03.

- CSAS Control Unit does not calculate the value for CSAS_GO during power up.
- Fuel Tank Interting System (FTIS) creates inconsistent failure reports.

- (1) Replace the CSAS Control Unit
