737

Service Bulletin

Number: 737-28-1303
Original Issue: April 26, 2012
Revision 1: January 22, 2015
ATA System: 2800

SUBJECT: FUEL - General - Left Environmental Control Systems Bay Wire Clamp - Inspection and Replacement

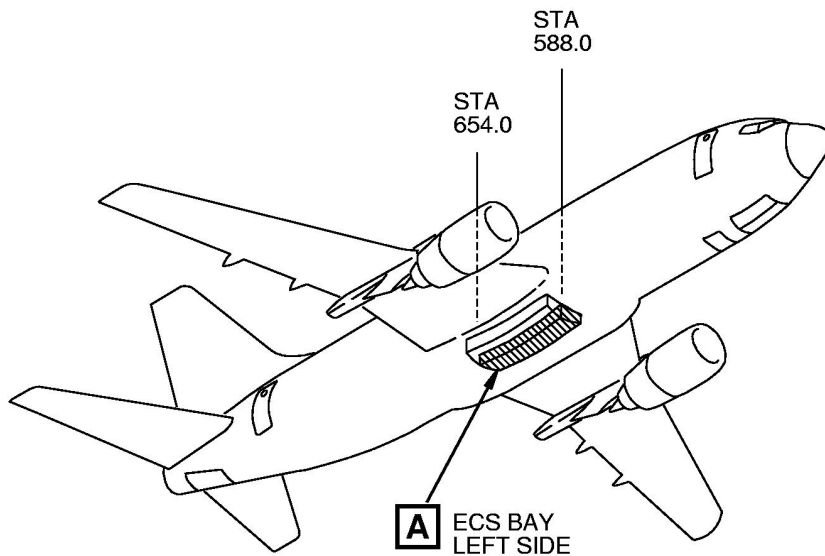
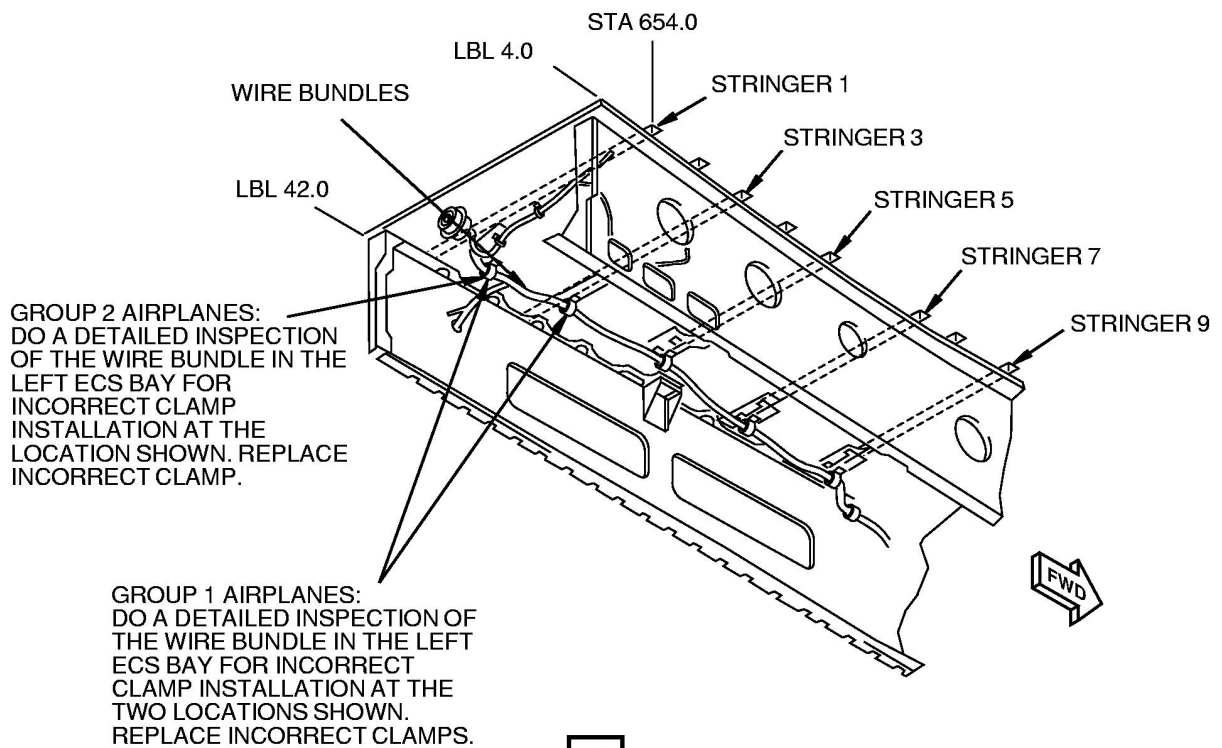
2110627

This service bulletin gives instructions to inspect and replace incorrect wire bundle clamp(s) installed on a wire bundle in the left Environmental Control Systems (ECS) bay. A fully cushioned clamp should be installed to prevent potential conductor to clamp short circuits. If this service bulletin is not done, conductor to clamp short circuits could produce arcing from a hot short and introduce a potential ignition source in the center wing tank and a subsequent fire or explosion.

During a drawing review, Boeing found that some callouts for the fully cushioned wire bundle clamp(s) were accidentally left out from the production drawings in the left ECS bay. This could lead to the installation of incorrect clamp(s). It was found that an incorrect clamp could be installed at two locations on 737-600 and -700 airplanes and one location on 737-800 and 900ER airplanes. The clamp(s) that should have been installed are fully cushioned and part of the Special Federal Aviation Regulation (SFAR) 88 requirement. The production drawings have now been corrected and airplane line number 3488 and subsequent have the correct clamp(s) installed. Boeing initiated this service bulletin to address this condition.

Get access to the left side ECS bay by opening the ECS bay access door 192CL. Do a Detailed Inspection of the wire clamp(s) installed at specified location(s). If a fully cushioned clamp TA0930034-10, TA0930034-10P, TA0930034-11 or TA0930034-12P clamp has not been installed, remove the clamp, do a detailed inspection for wire damage, repair damage found, and install a TA0930034-10, TA0930034-10P, TA0930034-11 or TA0930034-12P fully cushioned wire clamp. Close left side ECS bay access door 192CL.
