# A case study on causation of the landslide on 26 October 2016 in the northern Colombian Andes•

Article in *Dyna* (Medellin, Colombia) · February 2021

This paper presents the results of a technical investigation on the causation of the landslide that occurred in Las Nieves quarry on October 26/2016 in the municipality of Copacabana, located in the northern part of the Colombian Andes. This landslide caused the highest number of fatalities in Colombia in 2016 (16 deaths). The study included field visits, soil sampling, study of geology and geomorphology, analysis of rainfall and groundwater flows presented in the area. The information collected is consistent with the hypothesis that the regional groundwater flow generated an increase in water levels in the landslide zone thus triggering the landslide. Finally, a stability analysis (statistical and sensitivity analysis) was performed using the limit equilibrium method, where the effect of the rise in the groundwater table was modelled as the trigger. The stability analysis results showed a low safety factor for the slope, even when low water levels were considered.

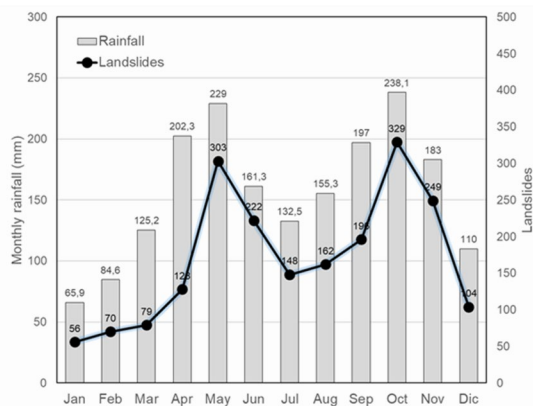
Figure 3. Monthly number of landslides versus mean monthly rainfall.

The data are consistent with previous studies conducted in the region [7], which indicate a high correlation between the occurrence of landslides and the rainy season. Fig. 3 shows that the highest number of landslides occurred in the months of May and October, with values of 303 and 329, respectively. In contrast, January and February showed the lowest number of landslides, with a total of 56 and 70, respectively.

Additionally, from Fig. 3, it is important to observe that most of the landslides occurred at the end of the rainy season when there is higher water content in the soils, which may reflect the effect of antecedent rainfalls on the generation of a greater number of landslides in the months of May and October.
