Stellaris[®] LM3S9B92 RevC Errata

This document contains known errata at the time of publication for the Stellaris[®] LM3S9B92 microcontroller. The table below summarizes the errata and lists the affected revisions. See the data sheet for more details.

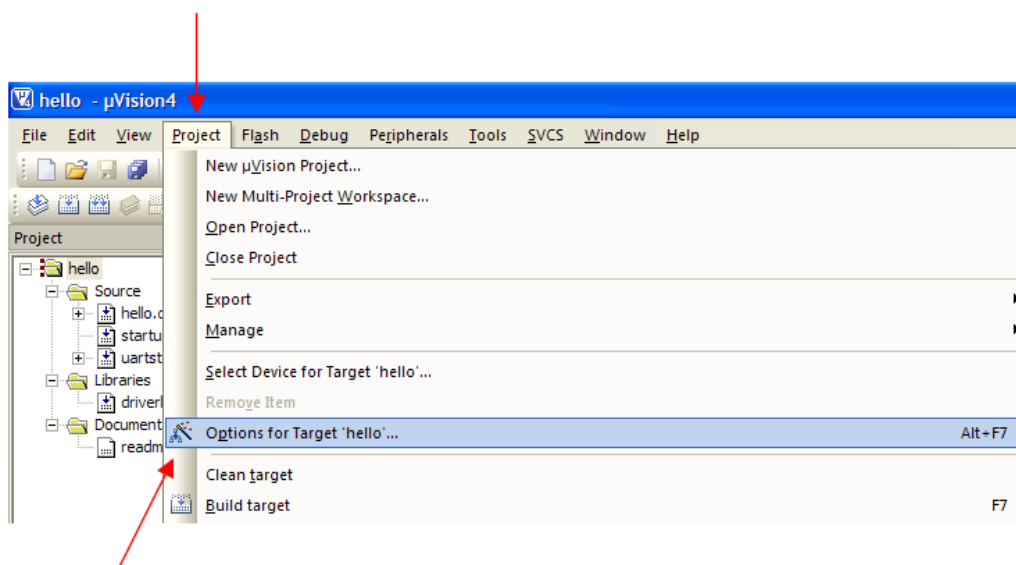
Figure A-1. Navigating to the "Run to Main()" Option

If the debugger is configured to simply reset/connect, it attempts to disassemble code in a protected region of Flash memory. The simple solution is to configure the debugger to "load/run to main". With this configuration, the patch code gets run and the Flash interrupt gets enabled. The PC runs to the main() function when the debugger starts. This option can be found in: Project □ Options for target '<project name>' as shown in Figure A-1 on page 14.

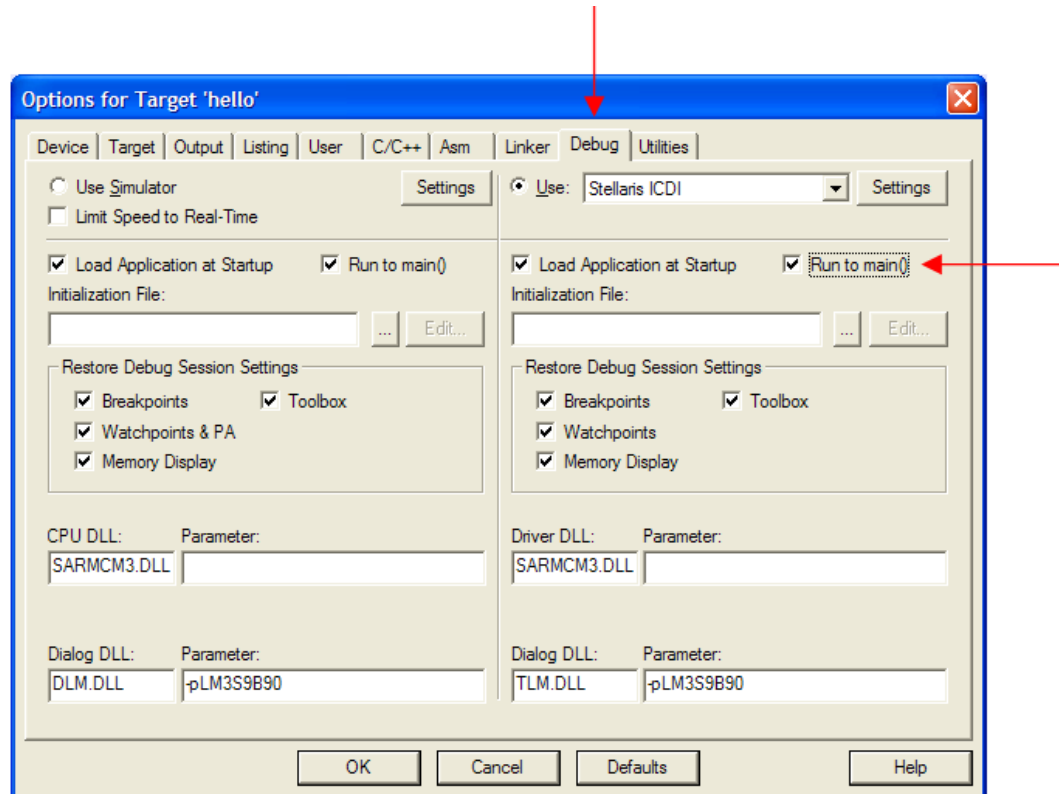
Figure A-2. Selecting the "Run to Main()" Option

When the Options window opens, select the Debug tab. Under Debug select “Run to main()” as shown in Figure A-2 on page 15.

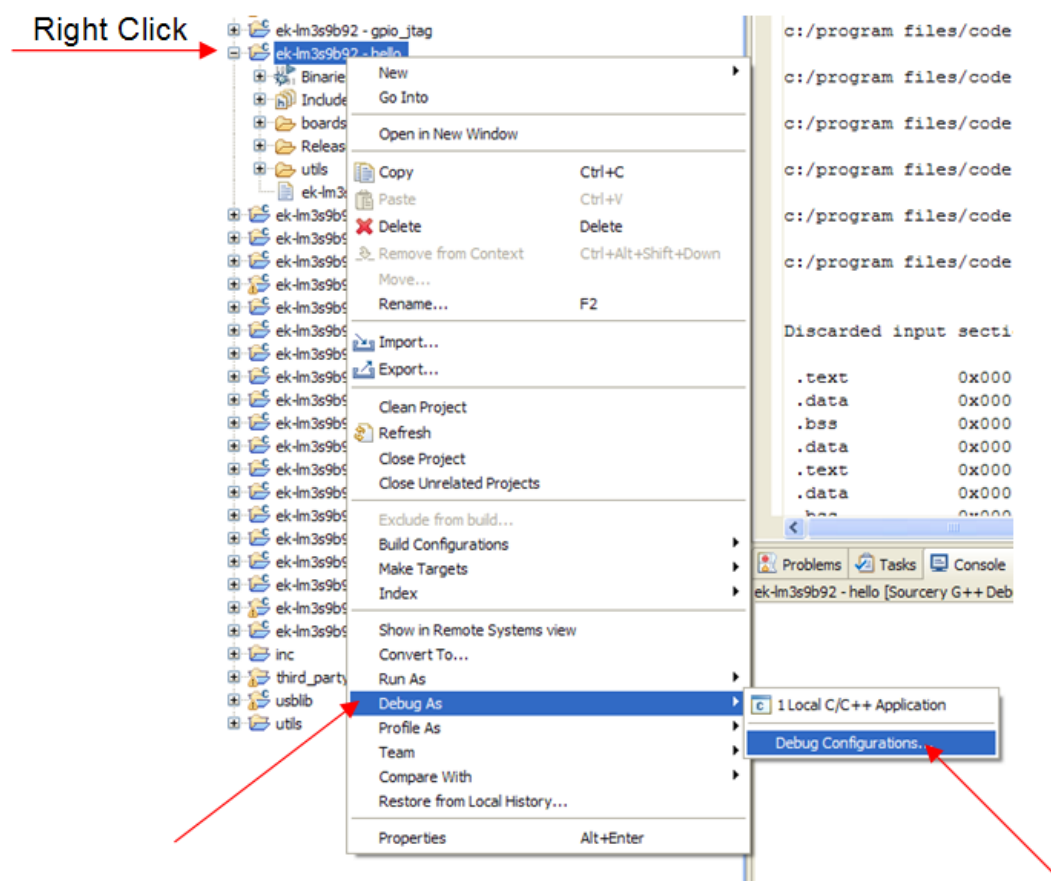
Figure A-3. Navigating to the Debugger Configurations Window

CodeSourcery does not run the patch code by default; it starts at the main() function. To get the patch code to run, manually set the stack pointer (SP) and program counter (PC). These register can be set by accessing the "Debugger Configurations..." tab. To do this, right click on the project and select Debug As ☐ Debug Configurations as shown in Figure A-3 on page 16.

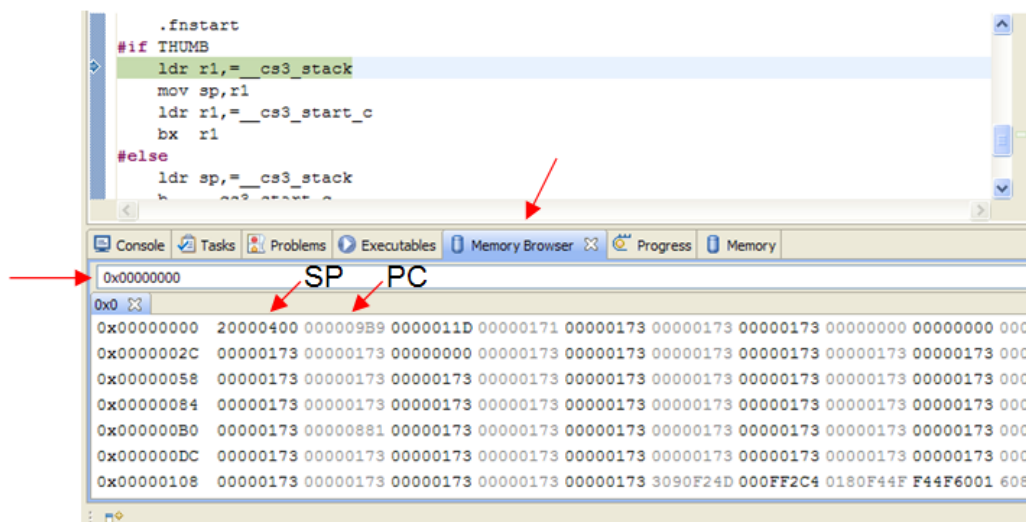
Figure A-5. Finding the Proper SP and PC to Use

Once the debugger is started, go to the “Memory Browser” window at the bottom of the screen and enter address 0x00000000. The first 2 locations show you the SP and PC for the patch as shown in Figure A-5 on page 18.

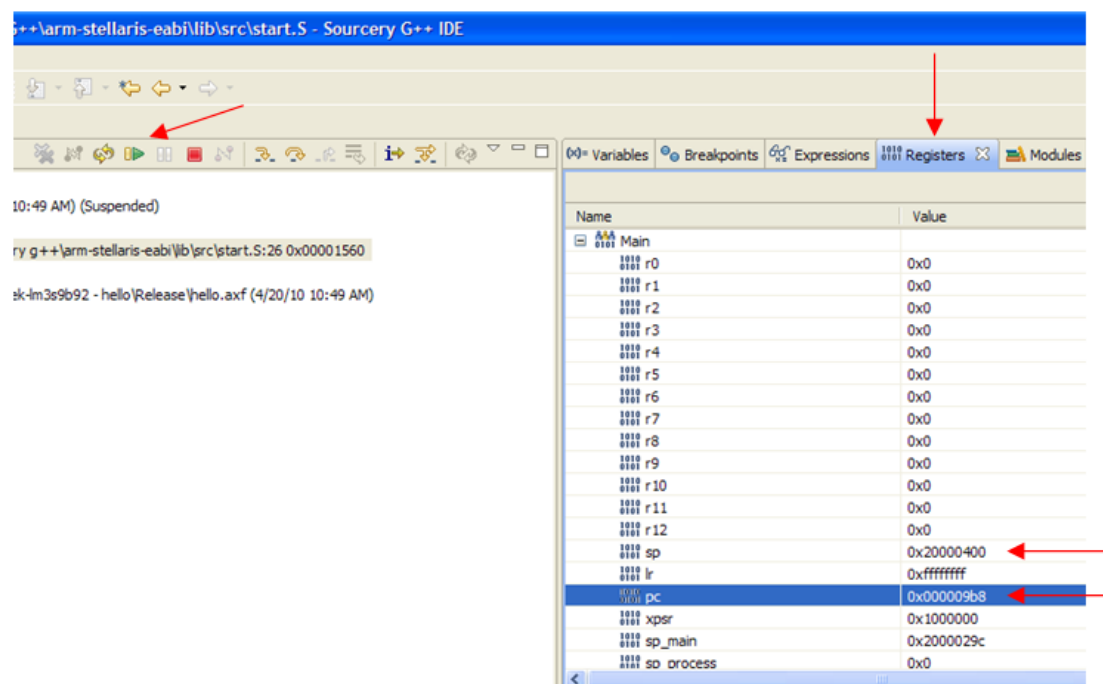
Figure A-6. Entering the SP and PC Manually

Go to the “Registers” tab and enter these values for the SP and PC manually as shown in Figure A-6 on page 18.

Once the new PC and SP have been entered, click the run button. The debugger will now successfully run through the patch code and stop at the `main()` function.

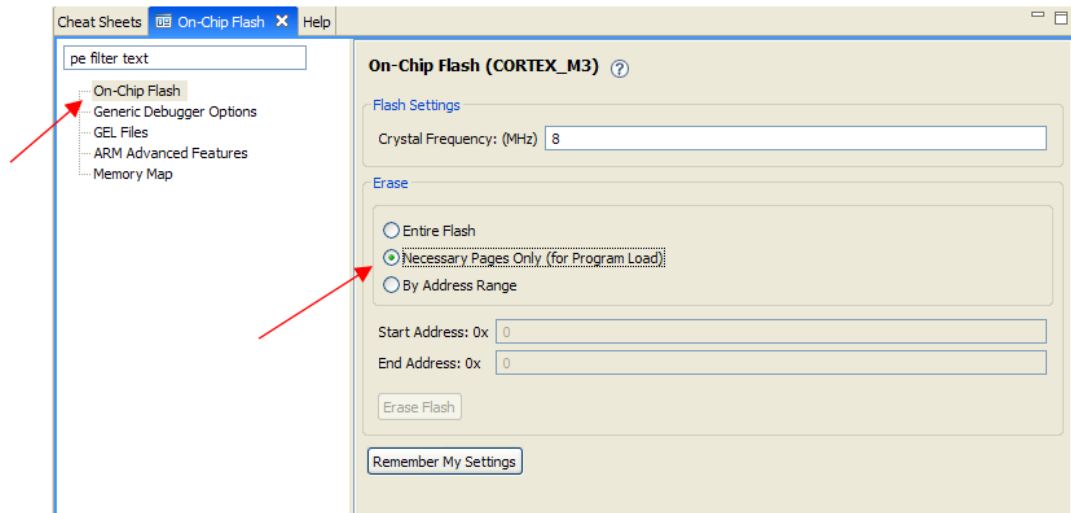
Figure A-7. Changing the Flash Erase Option

CCS does not work by default - it hangs when the debugger loads because the default flash erase option is mass erase (which won't work because the patch code is write protected). The flash erase option must be changed to page erase. To do this, start a debug session (even though it won't work correctly) to get access to the Flash settings. Once in the debug session, go to Tools ▢ On-Chip Flash then under Erase select "Necessary Pages Only (for Program Load)" as shown in Figure A-7 on page 19.

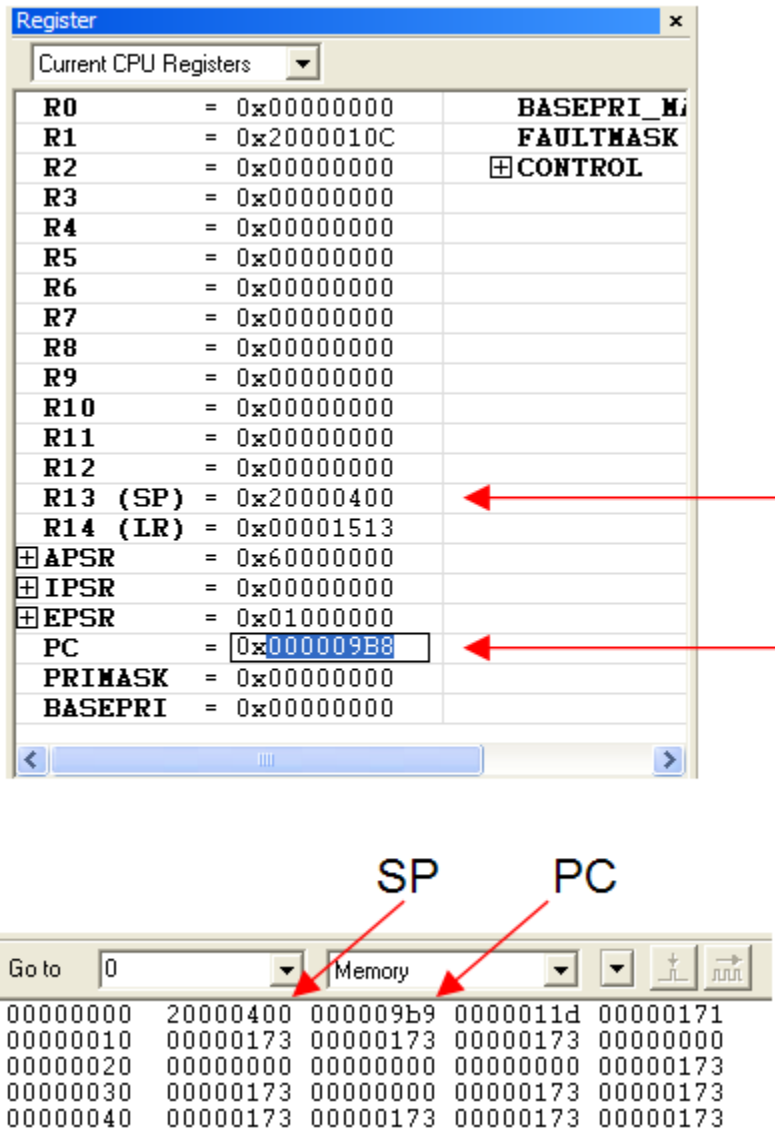
Figure A-9. Manually Configuring the PC and SP Registers

IAR has problems executing code at address 0x0000.0000 if it is not the main() application (such as bootloader examples). As a result, the PC and SP must be manually loaded. The values to load can be found at address 0x0000.0000 and 0x0000.0004 in the memory window and loaded into the PC (0x000009B8) and SP (0x20000400) as shown in Figure A-9 on page 21.

Set a breakpoint at the main() function and run the program. This process causes the Flash memory interrupt to be enabled and the debugger to operate as expected. Note: Every time you startup the debugger or do a reset in the IDE, you need to perform this sequence.
