UNIVERSITY OF THE
WITWATERSRAND,
JOHANNESBURG

Analysis of Torpedo Ladle Refractories Experiencing Premature Failure at the Spout

MSc (50/50) RESEARCH REPORT

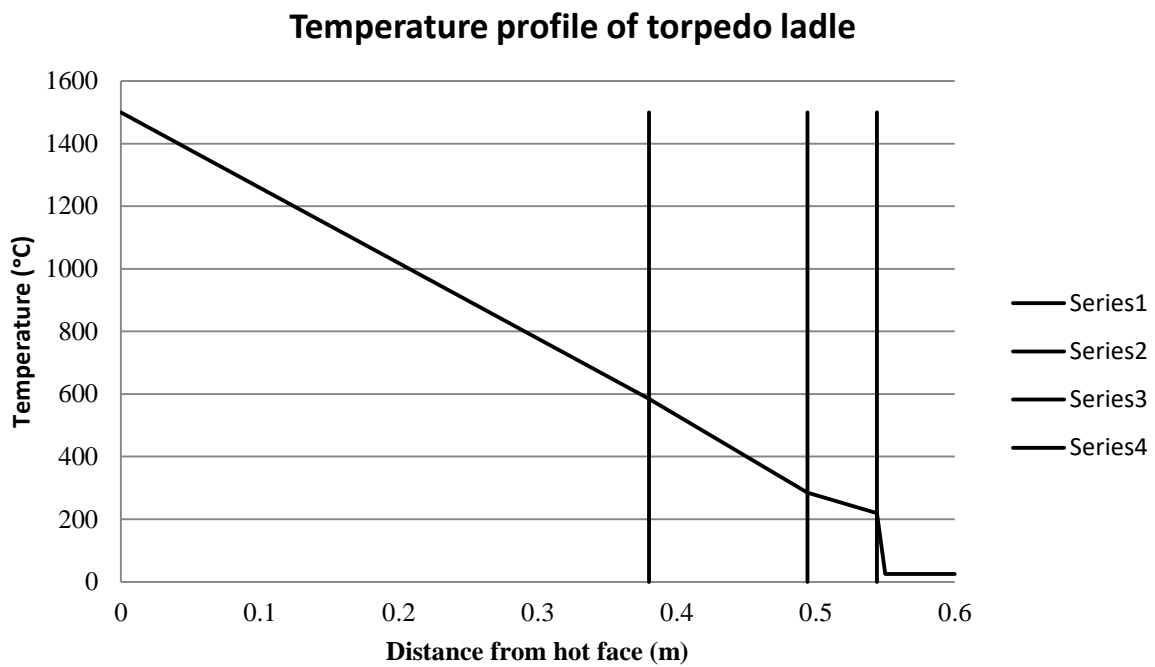
Figure 4: Temperature profile of torpedo ladle

The torpedo shell is fabricated from EN10028, which is a heat resistant pressure vessel steel. The steel contains chromium and molybdenum to improve the heat and corrosion resistance, as well as weldability. It has a maximum operating temperature of 400°C, after which, the shell's properties begin to deteriorate. As seen in Figure 4, for a new torpedo, the average shell temperature should be 220°C, which is significantly lower than the maximum operating temperature. Furthermore, it can be seen that the average temperature of the back-up lining is 285°C, which is also below the maximum operating temperature, indicating that the chosen refractories have excellent thermal properties. Thus, the heat profile of the torpedo indicates that the material chosen for the refractory lining is suitable to prevent plastic deformation to the torpedo shell.

However, due to wear and corrosion of the refractory, the thickness of the hot face gradually decreases. This is especially important for the slag line as corrosive slag results in a high erosion rate. The critical thickness was found to be 158 mm (Appendix 2). When the

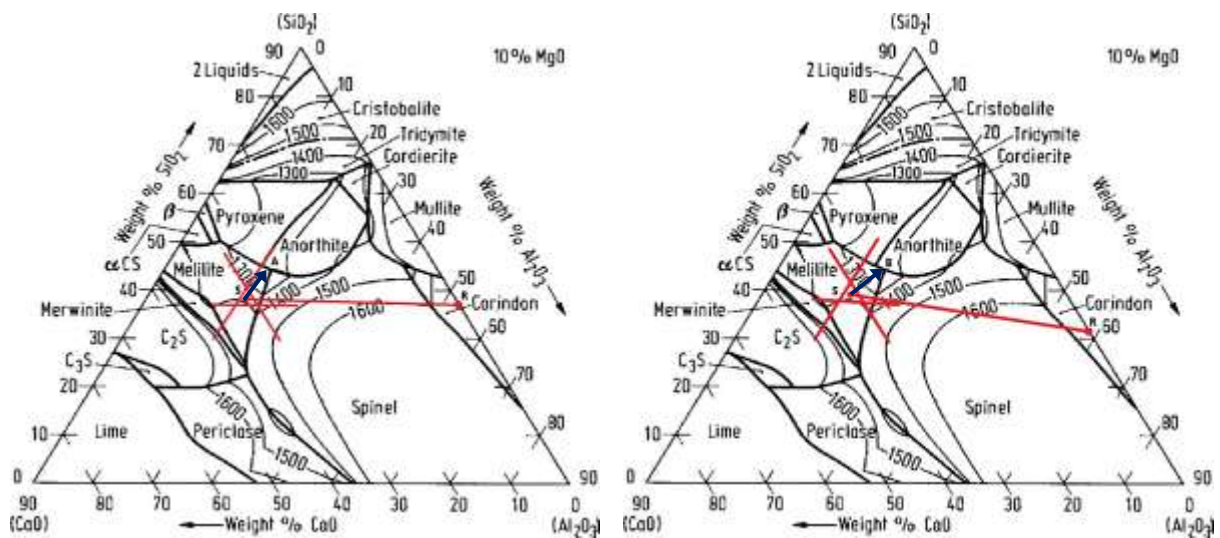
Figure 5: Al₂O₃-CaO-SiO₂-10%MgO Ternary phase diagram showing slag and refractory interaction in (a) 2019 and (b) 2010

In Figure 5 (a), the refractory composition is represented by point R and the slag by point S. When the bulk composition is plotted, a triangle is formed due to other chemical species that are present in the slag. The triangle represents possible slag composition. At the slag-refractory interface, the composition move towards the slag from the refractory. Since the slag is not saturated with Al₂O₃, there will be dissolution of Al₂O₃ into the slag. Thus, the composition at the hot face will have a lower Al₂O₃ content. As dissolution occurs, the composition of the slag moves towards the ternary eutectic at point A, at which it becomes saturated with Al₂O₃. The reaction rate at the interface is not uniform. The reactions begin to slow down as the temperature decreases and slag viscosity increases, as a result of temperature losses and increasing alumina content in the slag. When saturated, diffusion of CaO into the refractory takes place. At point A, precipitation of the corrosion product occurs.

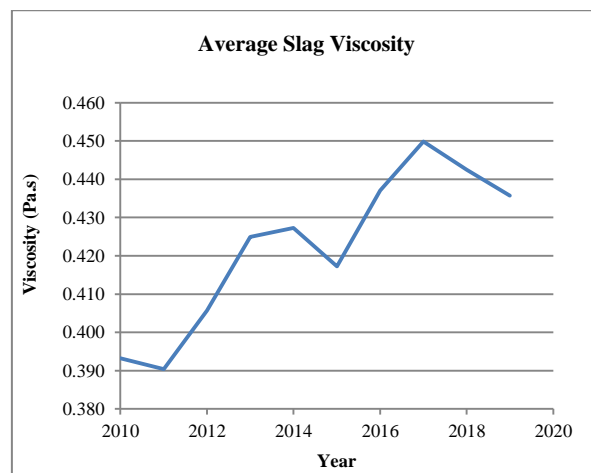
Figure 6: Average slag viscosity

Over the 10 year period, there has been a gradual increase in the slag viscosity. This is due to the increasing Al_2O_3 content in the slag. Since literature (Lee & Zhang, 2004) states that slag viscosity is inversely proportional to corrosion rate, an increasing viscosity indicates that there should be a decrease in corrosion rate of refractories. This occurs due to the slag becoming less fluid, decreasing penetration. Thus, the decrease in torpedo life is not a result of the change in slag viscosity.

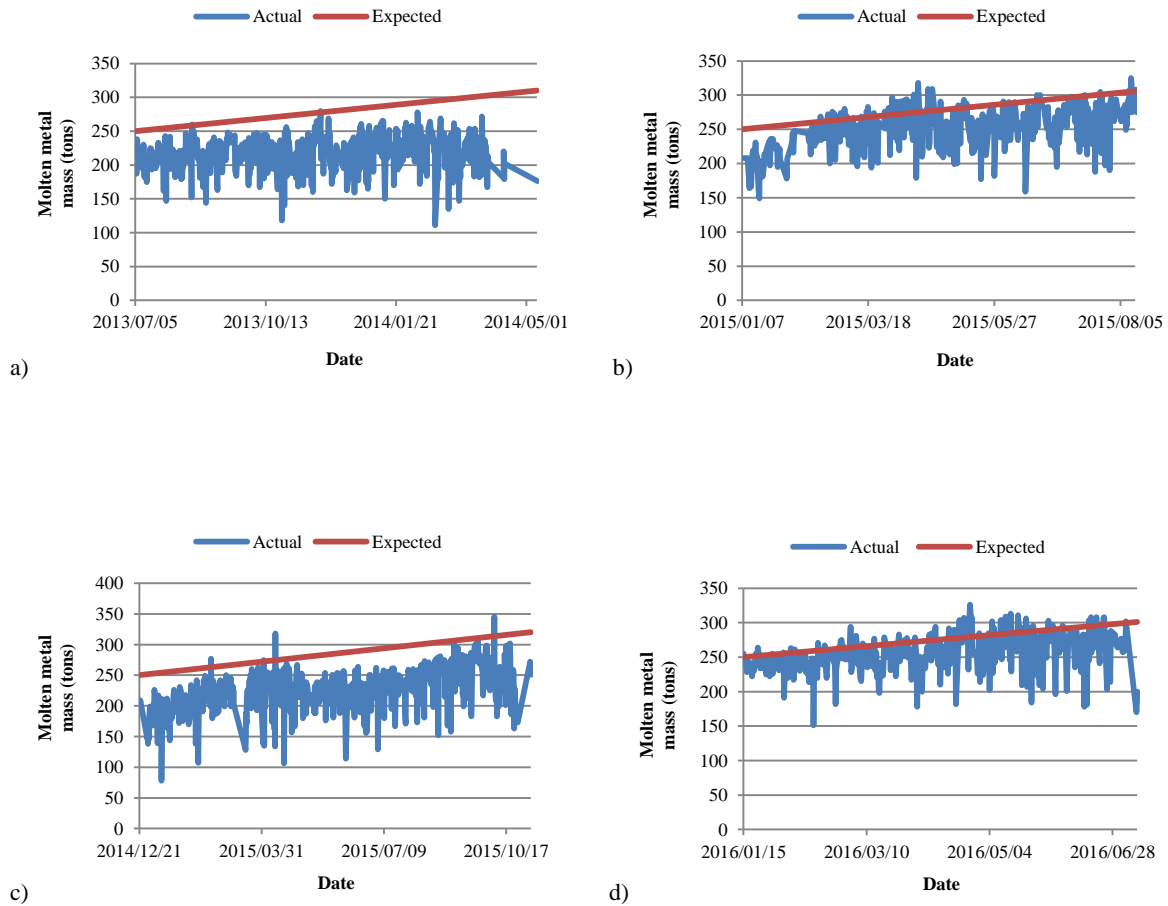
Figure 7: Molten metal mass for (a) Torpedo no. 5 during mid-campaign, (b) Torpedo no. 5 during full campaign, (c) Torpedo no. 1 during mid-campaign, and (d) Torpedo no. 1 during full campaign

The mass of liquid iron is expected to increase during the campaign life of the torpedo due to an increase in volume as the refractory is worn away. The red line represents the expected molten metal mass during the campaign. For both torpedoes, as shown in Figure 7 (a) and (c), the actual masses before the mid-campaign reline were equal to or below the expected mass, which resulted in a good mid-campaign life. However, Figure 7 (b) and (d) show that after the mid-campaign reline was completed, actual masses frequently exceed the expected mass,

which lead to shortened campaign lives. Thus, in keeping with literature (Ministry of Steel, 2004), overfilling of torpedoes has an adverse effect on the life of the torpedo.

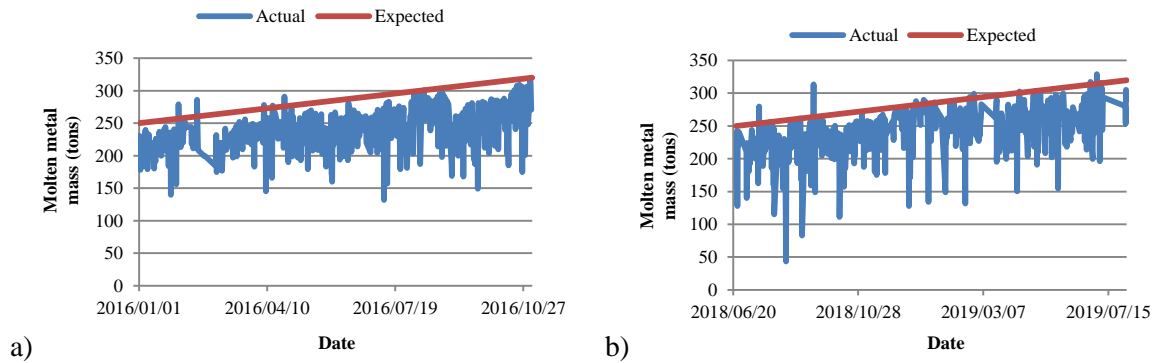
Figure 8: Molten metal mass for (a) Torpedo 7 and (b) Torpedo 2

For both torpedoes, the molten metal mass does not exceed the expected mass, which indicates the torpedoes were not removed as a result of damage caused by overfilling. Thus, the shell temperature was investigated. Figure 9 (a) and (b) shows the maximum shell temperature of the torpedo, as determined by thermal scanning.

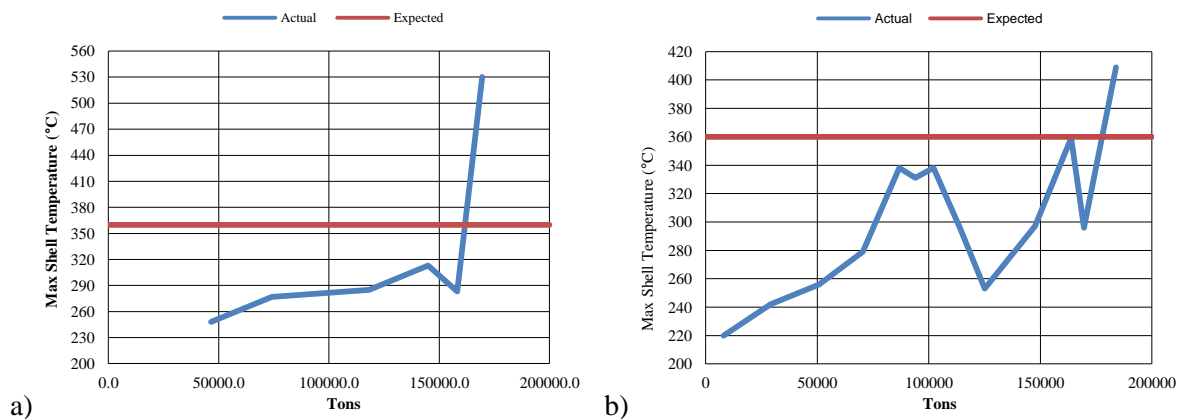
Figure 9: Maximum shell temperature of (a) Torpedo 7 and (b) Torpedo 2

Thermal scanning of torpedoes, which is also known as condition monitoring, is a form of predictive maintenance, which involves monitoring of the shell temperature at specified intervals, to identify significant changes indicative of developing faults. Typically, an

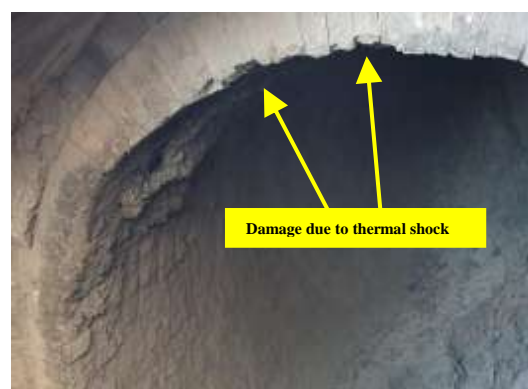
Figure 10: Refractory bricks inside torpedo ladle

The bricks at the top of the torpedo are much longer than those found at the slag line or in the metal zone. This is expected as the torpedo is considered to be full when the molten metal level is at 250mm from the top, thus, the roof is not in direct contact with the molten metal. However, some bricks have experienced some damage to the hot face. The damage is non-uniform, thus, it is likely due to an undesirable condition, such as overfilling or improper heating of torpedoes. It can be seen that the hot face of some bricks have broken off completely. This indicates that the brick may have experienced thermal shock, causing the brick to fracture. This is typically a result of overfilling of the torpedo. Figure 11 shows the refractory bricks present on the upper arch.

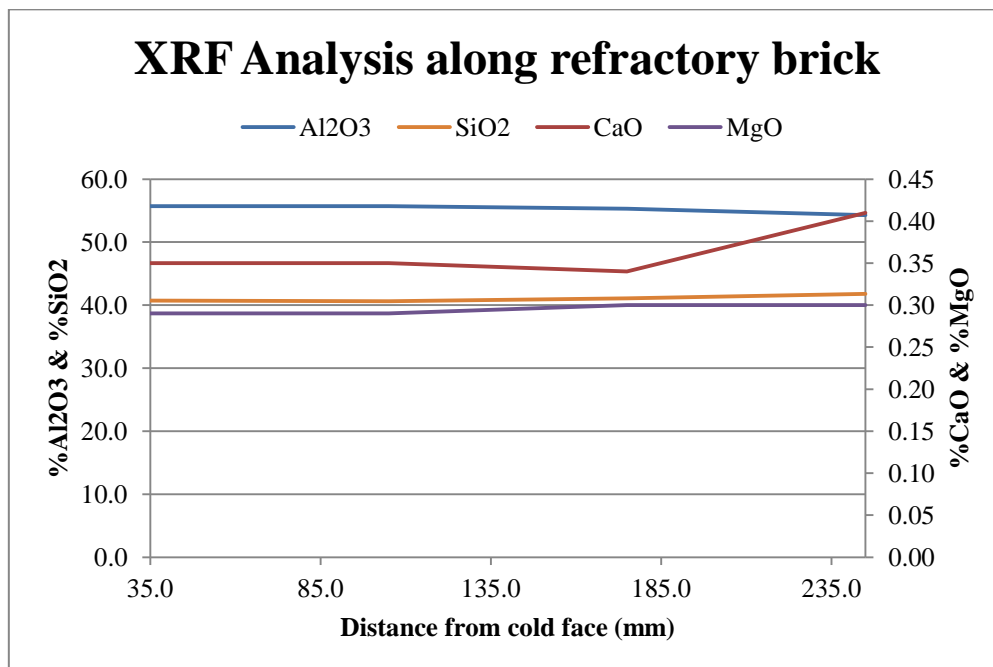
Figure 19: XRF analysis of refractory brick

The %Al₂O₃ and %SiO₂ in the original refractory, which is found at the cold face, was found to be 55.7% and 40.7%, respectively. This composition confirms that the actual brick
