ANALYSIS OF NR FLOWMARK DEFECT & TROUBLESHOOTING GUIDE

FROM : TOP GLOVE – F05 (IPOH)

PREPARED BY : MR. KC. KONG

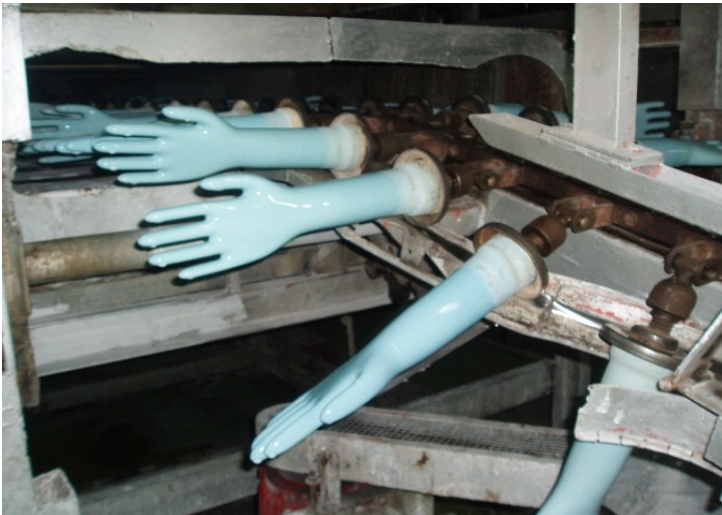
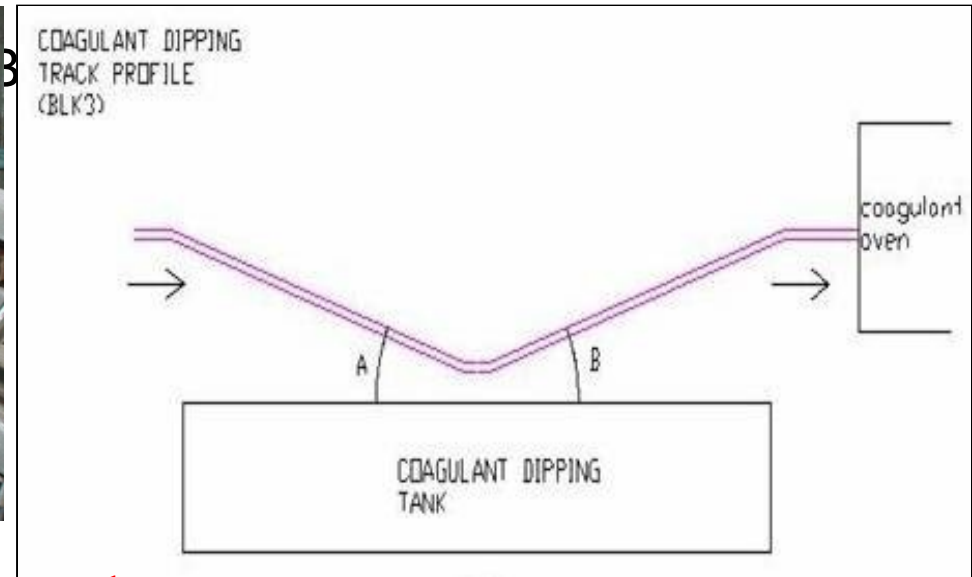
There is a 'C' plate immediately after formers withdrawal from Coagulant that causes the Coagulant accumulate at finger & less Coagulant flow downwards.

- Ensure the horizontally of the formers before Coagulant dryer not focusing on the fingers area
- Design the line for future with better dripping & have better rotation before going into Coagulant dryer
- Dipping lower weight products type at single layer Coagulant

- Install digital temperature system for monitoring and consistency
- Maintain latex TSC at higher and lower formers temperature before latex dipping
- Ensure smaller size formers (XS, S) lines maintained lower Coagulant temperature, lower percentage of powder, lower formers temperature before latex dipping
- Replacing Z80 (GCC) powder with CaCO_3 (PCC) type of powder
- To use the semi-worn out formers for Blue colour dipping
- Maintain the Coagulant solution temperature at 55 – 56°C
