DAS 2016

The influence of high temperature on DV-2 jet engine Ni-based superalloy turbine blade degradation

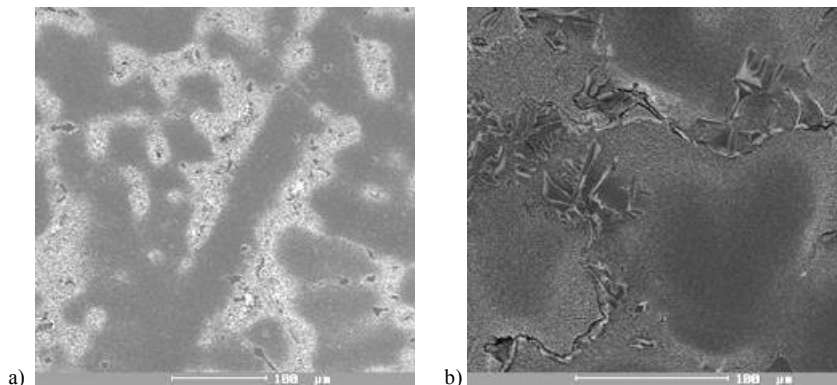
A typical microstructure of ŽS6K Ni – base superalloy as – cast is showed on Figs. 2 and 3. Microstructure of as – cast superalloy contain dendritic segregation caused by chemical heterogeneity (Fig. 2 (a)) and particles of primary MC and secondary $M_{23}C_6$ carbides (Fig. 2 (b)).

Fig. 2. Microstructure of As – cast Ni – base superalloy ŽS6K: (a) dendritic segregation, (b) primary MC and secondary $M_{23}C_6$ carbides, etch. Marble, SEM

Primary carbides (Ti, Mo, and W)C are presented as an block shaped particles mainly inside of grains. Secondary carbides are presented as a “Chinese” script shape particles on grain boundaries.

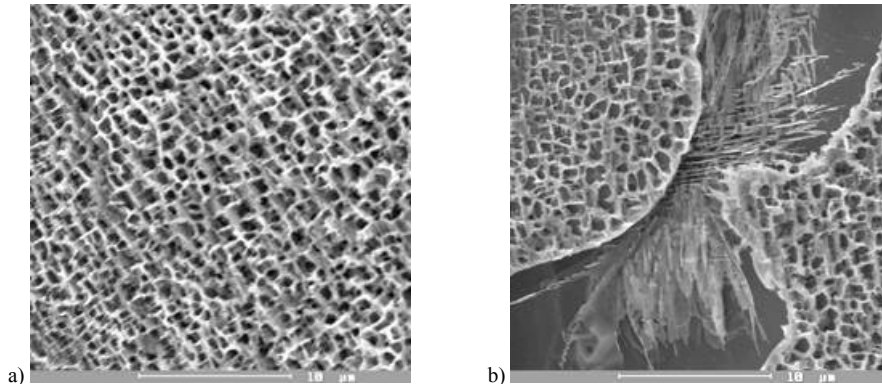
However, microstructure also contains solid solution of elements in base nickel matrix – so called γ phase (Ni(Cr, Co, and Fe), an austenitic FCC matrix phase) and intermetallic strengthening precipitates, which are a product of artificial age – hardening and has significant influence on mechanical properties and creep rupture life – so called γ' phase (gamma prime, $\text{Ni}_3(\text{Al, and Ti})$ – ordered coherent precipitate phase with L1_2 structure), Fig. 3 (a). The γ' precipitates are usually present in volume fractions in the range of 20÷60% depending on the alloy, with a typical precipitate size of 0.25 to 0.5 μm for high temperature applications [14]. Both of these phases, γ (gamma) and γ' (gamma prime) are also creating γ/γ' eutectic, Fig. 3 (b).

Fig. 3. Ni – base superalloy ŽS6K: (a) morphology of γ' precipitate, as - cast, (b) eutectic cell of γ/γ' , etch. Marble, SEM
