# US 90 in Beaumont District

- Liberty County, US 90 RM 847
- Project Completed ; 2000
- Thickness ; 10-in
- Base type ; Existing 6" Flexible Base
- Subgrade type ; -
- West (Dayton Direction) ; Gravel
- East (Liberty Direction) ; Limestone(?) or ...
- Survey Date ; 03-15-2012

# Dayton Direction

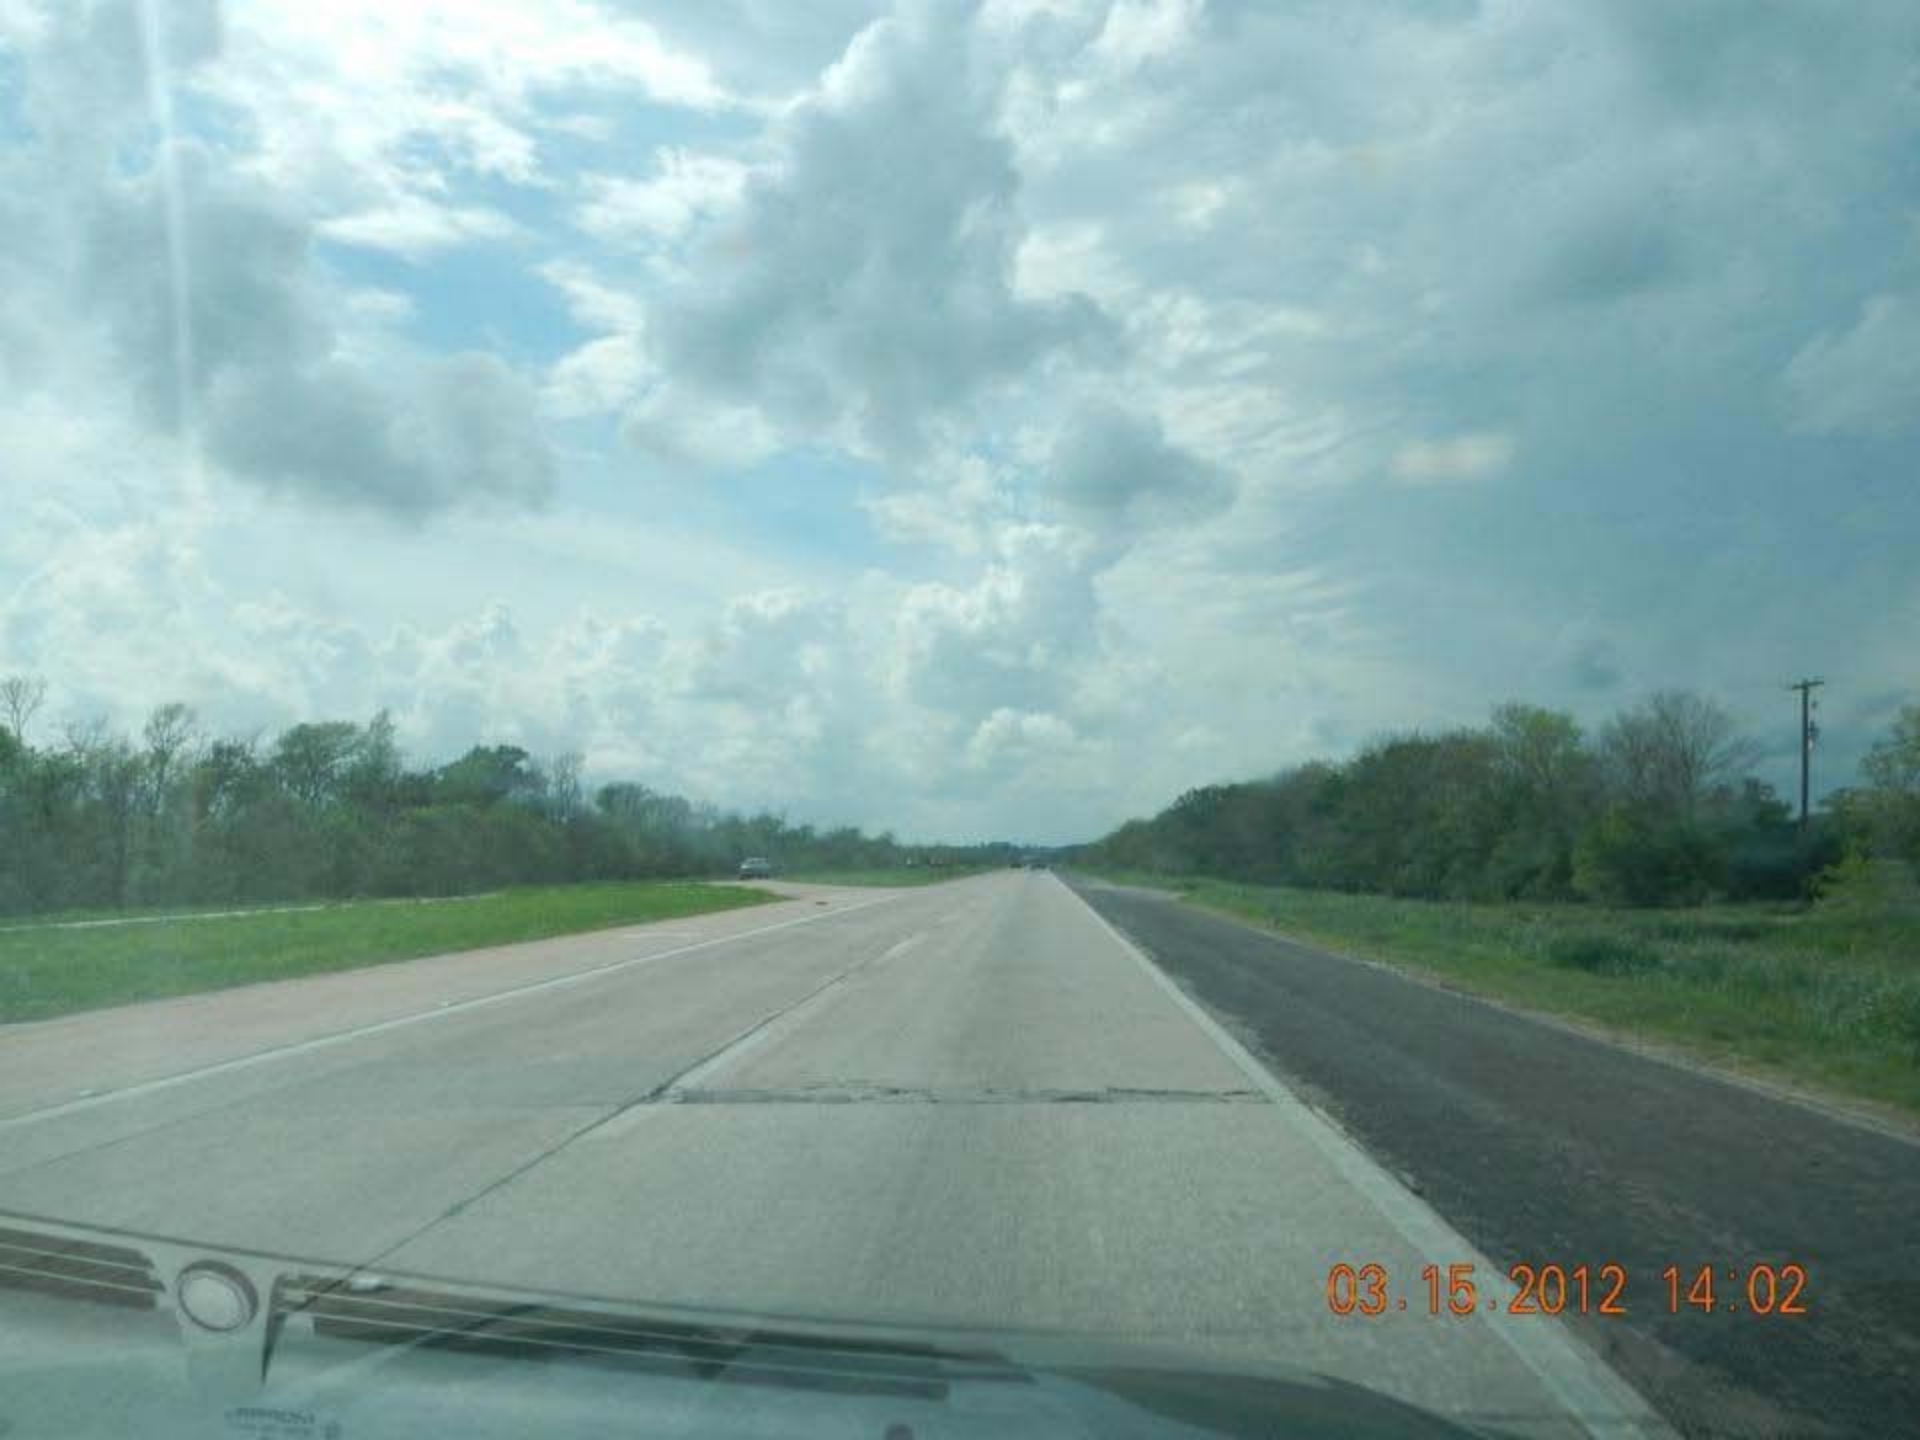
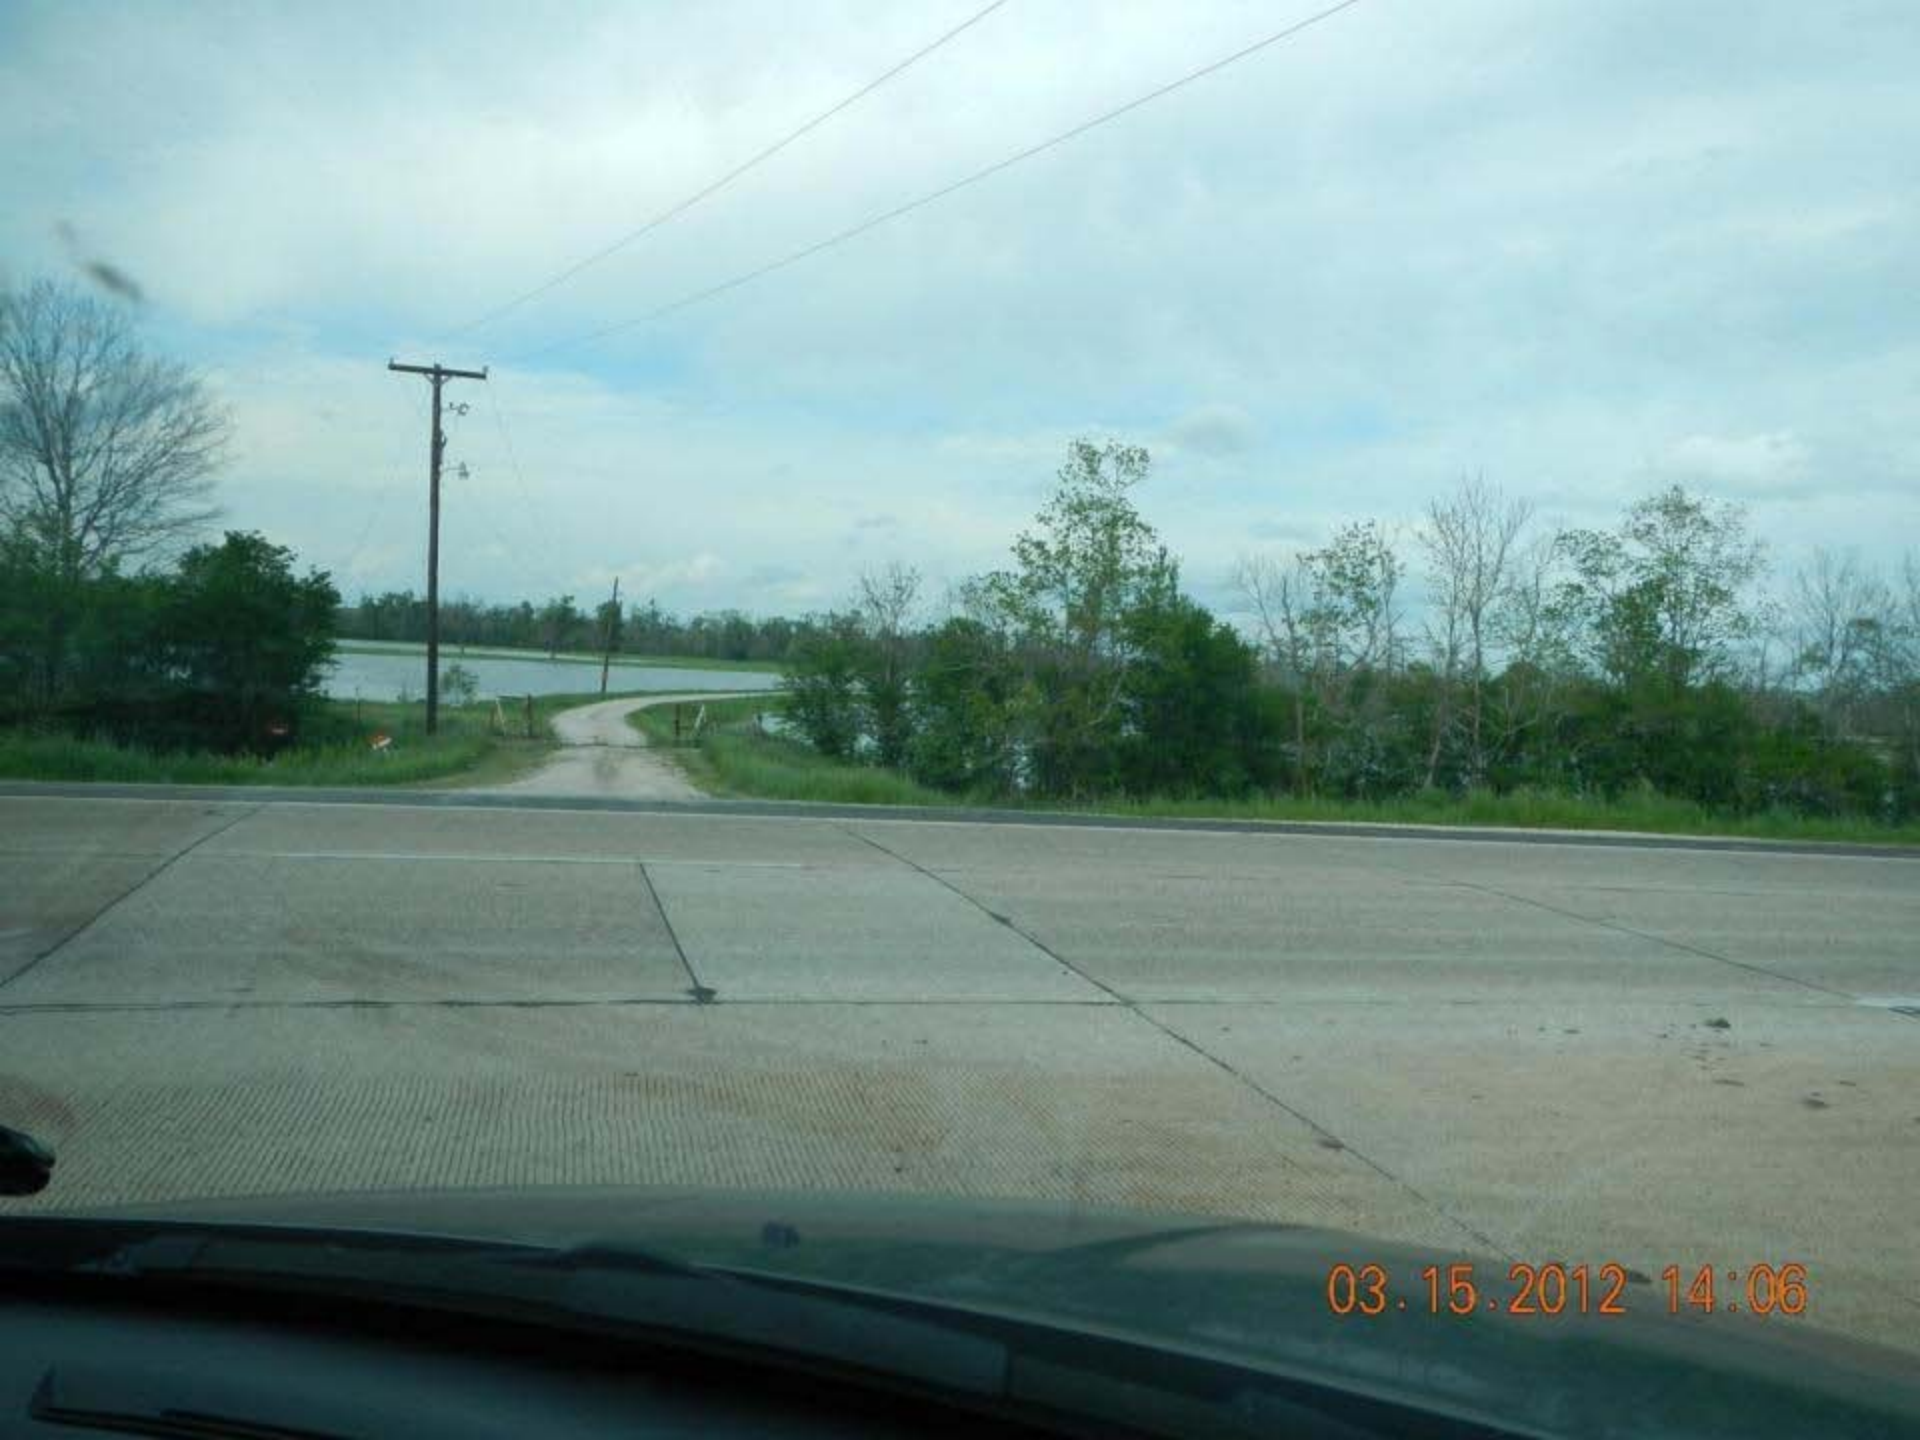
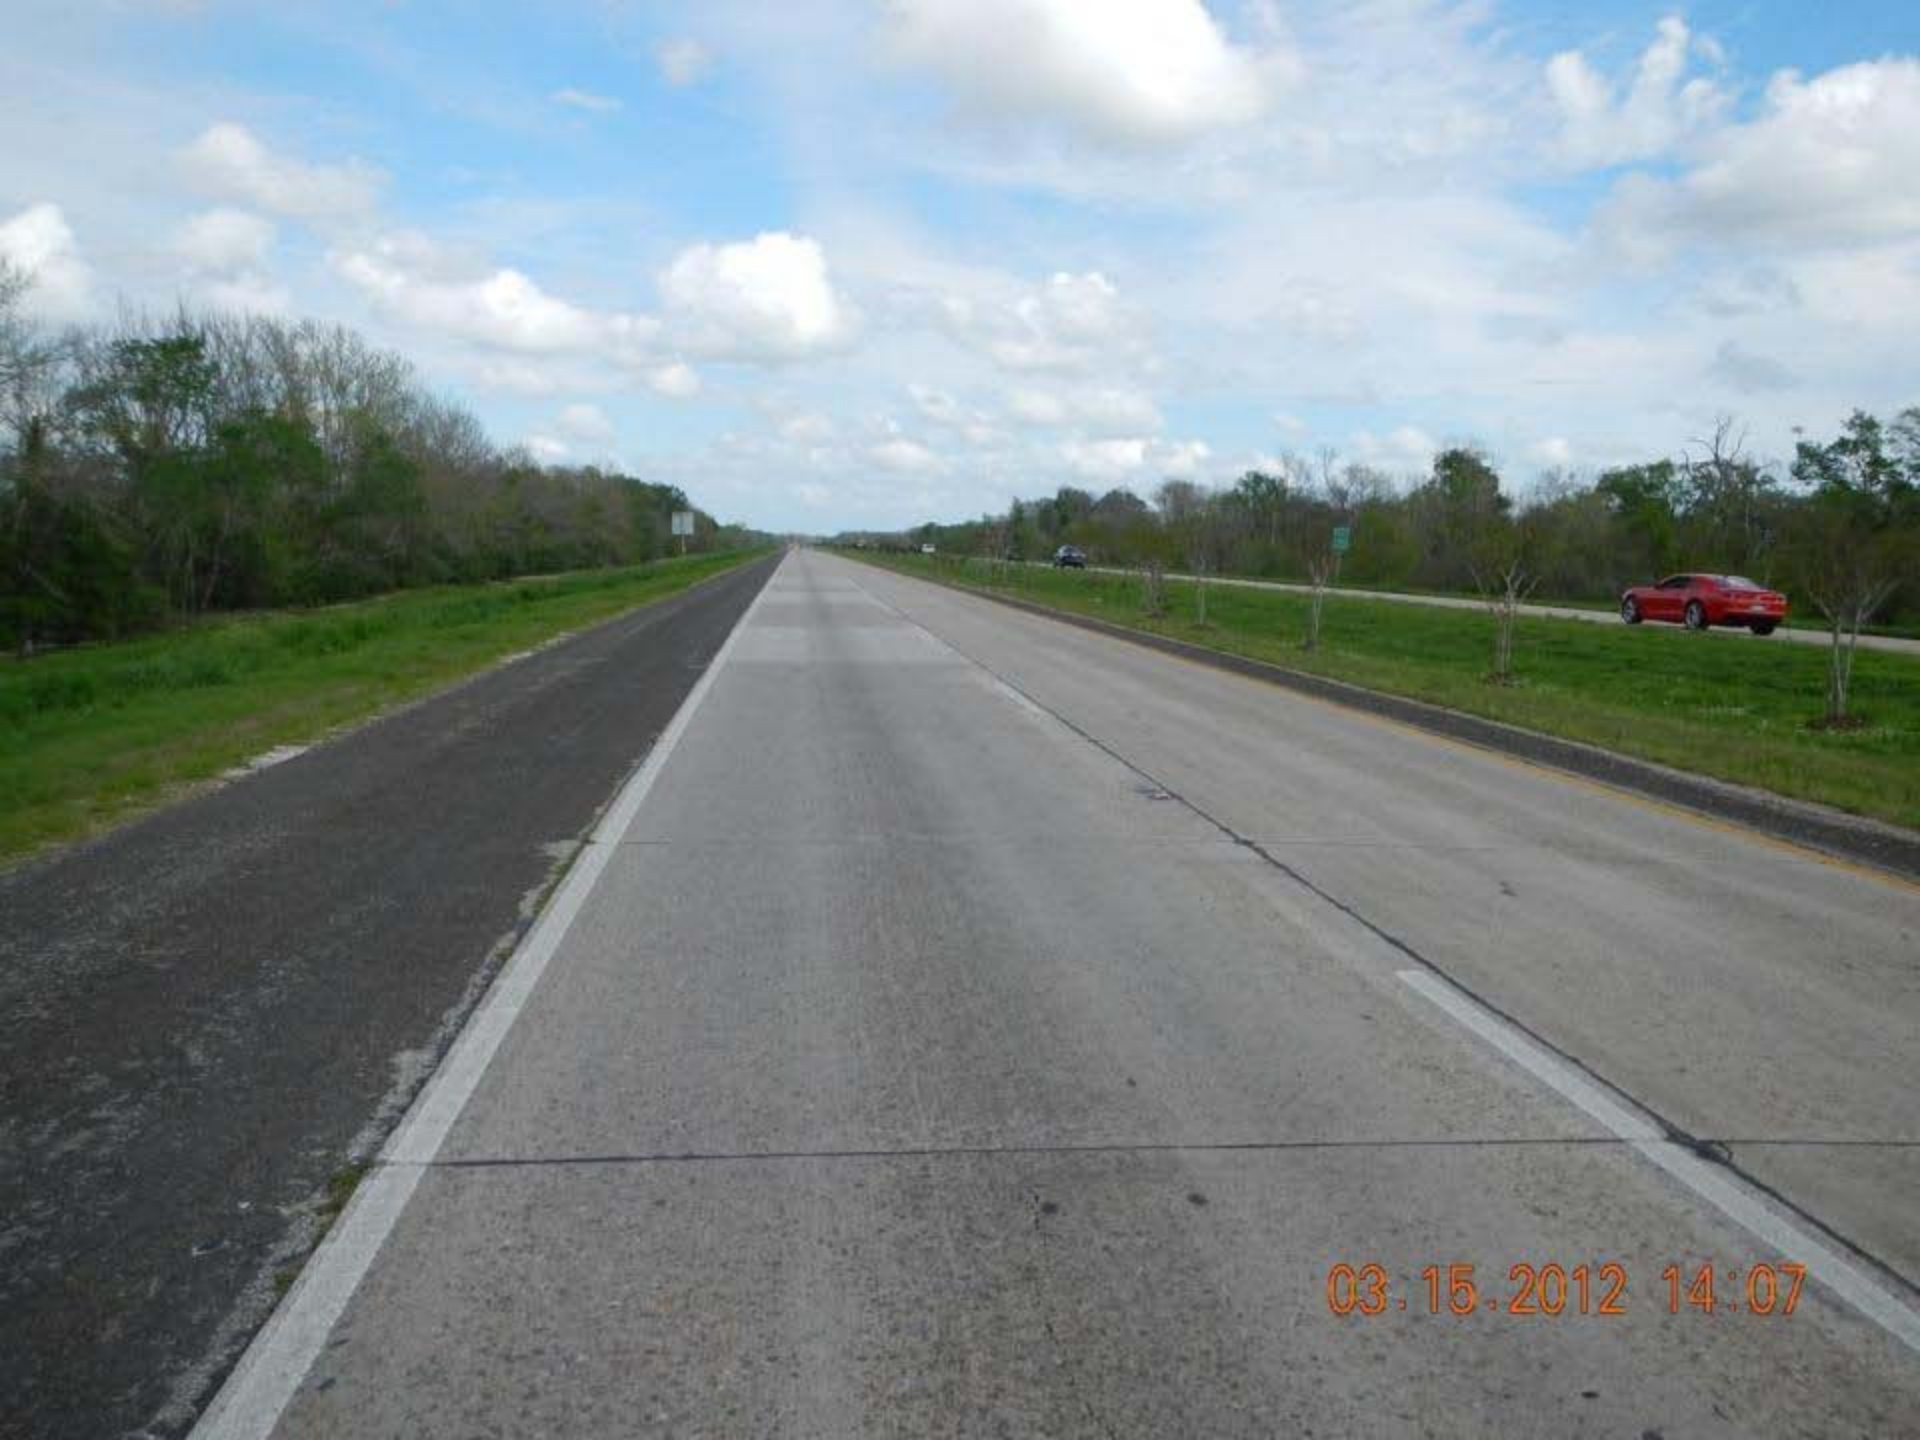
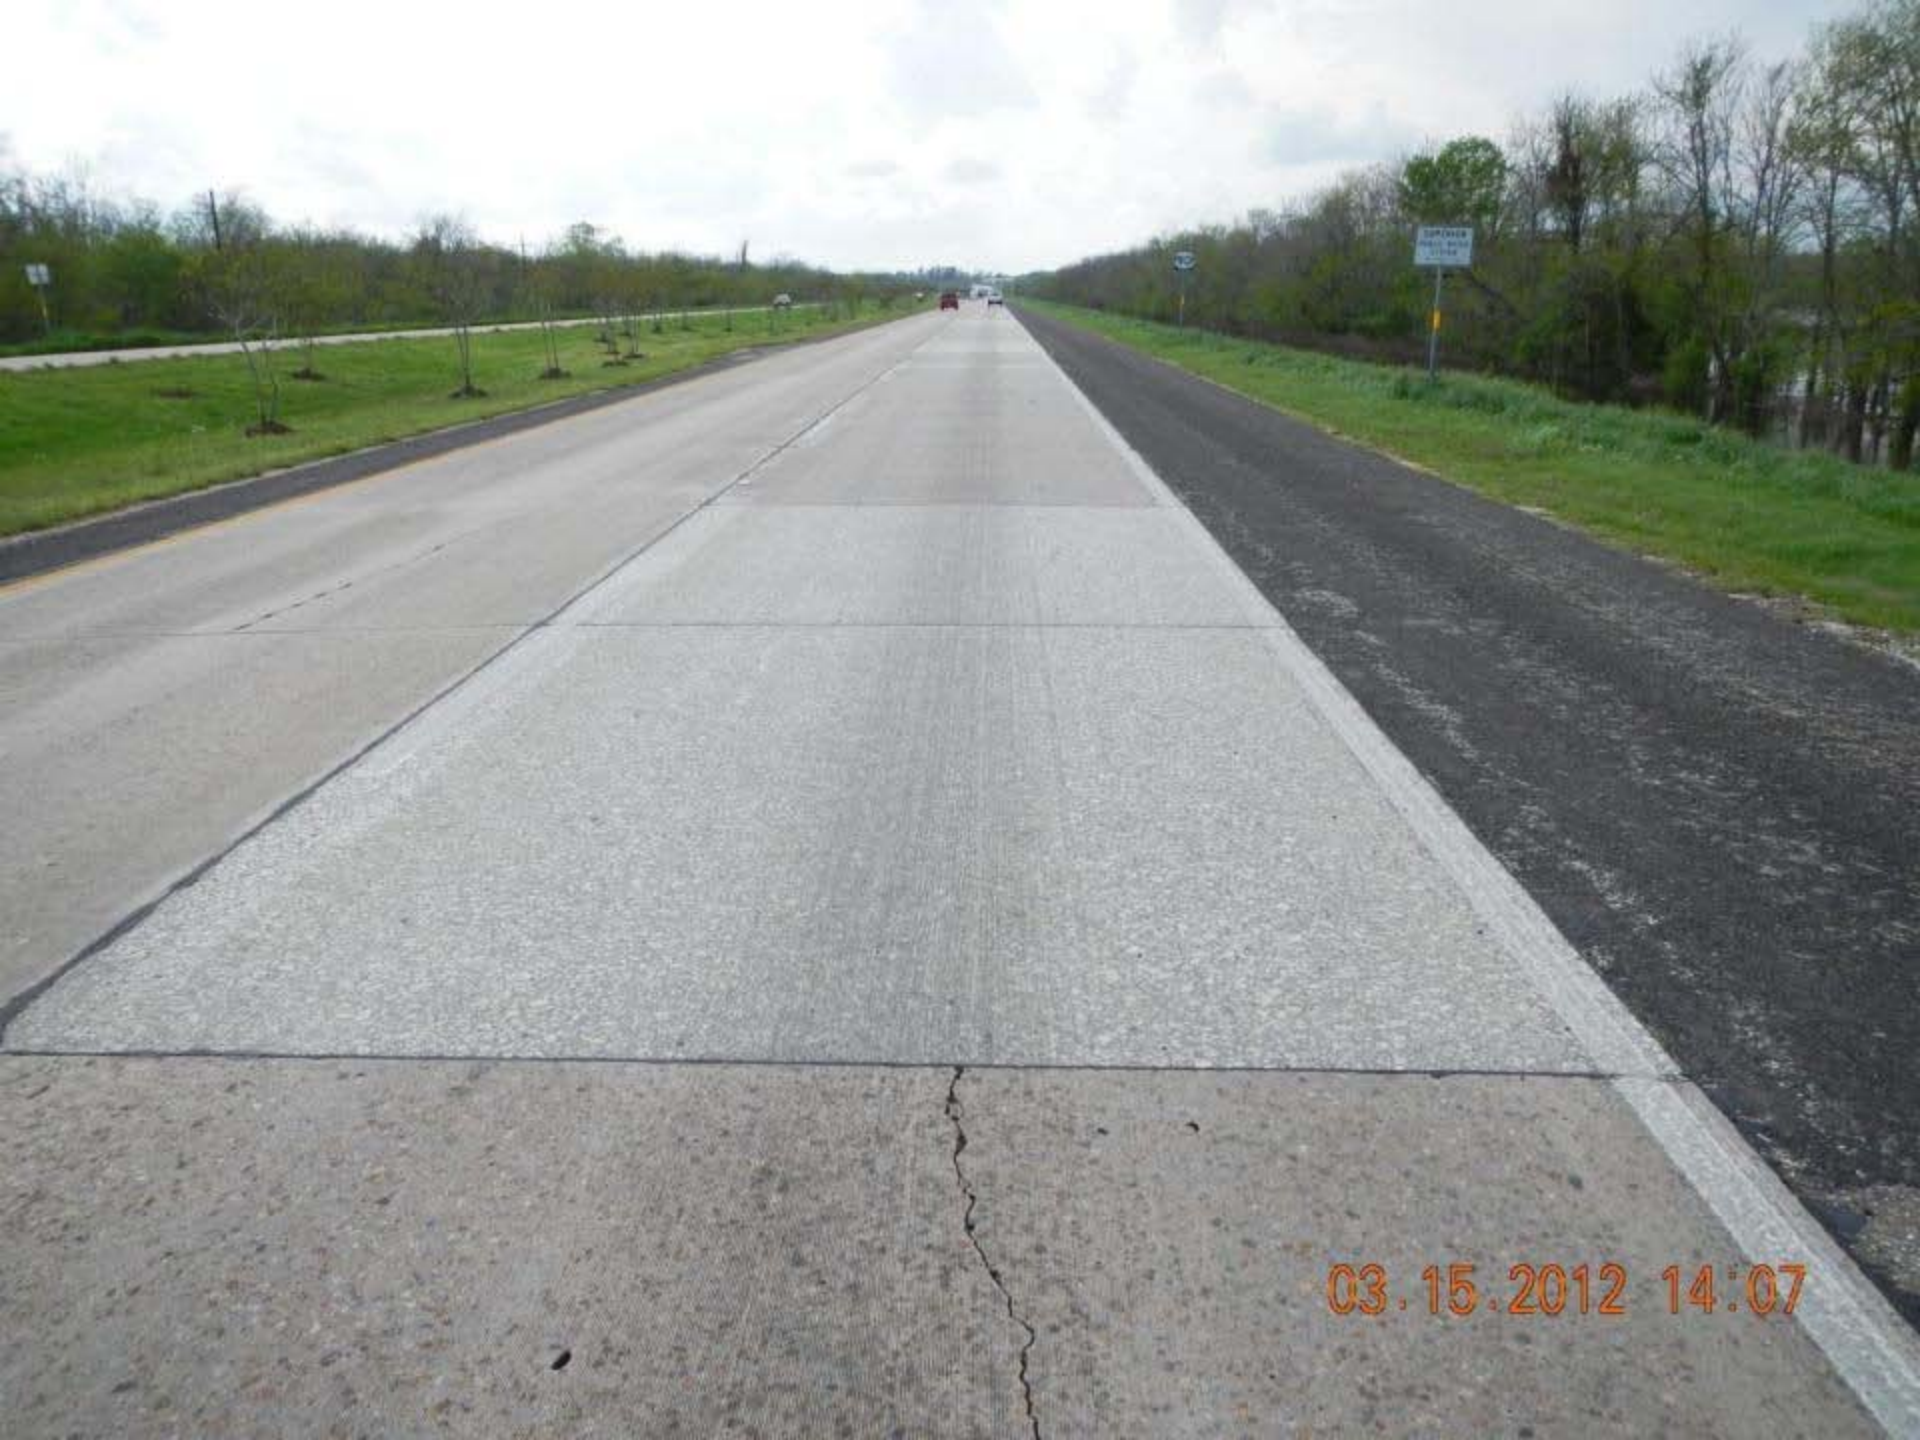
PCP

- CAT ; Gravel
- Overall CPCD Condition ; Not Good
- Observed Distresses
  - Small Map Cracking, Transverse Cracking, Longitudinal Cracking
  - PCP, Diamond Grinding.
