# US 90 in Beaumont District

- Liberty County, US 90 RM 847
- Project Completed ; 2000
- Thickness ; 10-in
- Base type ; Existing 6" Flexible Base
- Subgrade type ; -
- West (Dayton Direction) ; Gravel
- East (Liberty Direction) ; Limestone(?) or ...
- Survey Date ; 03-15-2012

# Dayton Direction

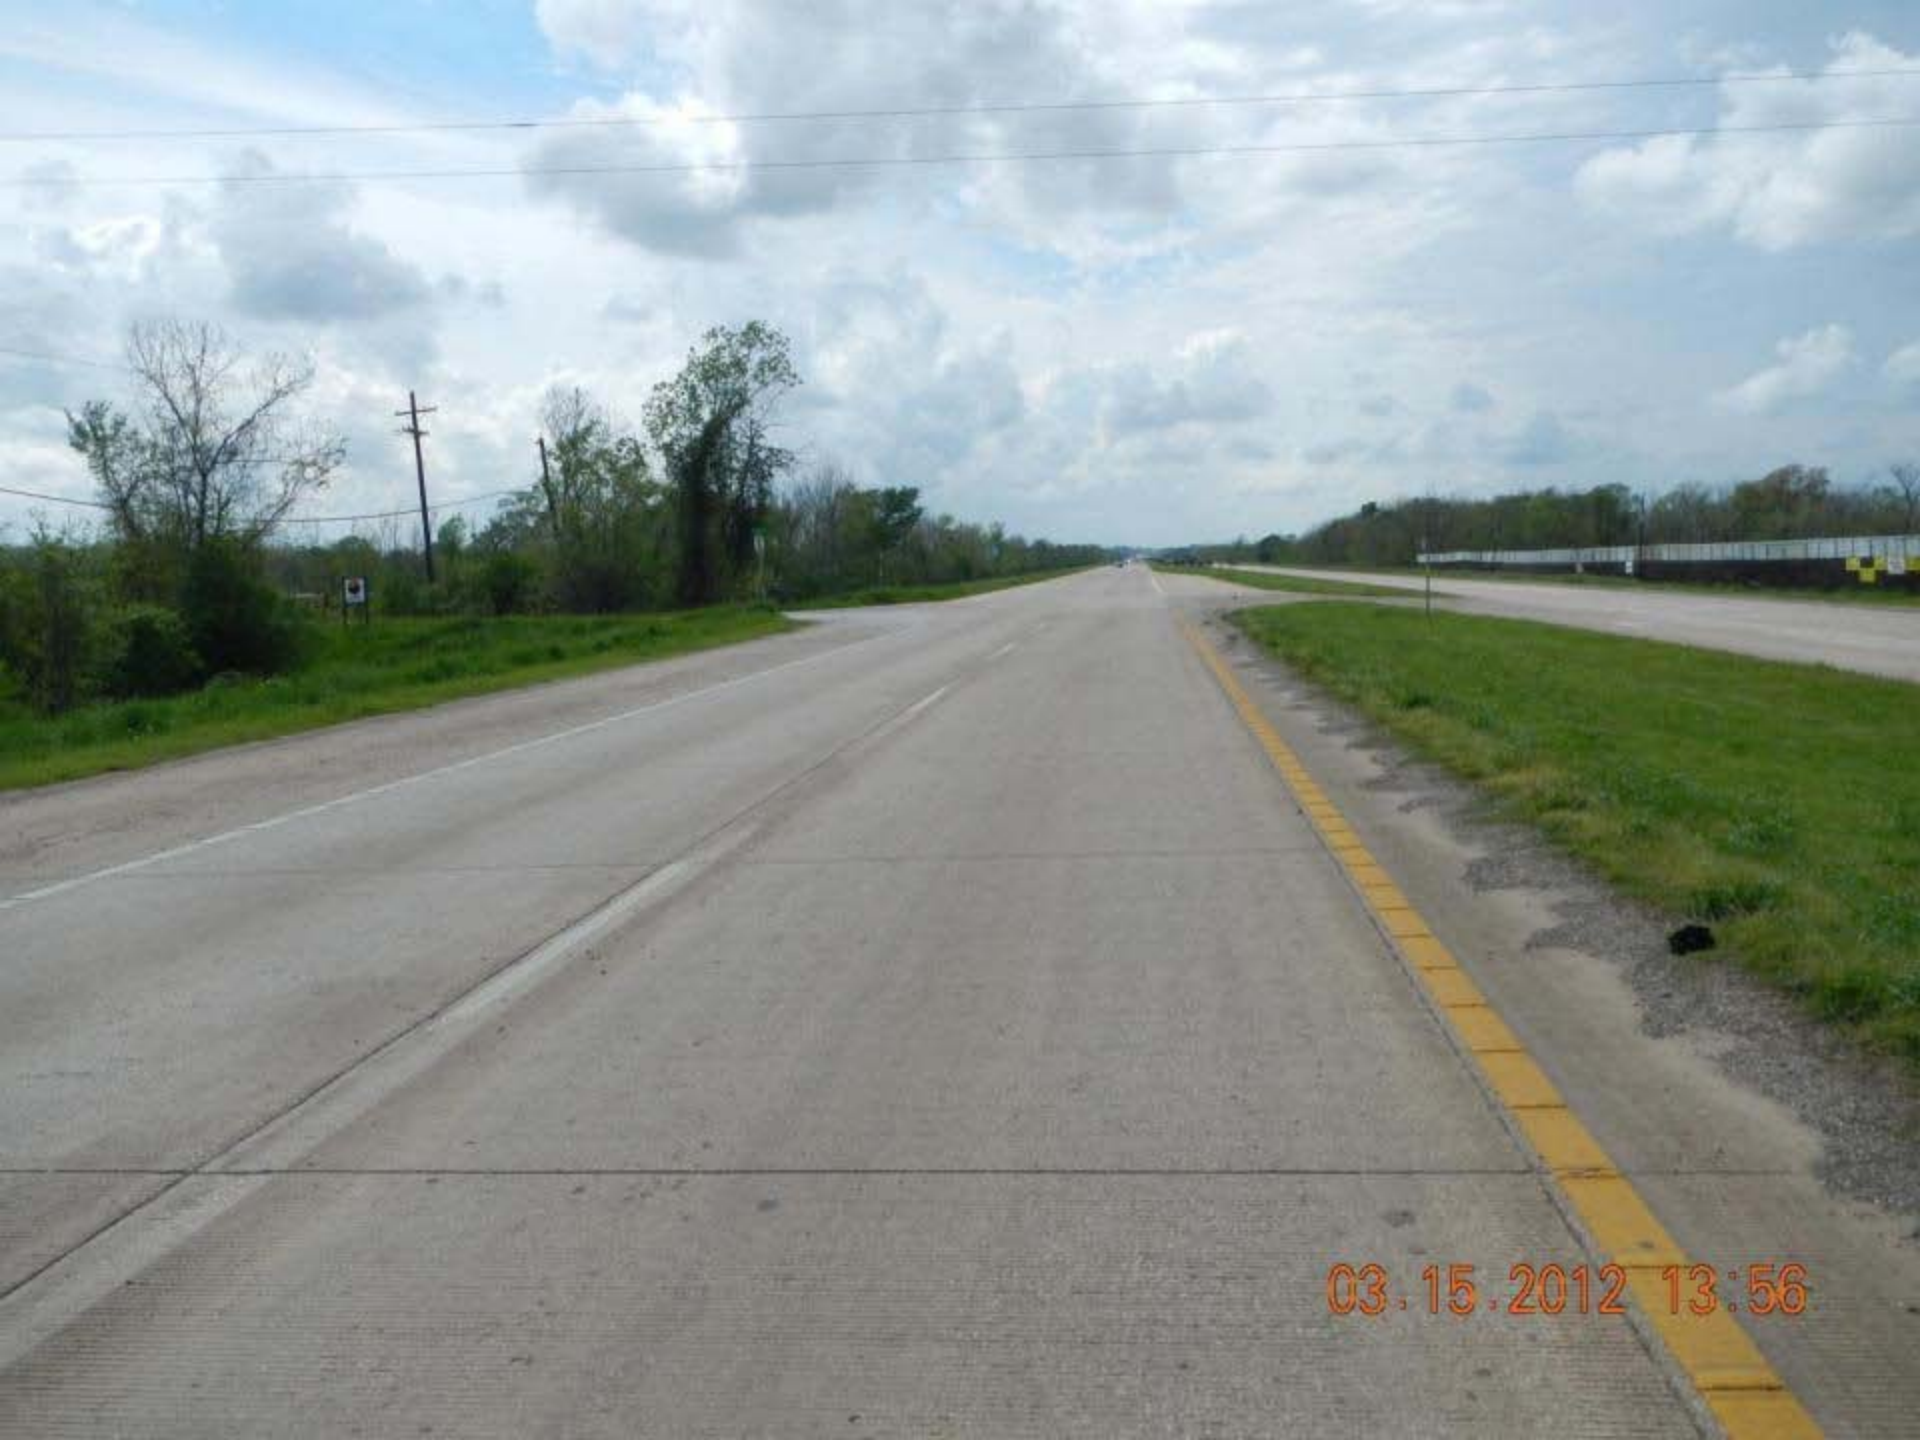
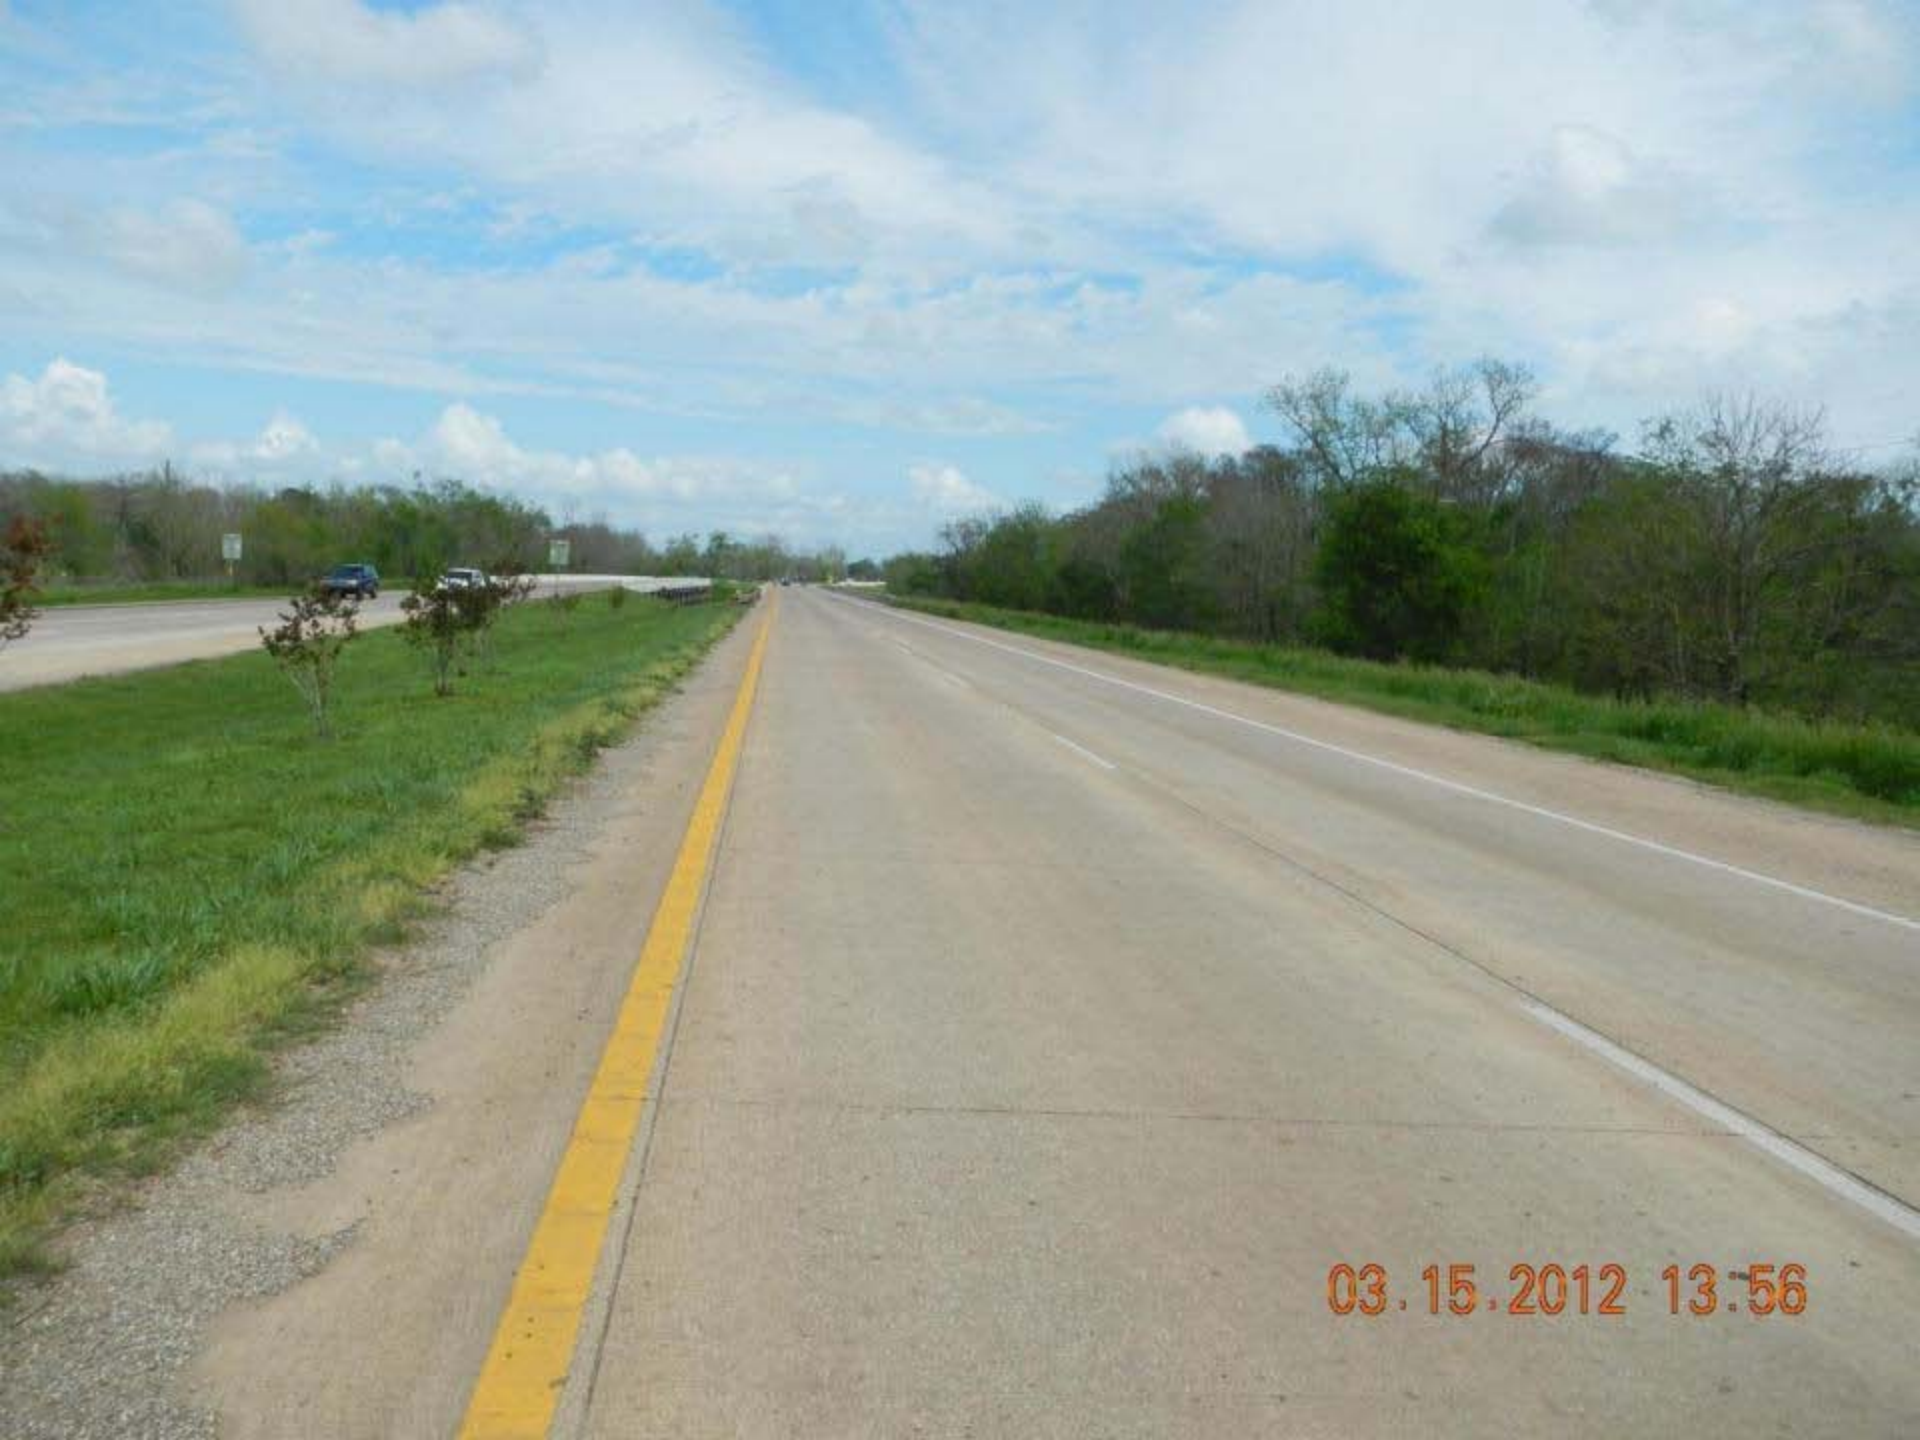
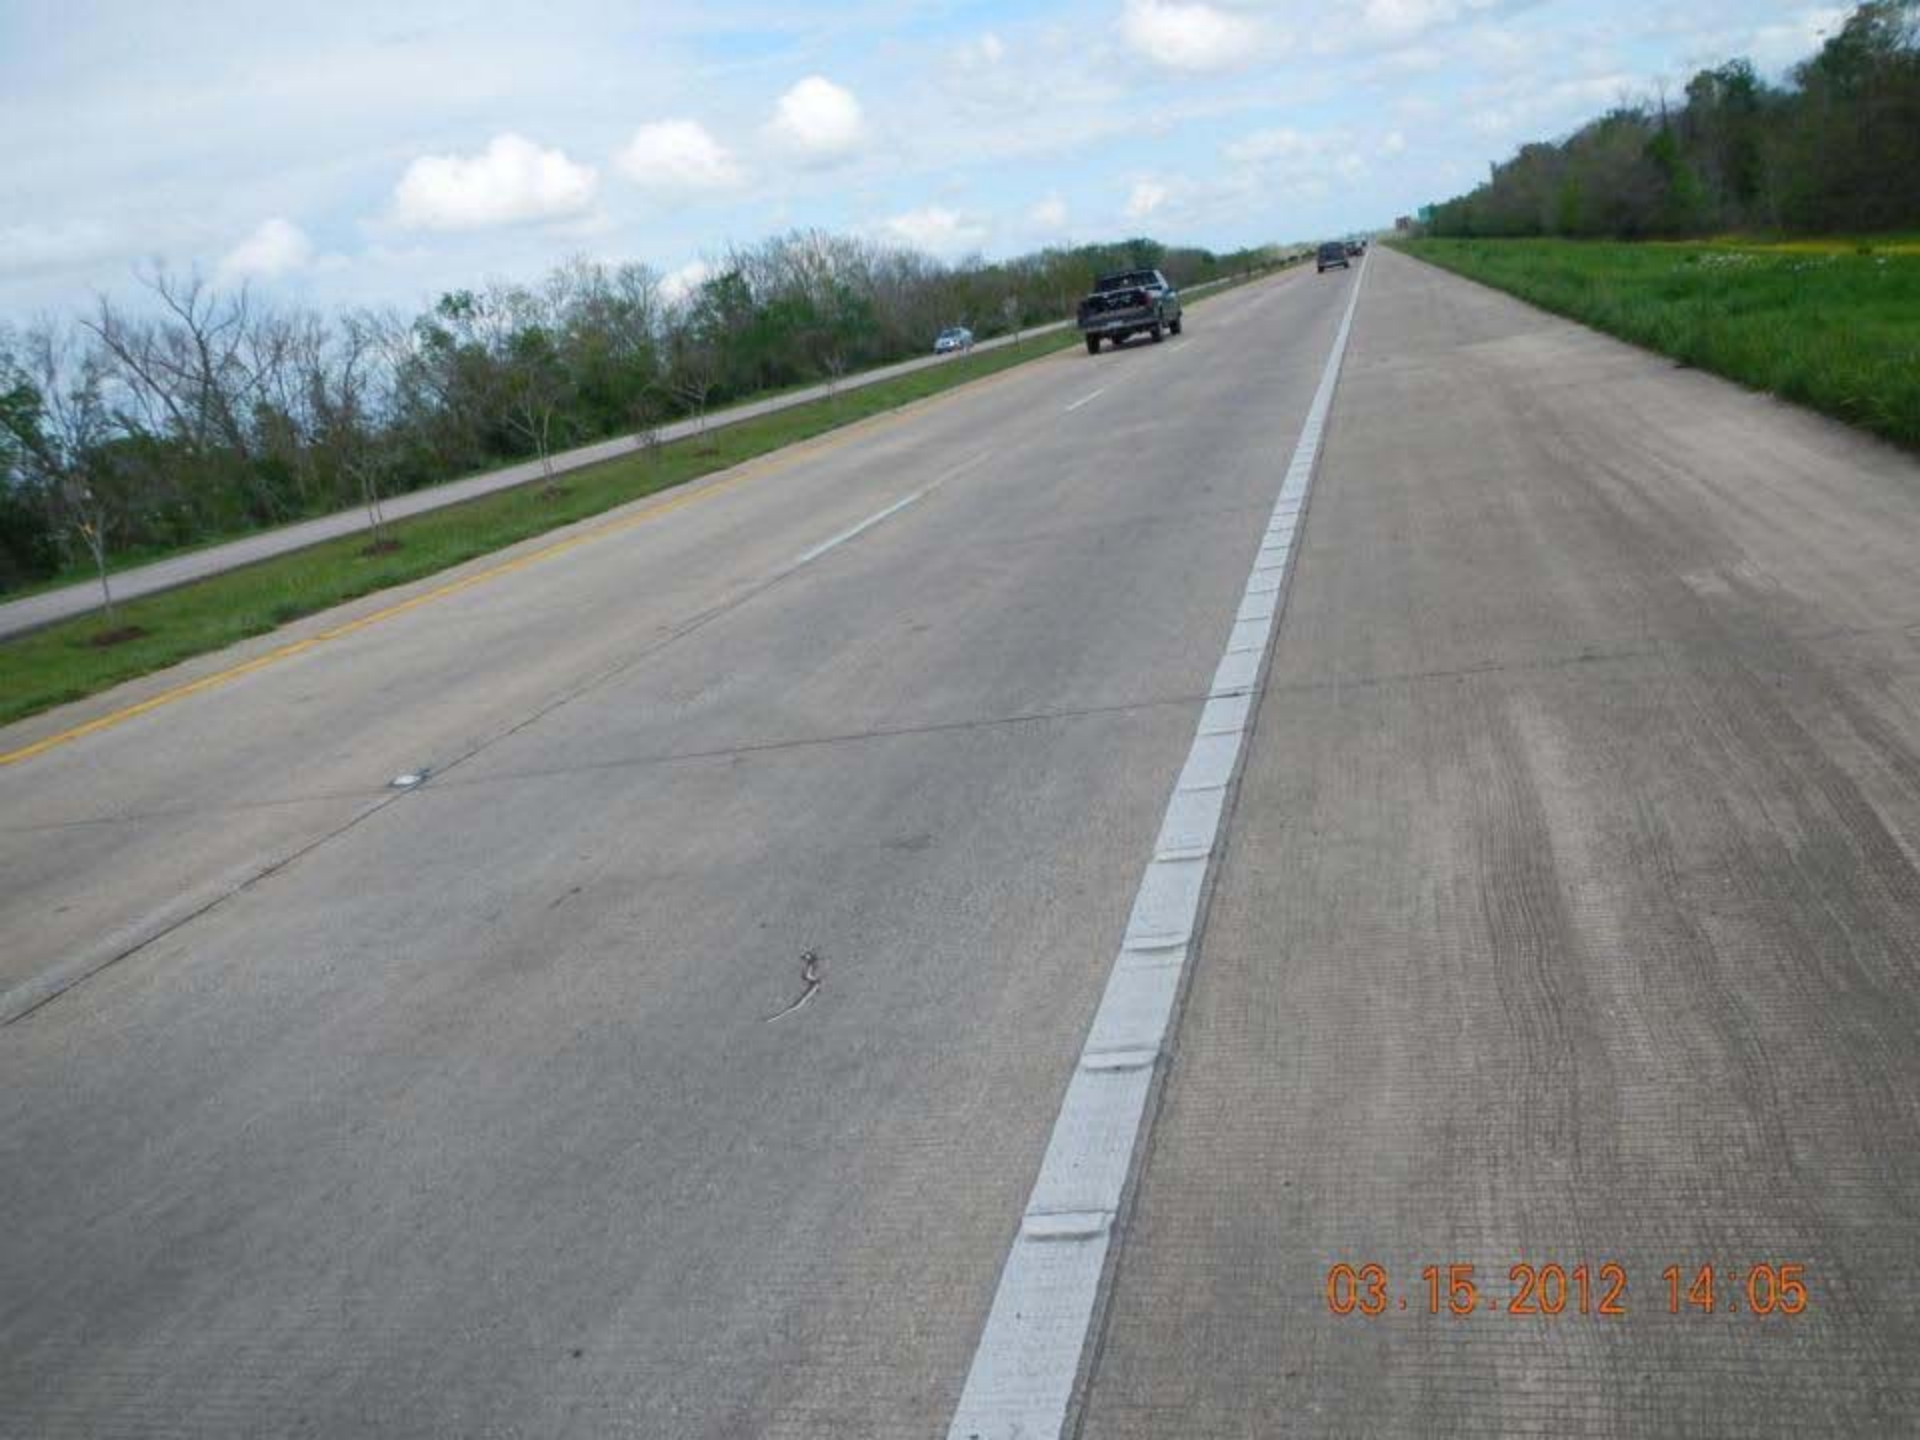
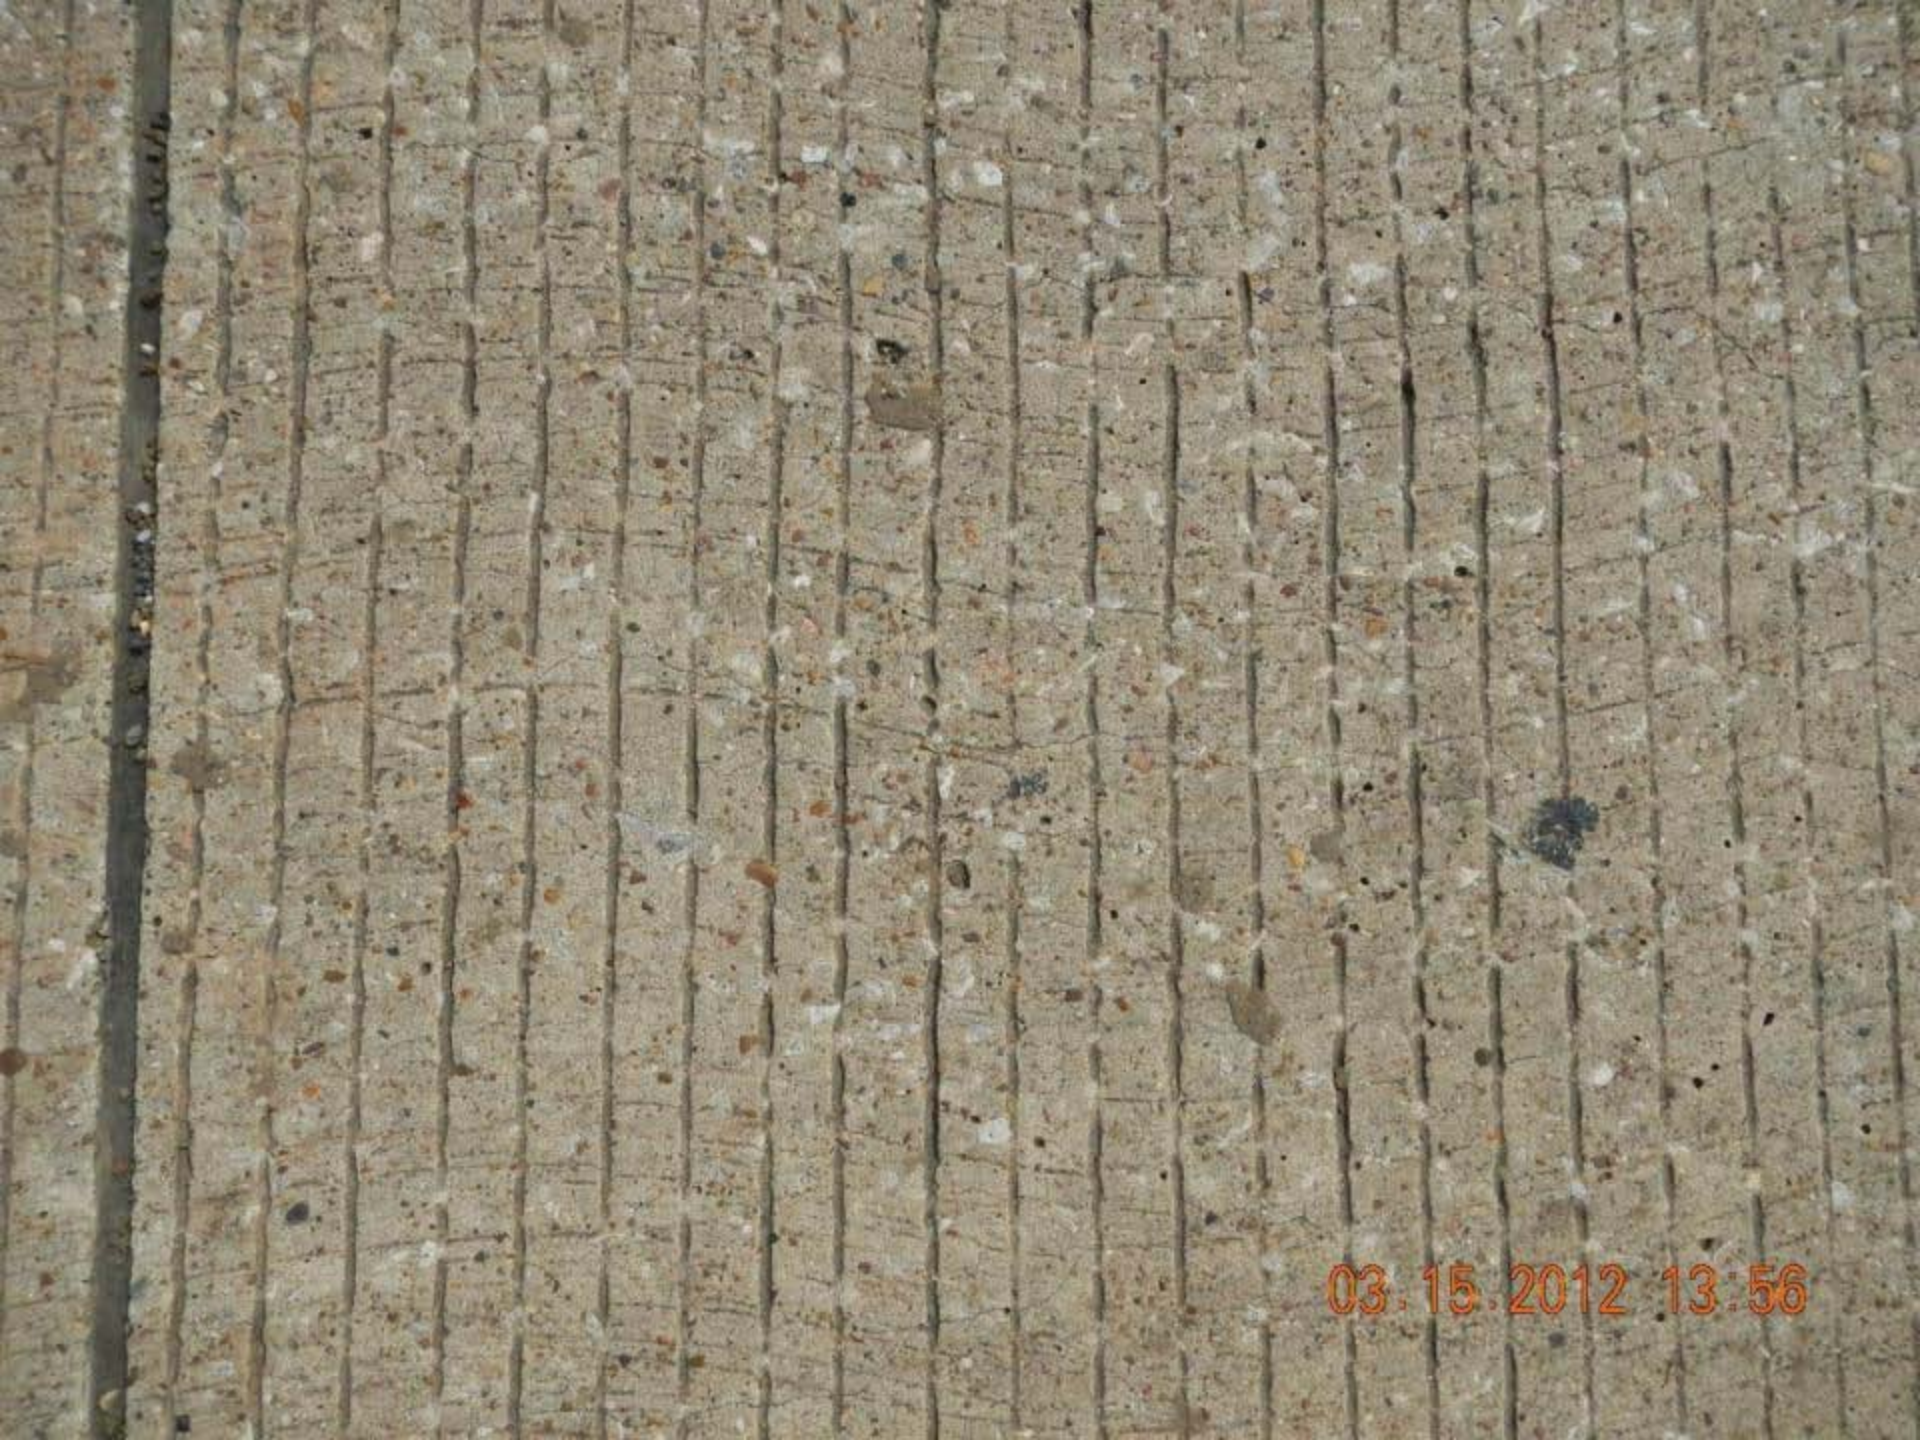
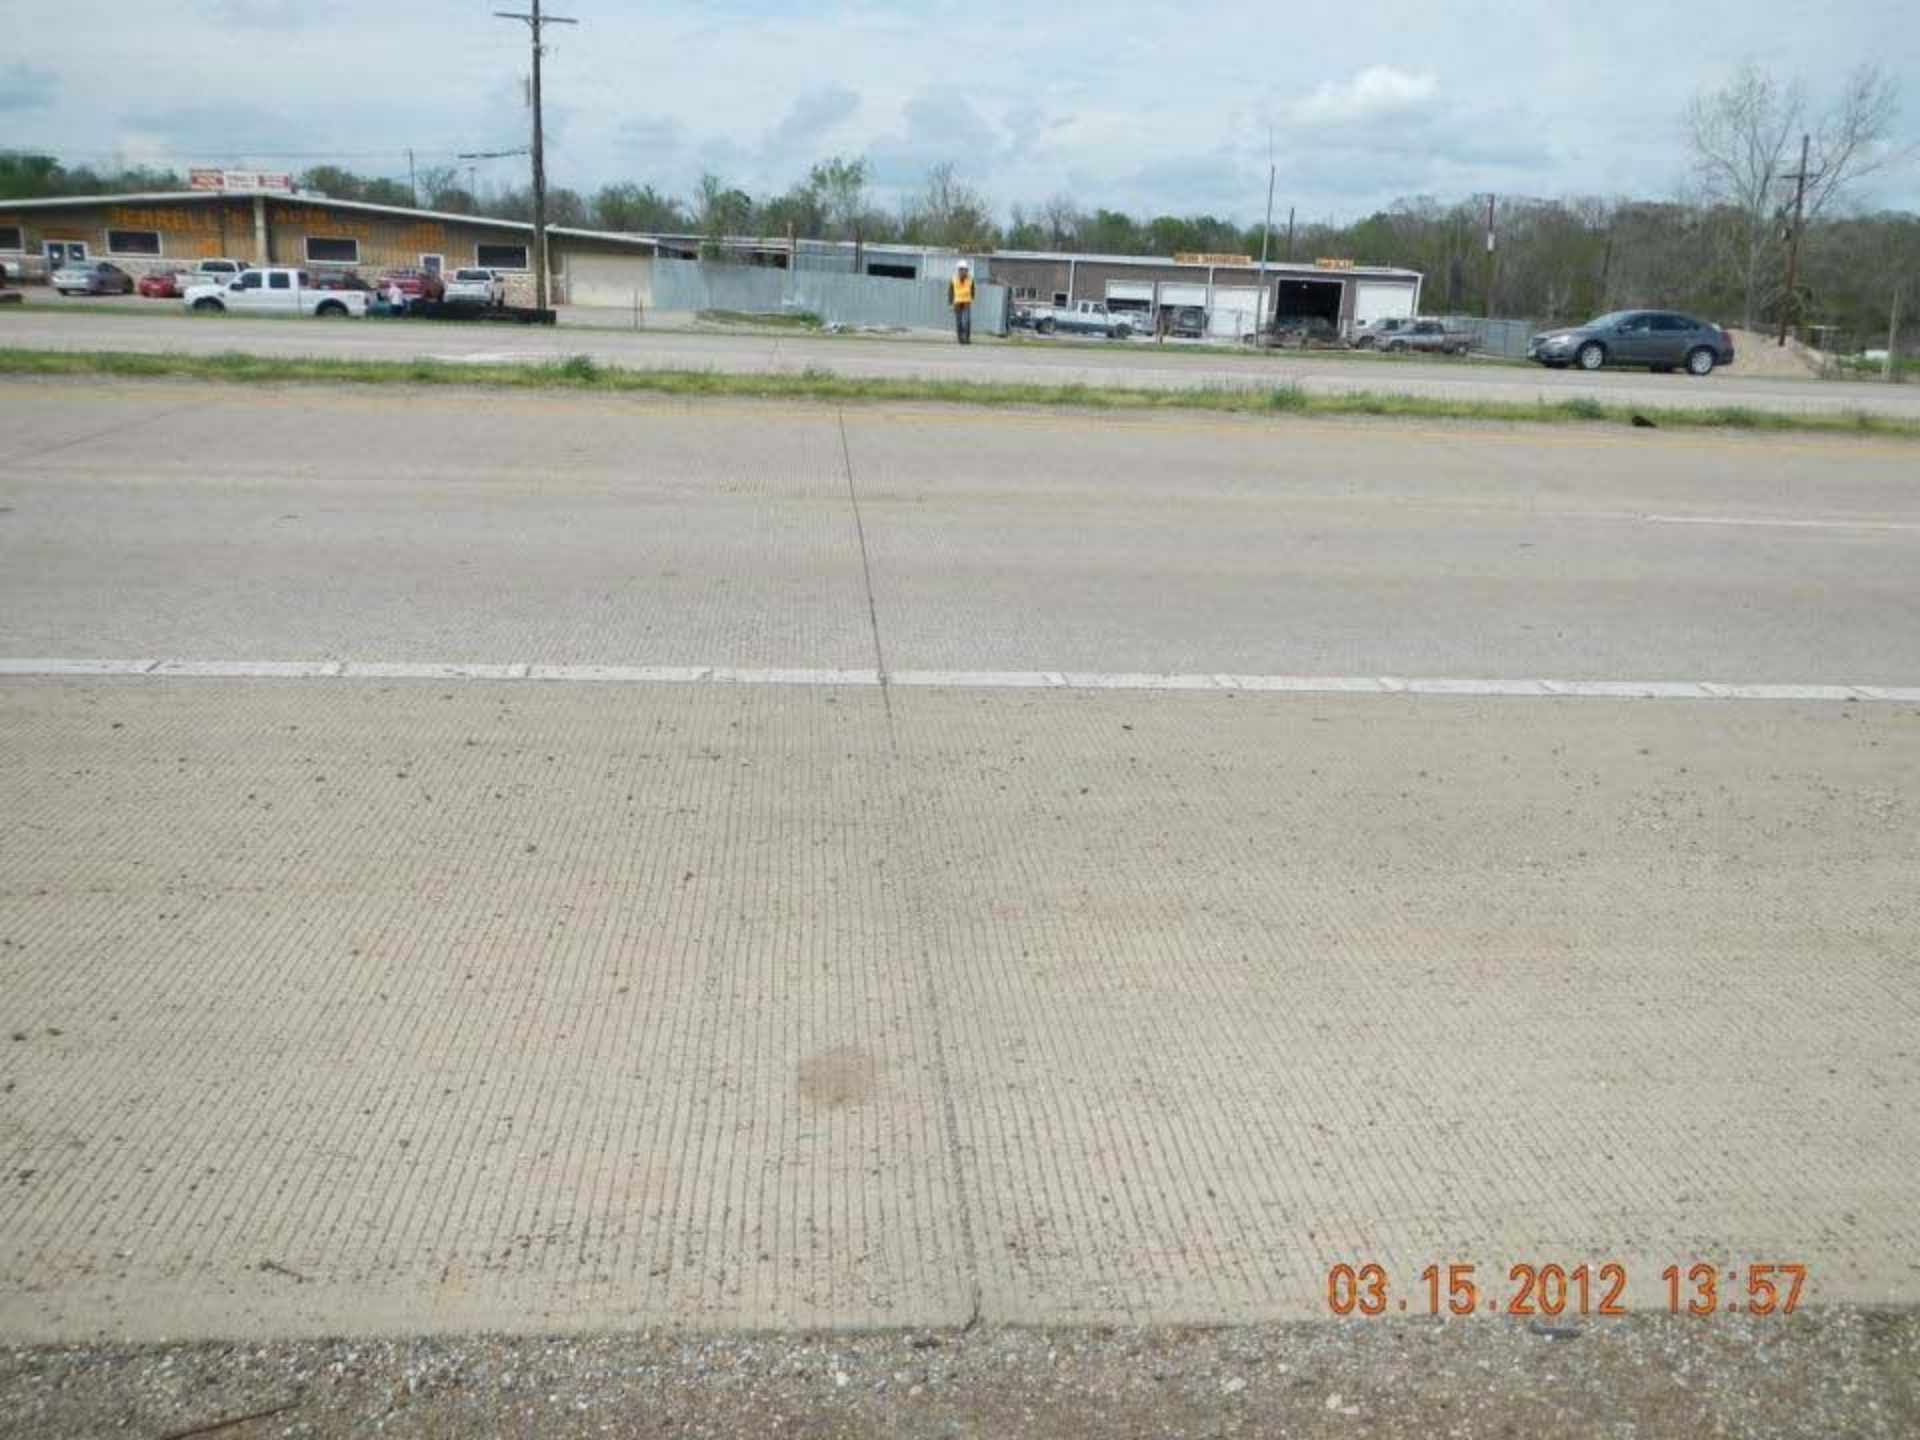
- Construction Year ;
- CAT ; Limestone(?) + ?
- Overall CPCD Condition ; Very Good
- Observed Distresses
  - Exposed Dowel 1ea
