## Volume 6 Paper H012

### In advanced Creep Failure of H.P. Modified Reformer Tubes in an Ammonia Plant

#### Abstract

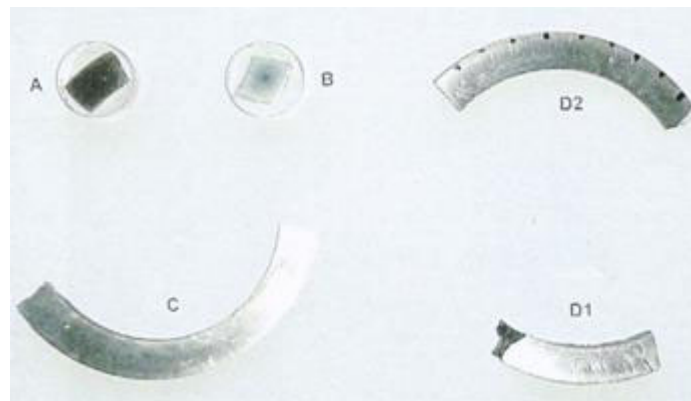
Figure 6. Samples Collected From the Failed Tube

Five samples labeled A, B, C, D1 and D2 (*Figure 6*) were collected for evaluation. The locations from which the samples were taken are shown in *Figure 7*. Visual examination of samples A and B did not reveal anything untoward. Examination of samples C and D2 revealed a smooth inner surface to the tube typical of a machined finish. Sample D1 showed undulations oriented in the axial direction typical of macrostrain accumulation (*Figure 8*). The outer surfaces of samples D1 and D2 appeared unusually smooth for centricast tubes; however, discussions with manufacturer revealed that the failure occurred within the area machined as part of the manufacturing process for this section of tube.

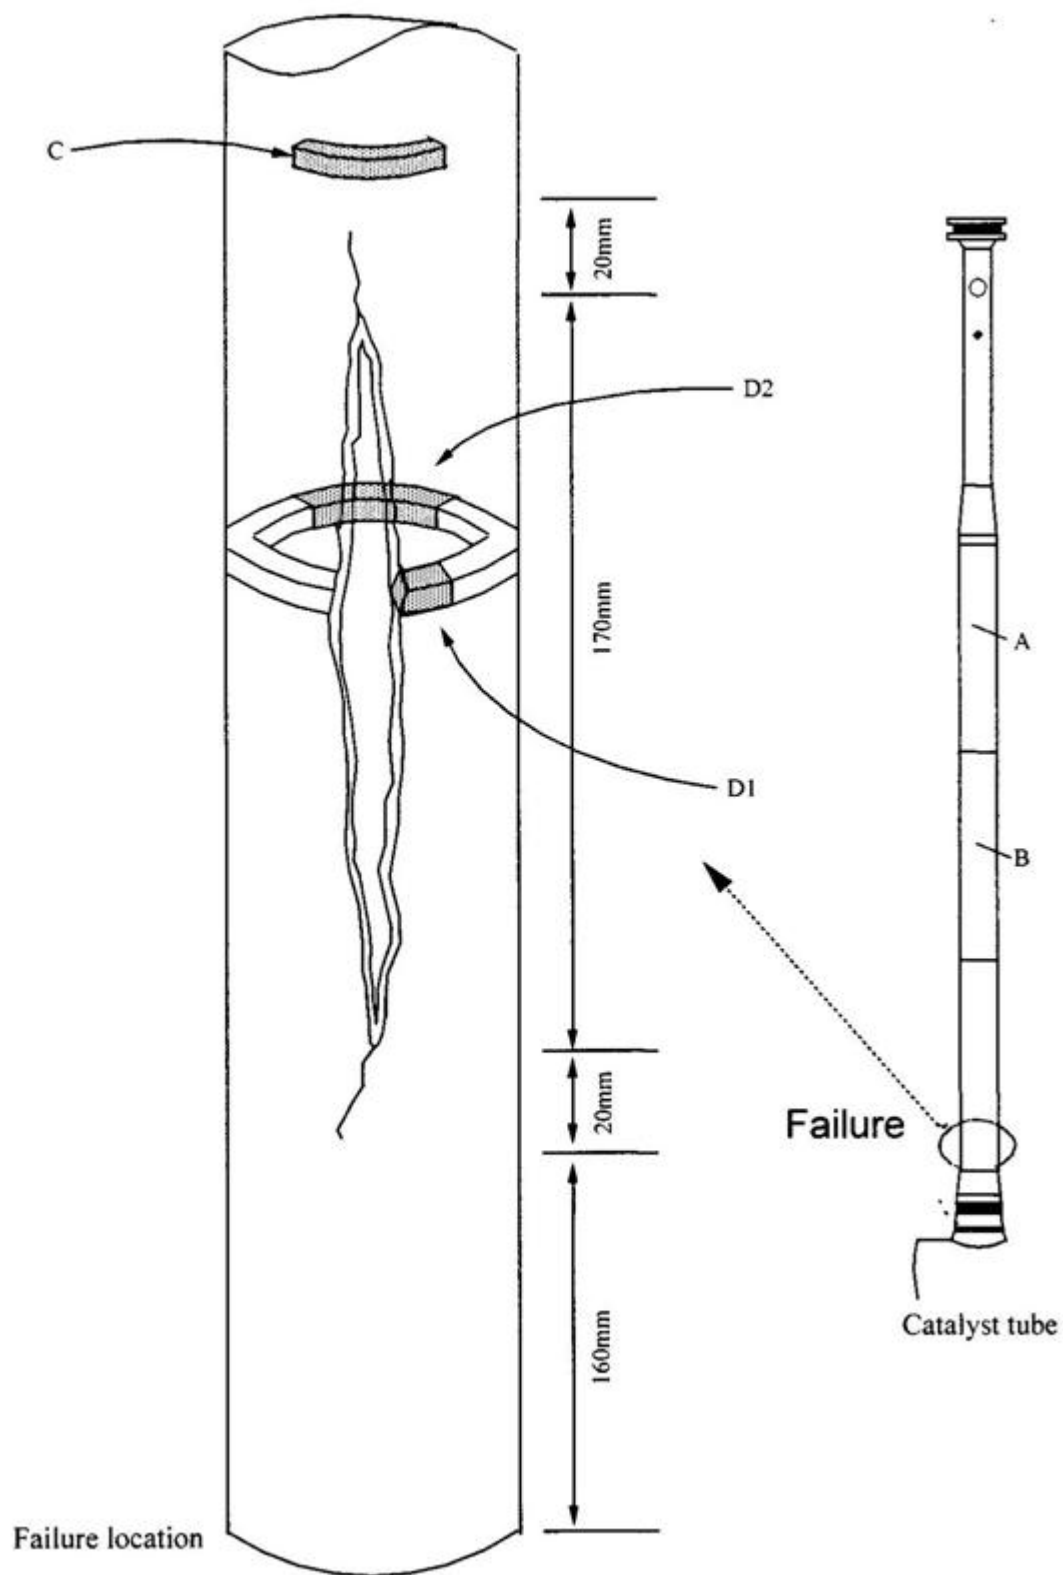
Figure 7. Sketch Showing sample locations from catalyst tube

3. Thickness Measurements indicate that all the tube walls measured, apart from that immediately adjacent to the failure, are above maximum specified in the design.
4. Samples A and B, taken from higher positions in the tube, represent material appropriate for further extensive service. They show no significant creep damage.

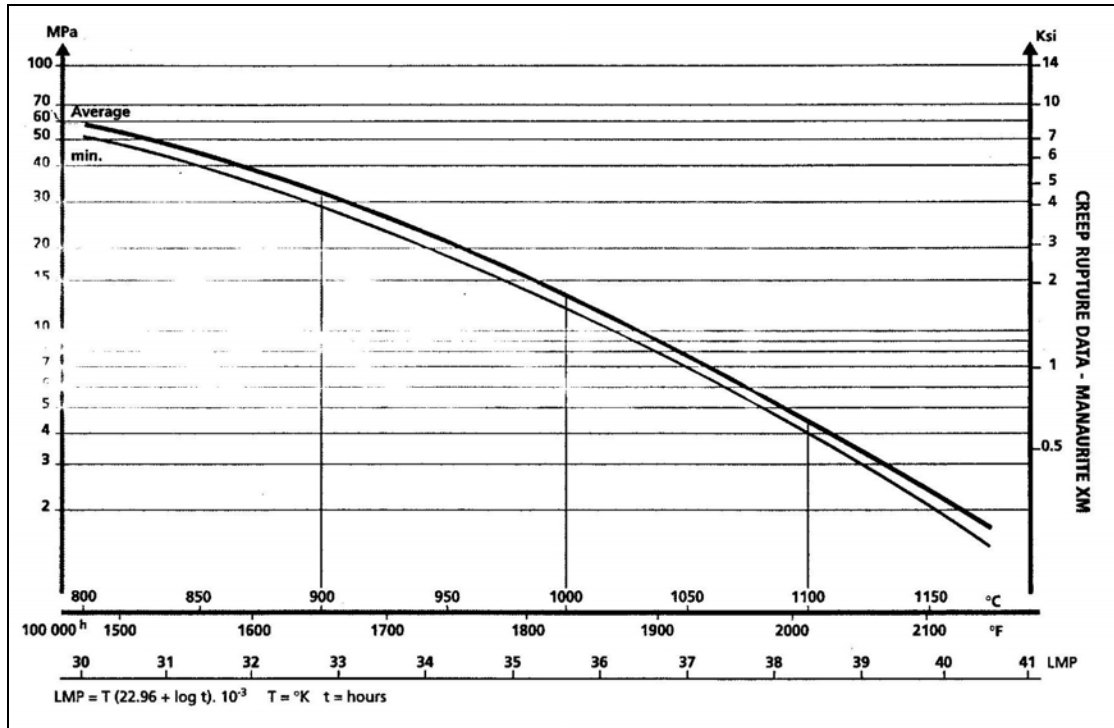
Figure 14.Lason-Miller Curve for Manaurite XM

According to XM Larsen Miller curve in *Figure 14*:

1. The tube failure occurred as a result of excessive operating temperatures ( $1049^\circ\text{C}$ ). Samples C, D1 and D2 all contain significant creep damage, distributed in a manner indicative of pressure stress loading under overheat conditions rather than through wall thermal stress loading under normal conditions.
2. Chemical analysis revealed sample D2 to be consistent in composition with Manaurite XM.
