## Failure analysis of chrome plated rotor of down-hole drilling motors

Meysam Zarchi

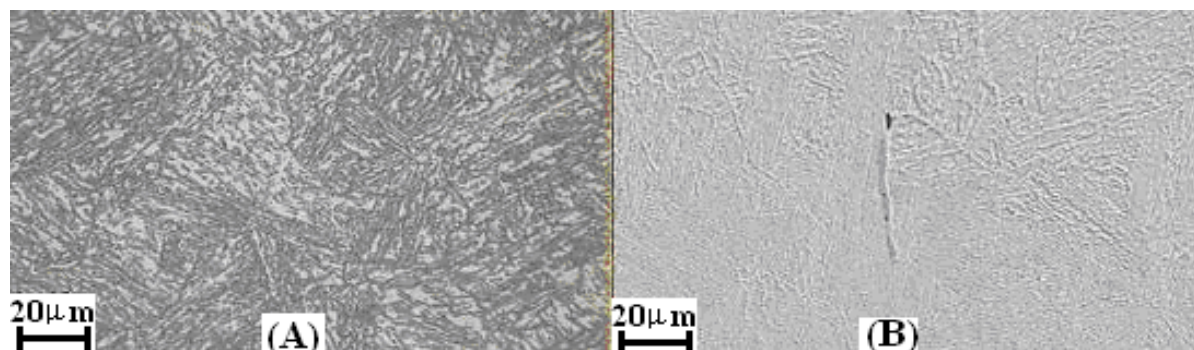
Results of chemical analysis showed that samples of rotor steel in the American standard of type 17-4 PH (AISI 630) and the type of martensite stainless steels with niobium and conducive hard deposits of copper. Table (1) chemical analysis of samples shows. The martensite structure of steel has also been associated with aging is alpha ferrite, which forms (3) is shown. Hardly conducive stainless steels deposited first time in 1940 and later evolve increasingly due to heat their properties as well as a combination of high strength, low distortion, corrosion resistance and wear good, excellent welding quality and relatively high hardness in different applications and many devices were actually used. The steels according to the chemical composition and phases in the microstructure can be separated. The most conducive hard alloy deposition, steel 17-4 PH (AISI 630) stainless steel martensite contains 3-5% by weight is copper-rich copper deposits nm distributed in a blade form martensite strength has been temper. Previous studies have shown that a layer structure in microstructure 17-4 PH alloy aging at temperatures higher than 570 C ° There may be returned due to formation of austenite and ferrite or alpha phase crystallization is found in temper martensite. After solution annealing up to room temperature and cold dissolution, martensite structure of steel, but high hardness will not show themselves. Aging temperature in the range of 480-620 C ° due to the formation of copper-rich phase, resulting precipitation hardening, increased in hardness and strength. If the aging temperature higher than 600 C ° increase, formation non-coherent copper deposits of in the base and the amount of martensite to austenite transformation during martensite blades occurs. It also shows the measuring of hardness by 33-35 for base metal while for coating the hardness number is much lower for the base metal. Studies and observations showed that on the steel hard chrome coating was applied and no sub-layer is nickel. Structure obtained by electron microscopy and map the distribution of elements is shown in Figure 4. The coating thickness has been measured as 80 to 100 microns. On the other hand, the interspaced between the coating and the base metal was not observed (Figure 5). This can be the reason for the lower hardness of the coating, Which is less than 33-35 HRC. Also, coating was not permanent along its length since at different places of the rotor it has been broken due to the chemical corrosion and the process of formation of holes which in some cases has reached the sub-layer of the steel (Figure 6). Creation of these

*Figure 3. Microstructure of rotor; A) by light microscope with magnification x 800 B) by SEM.*

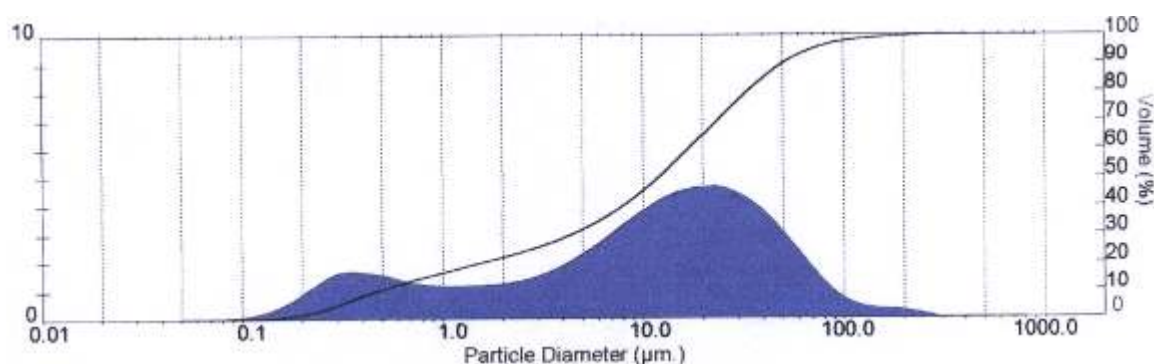
Figure 8. Distribution of the size of solid particles in drilling mud. full line indicates the destructive effect of particle on the part.
