Rajshahi University of Engineering & Technology

Experiment No. : 06

Experiment Name : Fatigue failure analysis and case study.

Course No. : MSE 2212

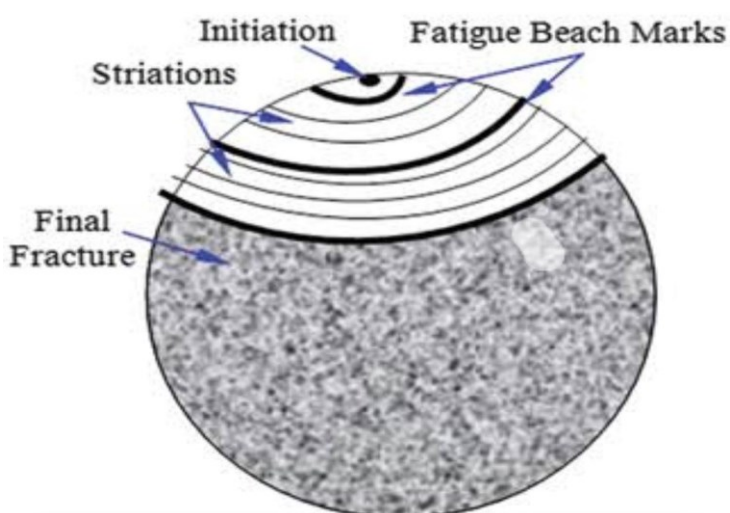
We can use an optical stereo microscope at magnifications of 50X or less for a microscopic examination which can help to reveal the fracture surface details. It can also confirm us the fracture initiation locations and mode of failure. By visual fractography we can observe two distinct regions of that failed connecting rod surface: the fatigue crack initiation & propagation region and the final overload region.

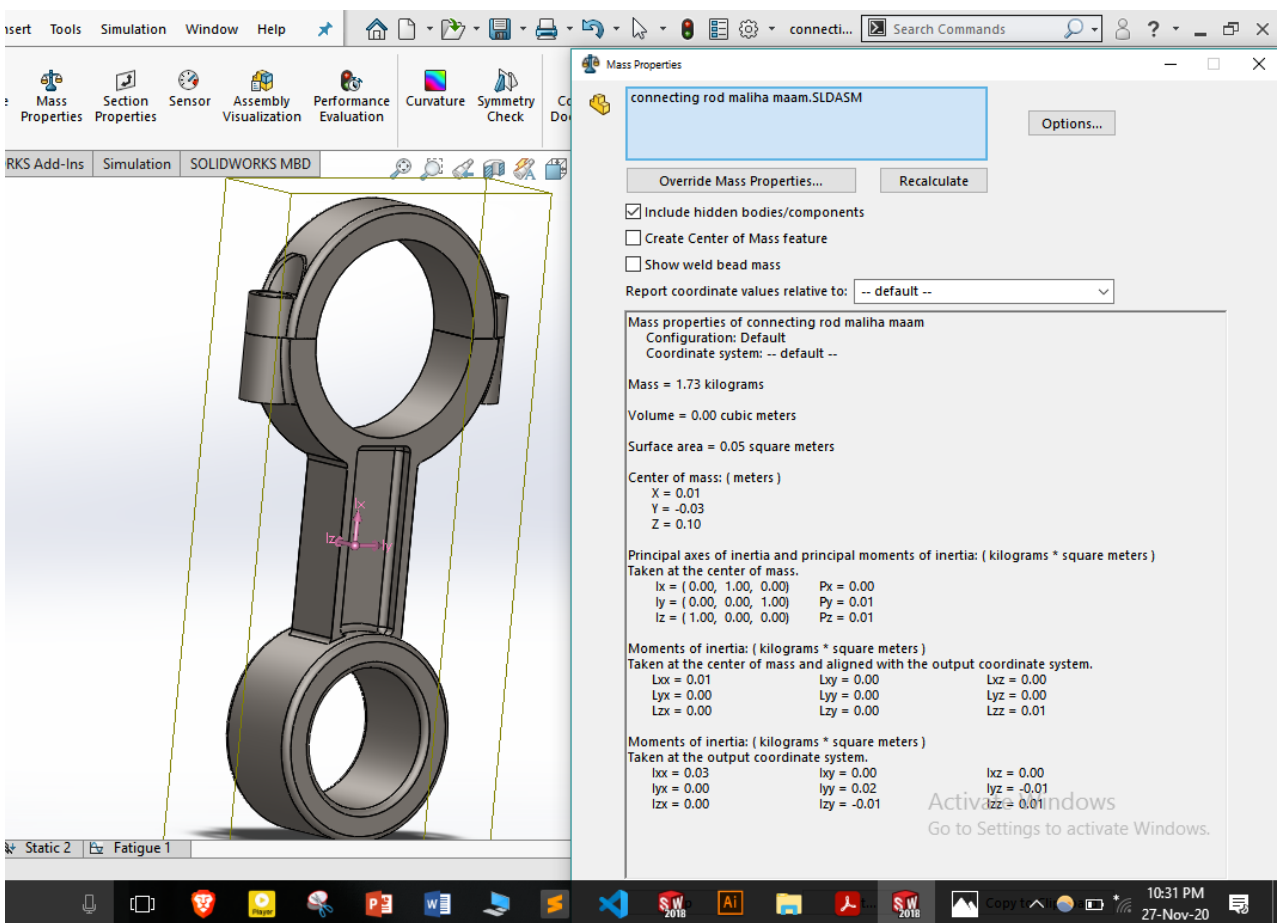
To simulate the static and fatigue study we made a solid 3D model of a connecting rod of ideal dimension in SolidWorks software :

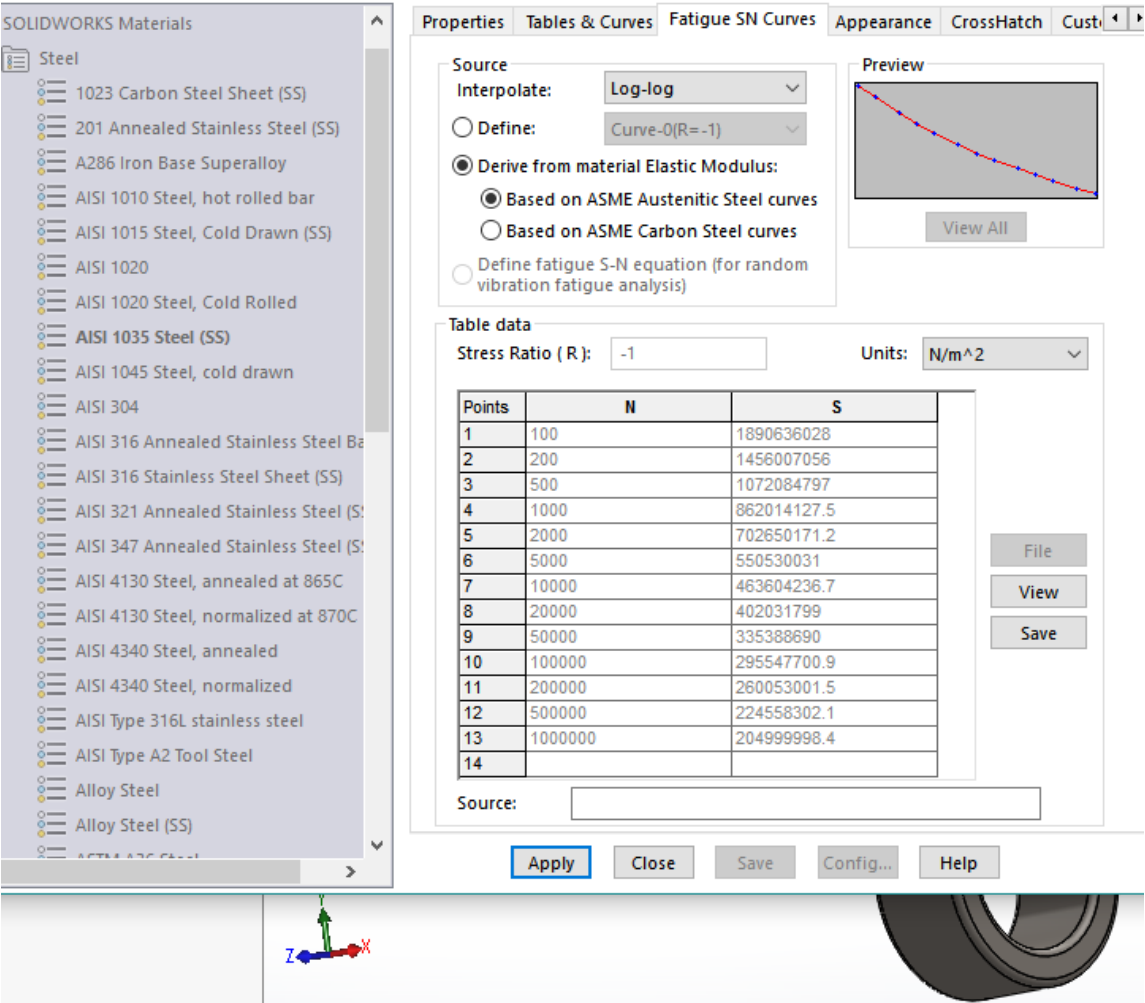
To find out how many cycles the connecting rod made of structural steel of that specific dimension we simulated the fatigue study. The end where the the piston head is connected was made rigid and tension and compressive load of $1 \times 10^5 \text{ Nm}^{-2}$ was applied on the connecting rod. For this we applied the fatigue data of AISI-1035 in our 3D model:

From this fatigue data we were able to simulate how many cycles our connecting rod can withstand

Our connecting rod survived 4.053×10^7 cycles prior fatigue failure. And failure occurred from the fillet corners as we predicted from our static stress simulation results.

To show how better designs can prevent fatigue failure we customized our previous model a little bit. We increased the fillet radius to 5mm and we got rid of the extruded cut which is used in connecting rods to reduce the material usage. Our new model survived 3.53×10^{06} cycles more than our previous model.
