Lexington High School

School Building Committee
Meeting

02.05.2024

Existing Conditions Update

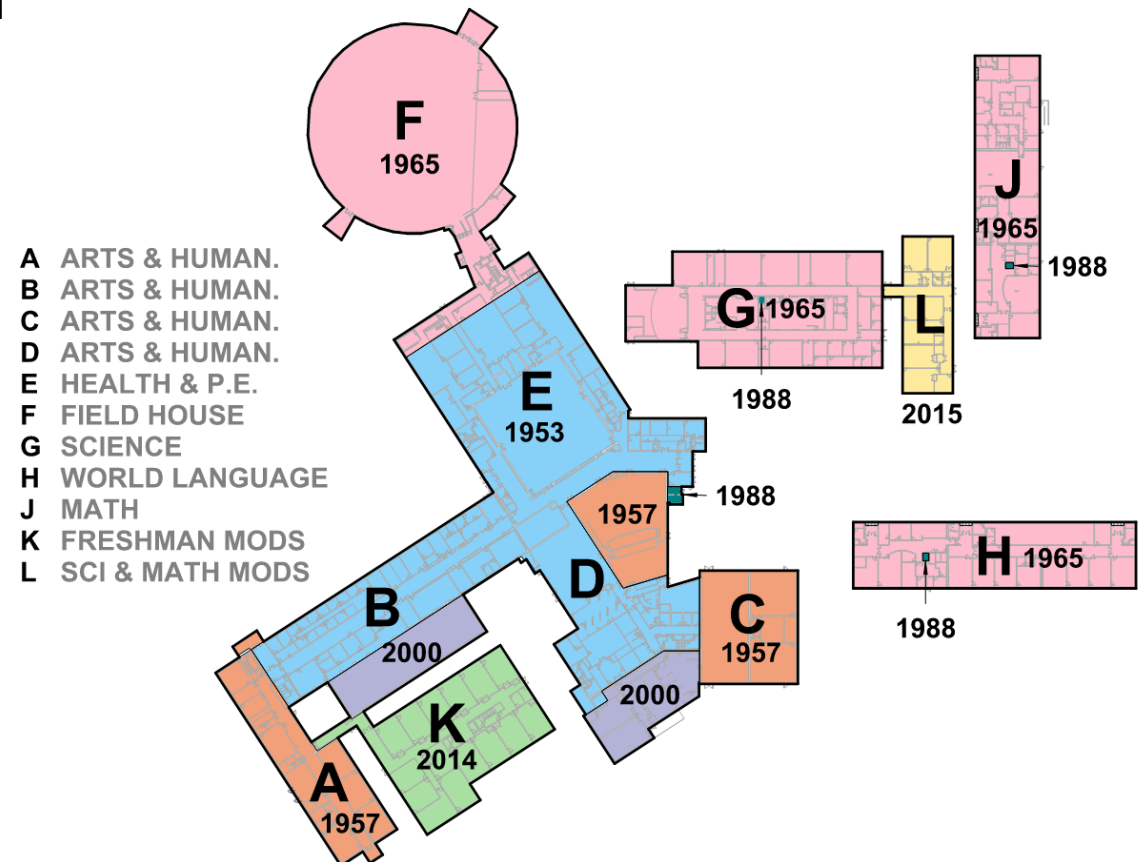
- Building & Site Investigations:
 - Architects and Engineers completed field work on 12/19 & 12/20
 - Campus is 56.5 Acres, High School portion is 28 acres
 - No structures are listed under Historic Places with the State or local inventories

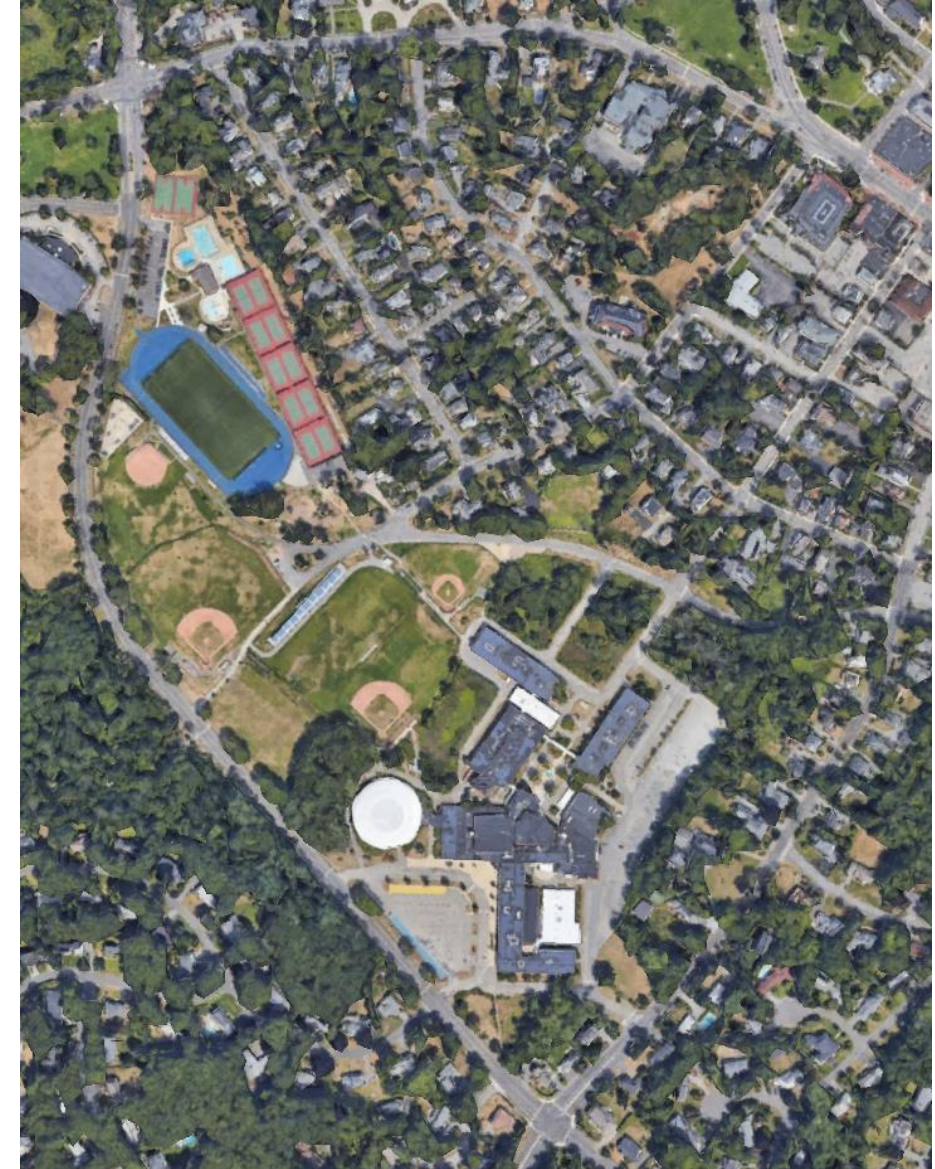
- Site Observations:
 - 450 Parking Spaces. Pavement is in generally fair to poor condition throughout.
 - 32 Buses, 20-30 LABBB taxi/rideshare vehicles, 6 LABBB vans. Afternoon pickup is as well coordinated as possible, but there is a tremendous amount of strain on the site and on the faculty to safely choreograph the quantity of vehicles

- The site contains pockets of Urban Forest to the north and east of the existing building and to the west of the field house. The mature forest vegetation appears to be in good condition. Urban forest and other existing trees will be preserved as much as possible.

- Current parent drop off/pick up is accessed from Waltham Street and Park Drive. Circulation appears sufficient, but numerous conflicts with students were observed in both locations.

- Current bus drop off/pick up is accessed from Worthen Road. The quantity of vehicles in the relatively restricted area causes a great deal of vehicle and student conflicts.

- Outdoor student quad at heart of building is heavily used, but is in fair to poor condition.
 - Current athletic facilities and recreation assets are all in good to very good condition, and are heavily used by physical education, the athletics programs, and the community.
