High Test Peroxide Incident at Stennis Space Center

R. Ross, D. Sewell, M. Cockrell

Propulsion Test Directorate, Building 4010
NASA John C. Stennis Space Center, MS 39529
Telephone: (228)688-2320, Fax (228)688-1485, Robert.Ross@ssc.nasa.gov

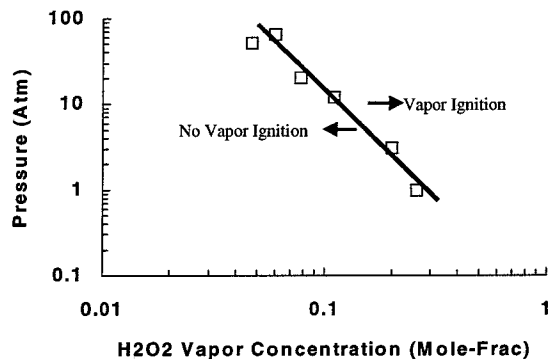
Figure 10: Critical Vapor Concentration as a Function of Pressure

Critical vapor concentrations are well defined as a function of concentration and pressure [2]. Figure 9 shows the critical temperature range for generating potentially dangerous levels of peroxide vapor at ambient pressure. As shown in the figure, the critical temperature range increases as the concentration increases, thus, 98% concentration is more sensitive to temperature than 85%. For the case at hand, it is known that peroxide vapor/liquid was present and that the temperature was approximately 121°C (250°F) at the start of the final test. These conditions are sufficient to create a dangerous vapor concentration at the start of the test. In addition, Figure 10 shows the critical vapor concentration as a function of pressure. As shown in the figure, the relationship is logarithmic with respect to pressure and concentration and the critical concentration decreases as the pressure increases. A high but less than critical vapor concentration in the system at low pressure can translate into a dangerous level by increasing the pressure from ambient to normal operating pressures of 3.4 MPa (500 PSIA).
