Lessons from Hurricane Katrina Storm Surge on Bridges and Buildings

Article in *Journal of Waterway Port Coastal and Ocean Engineering* · November 2007

DOI: 10.1061/(ASCE)0733-950X(2007)133:6(463)

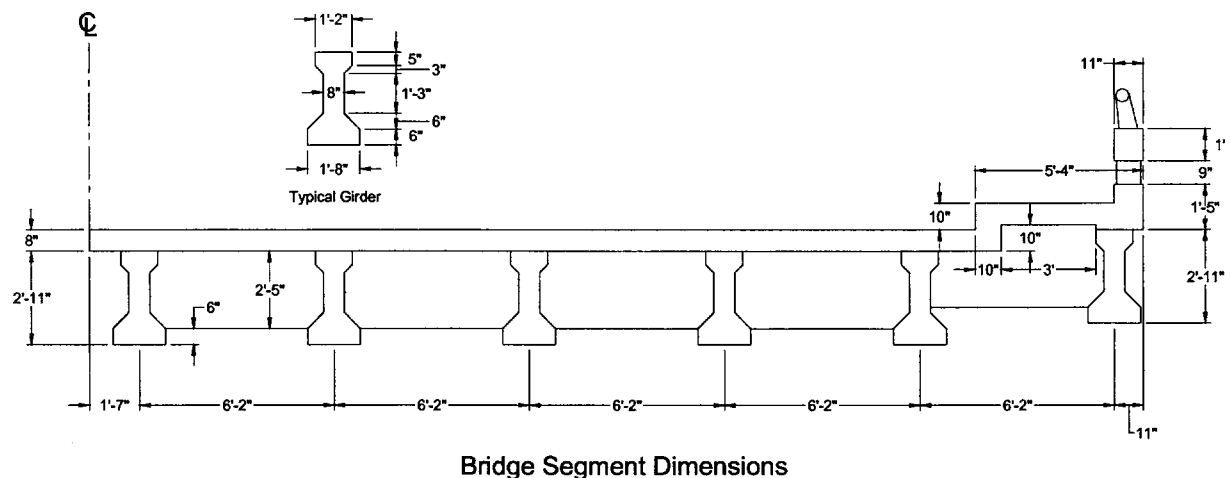
The US 90 highway bridge over Biloxi Bay is composed of simply supported bridge segments varying in length from 13.7 to 15.9 m (45 to 52 ft), each consisting of six prestressed concrete girders supporting half of the roadway deck and one sidewalk. The air trapped between the girders, along with the reduction in self-weight due to submersion in seawater, meant

Fig. 4. Cross-section details of US 90 highway bridge over Biloxi Bay (1 ft=0.3048 m)

that these segments were very nearly buoyant once submerged (Fig. 3). Fig. 4 shows the dimensions of a typical cross section of the bridge deck as measured on site, and Fig. 5 outlines the buoyancy calculation performed on this cross section, including the effects of air compressibility.

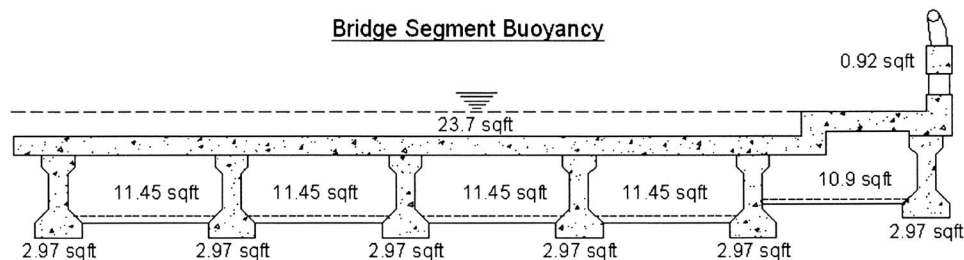
Fig. 5. Buoyancy calculation for US 90 highway bridge over Biloxi Bay (1 ft=0.3048 m, 1 lb=4.445 N)

The buoyancy analysis results based on in Fig. 5 for the US 90 highway bridge across Biloxi Bay are summarized in Table 3 along with those for six other bridge cross-sections measured during the reconnaissance trips. These calculations are based on a unit length of the bridge cross section. The bridge deck self-weight is also listed in Table 3 as a weight per unit length of the bridge cross section, based on field measurements of each

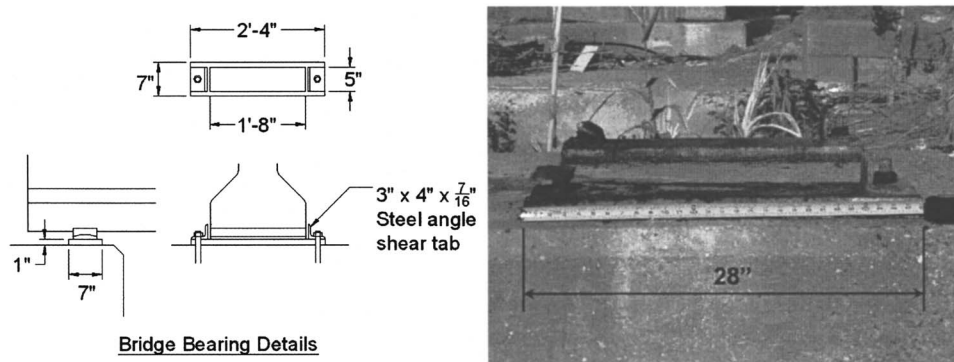
For the US 90 highway bridge across Biloxi Bay, the bearings supporting each end of the girders at the pier bents provided no restraint against uplift and only nominal resistance against lateral movement (Fig. 6). Being a low seismic zone, the region had no requirements for shear keys to provide lateral restraint or ties to prevent uplift, as is common in seismic regions. Friction induced by gravity load, and small 11 mm (7/16 in.) thick steel angles, were the only physical restraint against lateral movement for these bridge segments. When subjected to the wave-induced hydrodynamic uplift (Table 2) and/or buoyancy effects (Table 3), the segments were free to move off their supports under the lateral load from surge and wave action (Table 1). Apart from the bridge segments elevated over the ship channel, every segment of this bridge was dislocated from its supports and collapsed into the bay.

Fig. 6. Bearing restraint details for US 90 highway bridge over Biloxi Bay (1 in.=25.4 mm)

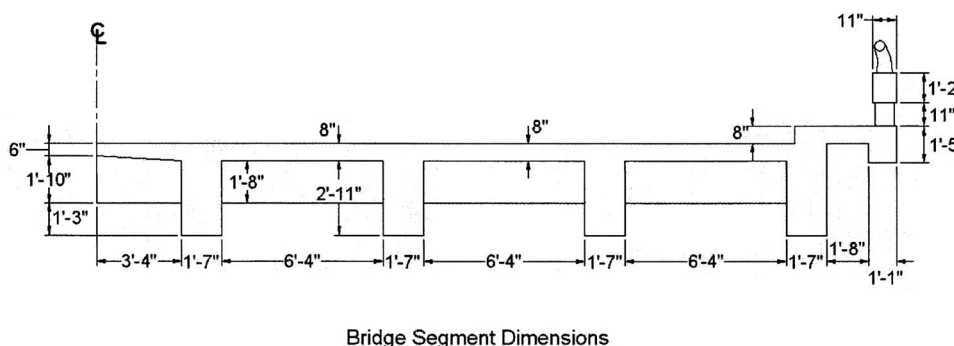
Even bridges with significant residual self-weight when submerged suffered failures due to inadequate shear keys to prevent lateral movement of the bridge deck segments. For example, the US 90 highway bridge across Bay St. Louis had a residual dead weight of 23.3% when fully submerged (Table 3). The bulkhead and bridging elements provided between the girders of this deck are only partial depth (Fig. 7), allowing much of the air below the deck to escape. Nevertheless, virtually every segment of this bridge was dislodged from the supporting piers. These failures are attributed to the additional effects of hydrodynamic uplift (Table 2) and lateral loads from surge and wave action (Table 1), combined with the lack of restraint against uplift or lateral movement at the support bearings. Fig. 8 shows the rocker bearing at one end of each span. The only restraint against lateral movement of the girders was the three small shear studs provided between the rocker and the bearing plate in the girder soffit.

Fig. 7. Cross-section details of US 90 highway bridge over Bay St. Louis (1 ft=0.3048 m, 1 in.=25.4 mm)

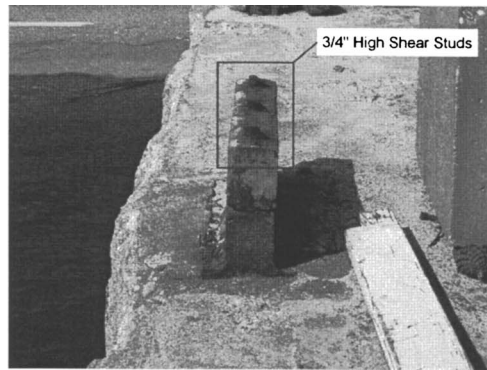
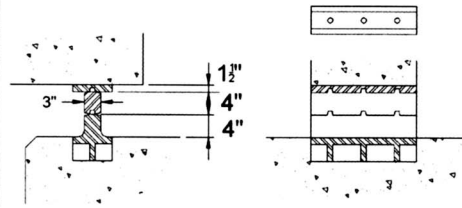
Fig. 8. Rocker bearing details at US 90 highway bridge over Bay St. Louis (1 in.=25.4 mm)

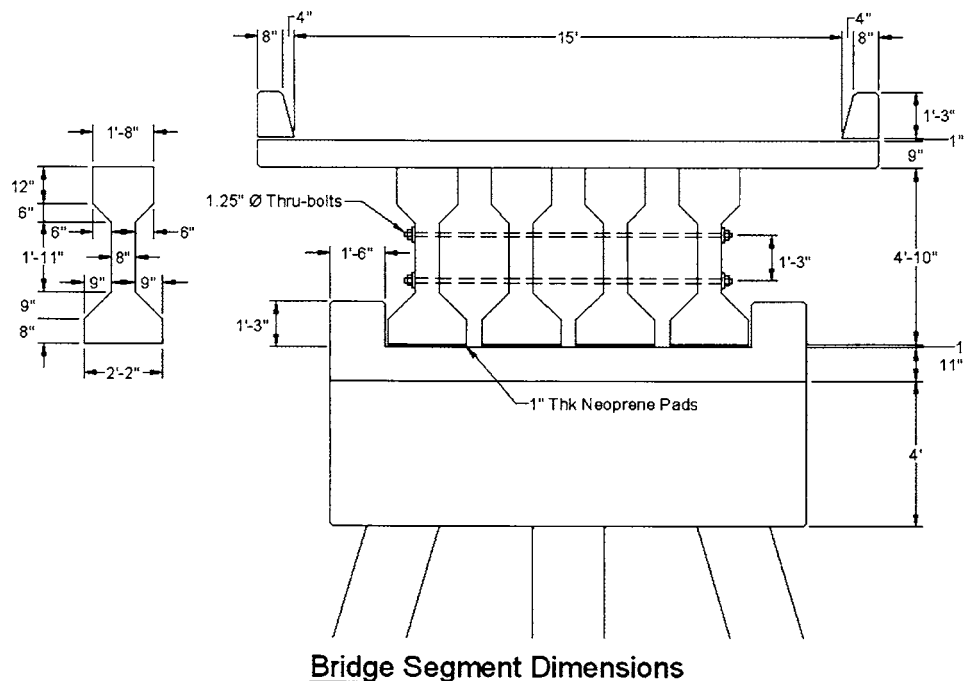
In addition, the superior lateral restraint provided by 380 mm (15 in.) high concrete shear keys on either side of the girders at each support pier (Figs. 9 and 10), was sufficient to resist the lateral hydrodynamic loads (Table 1). Not a single segment of this bridge collapsed.

Fig. 10. Cross-section details of railroad bridge over Biloxi Bay (1 ft=0.3048 m)

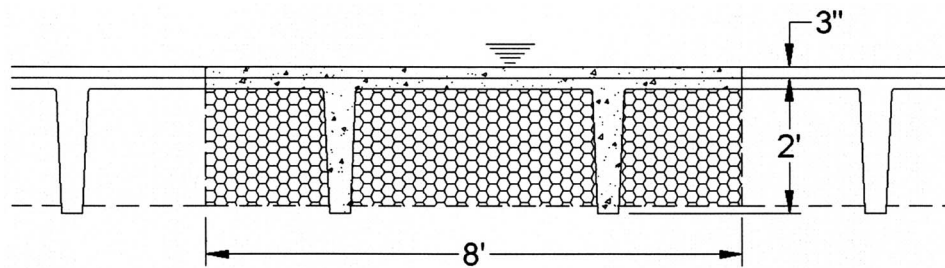
The elevated floors of these precast parking structures consist of prestressed concrete double-tee girders supporting a 50 to 75 mm (2 to 3 in.) thick cast-in-place concrete topping slab. Significant uplift resulted from buoyancy of air trapped between the girder webs below the floor deck (Fig. 12). This air could not escape because of the supporting inverted T-beams or spandrel beams at either end of the span. In addition, the cast-in-place topping slab covers the joint between adjacent double-tees and any gap between the double-tee and the supporting elements at either end of the span. Unable to escape, the air below the floor slab induced uplift well in excess of the submerged dead weight of the double-tee plus topping, resulting in significant negative bending (hogging) of the precast sections.

Fig. 12. Volume of air potentially trapped below a single double-tee girder (1 ft=0.3048 m)

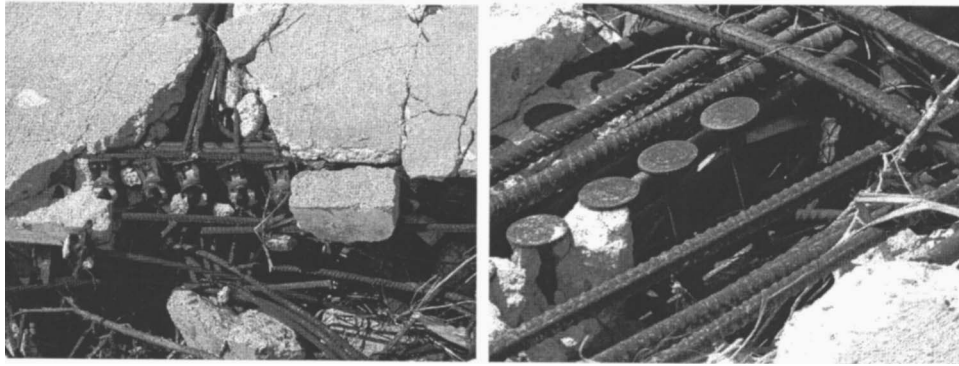
Both buildings suffered partial collapse of the front section of structural concrete framing (Fig. 16). Floor slabs in the front bay (ocean side) are 178 mm (7-in.) thick PT flat slabs, spanning between 406 by 508 mm (16 by 20-in.) rectangular columns. In the second bay, 178 mm (7-in.) thick one-way slabs span between beams running perpendicular to the shore. The two-way floor slab extends 1.8 m (6 ft) in front of the front columns as cantilever balconies. The PT beams in the second bay of the building contain numerous PT tendons that extend as banded PT reinforcement into the two-way slab and cantilever balcony. Fig. 17 shows the PT anchors at the edge of the balcony slab and headed stud shear reinforcement used around the front slab-column connections supporting the flat slab section. Distributed PT tendons were also provided perpendicular to the banded PT in the two-way slab.

Fig. 17. Posttensioned anchors at slab edge and headed stud shear reinforcement at slab-column connection

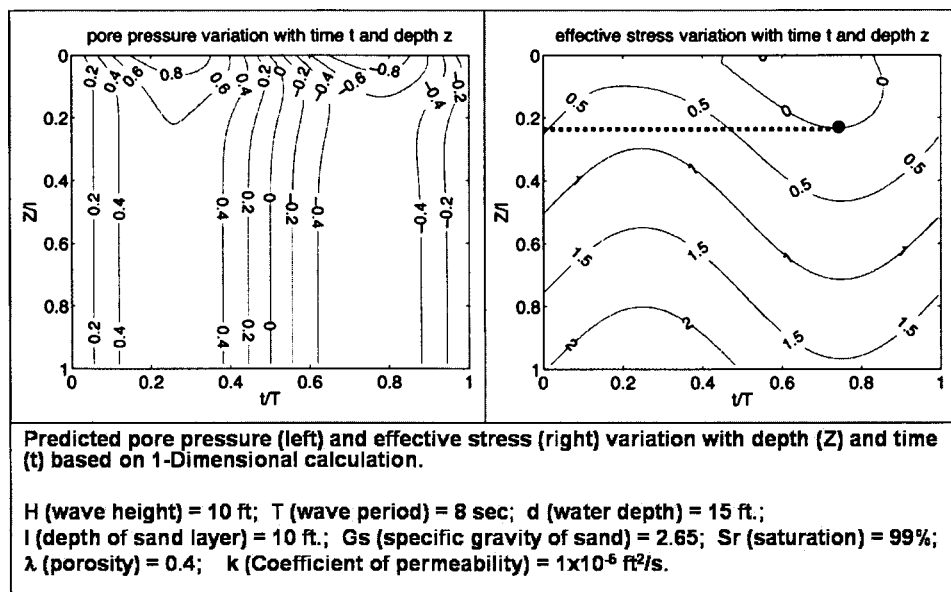
Fig. 22. Predicted pore pressure and effective stress variation based on 1D calculation (1 ft=0.3048 m)

During Hurricane Katrina, the storm surge lasted for several hours and exceeded 7.5 m (25 ft) along portions of the Mississippi coastline. The nearly saturated sandy deposits also were subjected to pressure fluctuations due to wave actions, which can also result in liquefaction-induced scour. As demonstrated in Fig. 22, at a water depth of 4.5 m (15 ft) and a wave height of 3 m (10 ft), the depth of liquefaction of nearly saturated sand deposits can reach up to 0.75 m (2.5 ft) below the seabed surface. This wave-induced liquefaction can be even more severe during wave drawdown or ebb surge due to rapid decrease of the water level, without time for the internal pore pressure to dissipate.
