IMPACT OF 2008 HURRICANE IKE ON BRIDGE INFRASTRUCTURE IN THE HOUSTON/GALVESTON REGION

Matthew Stearns¹, Jamie E. Padgett^{2*}

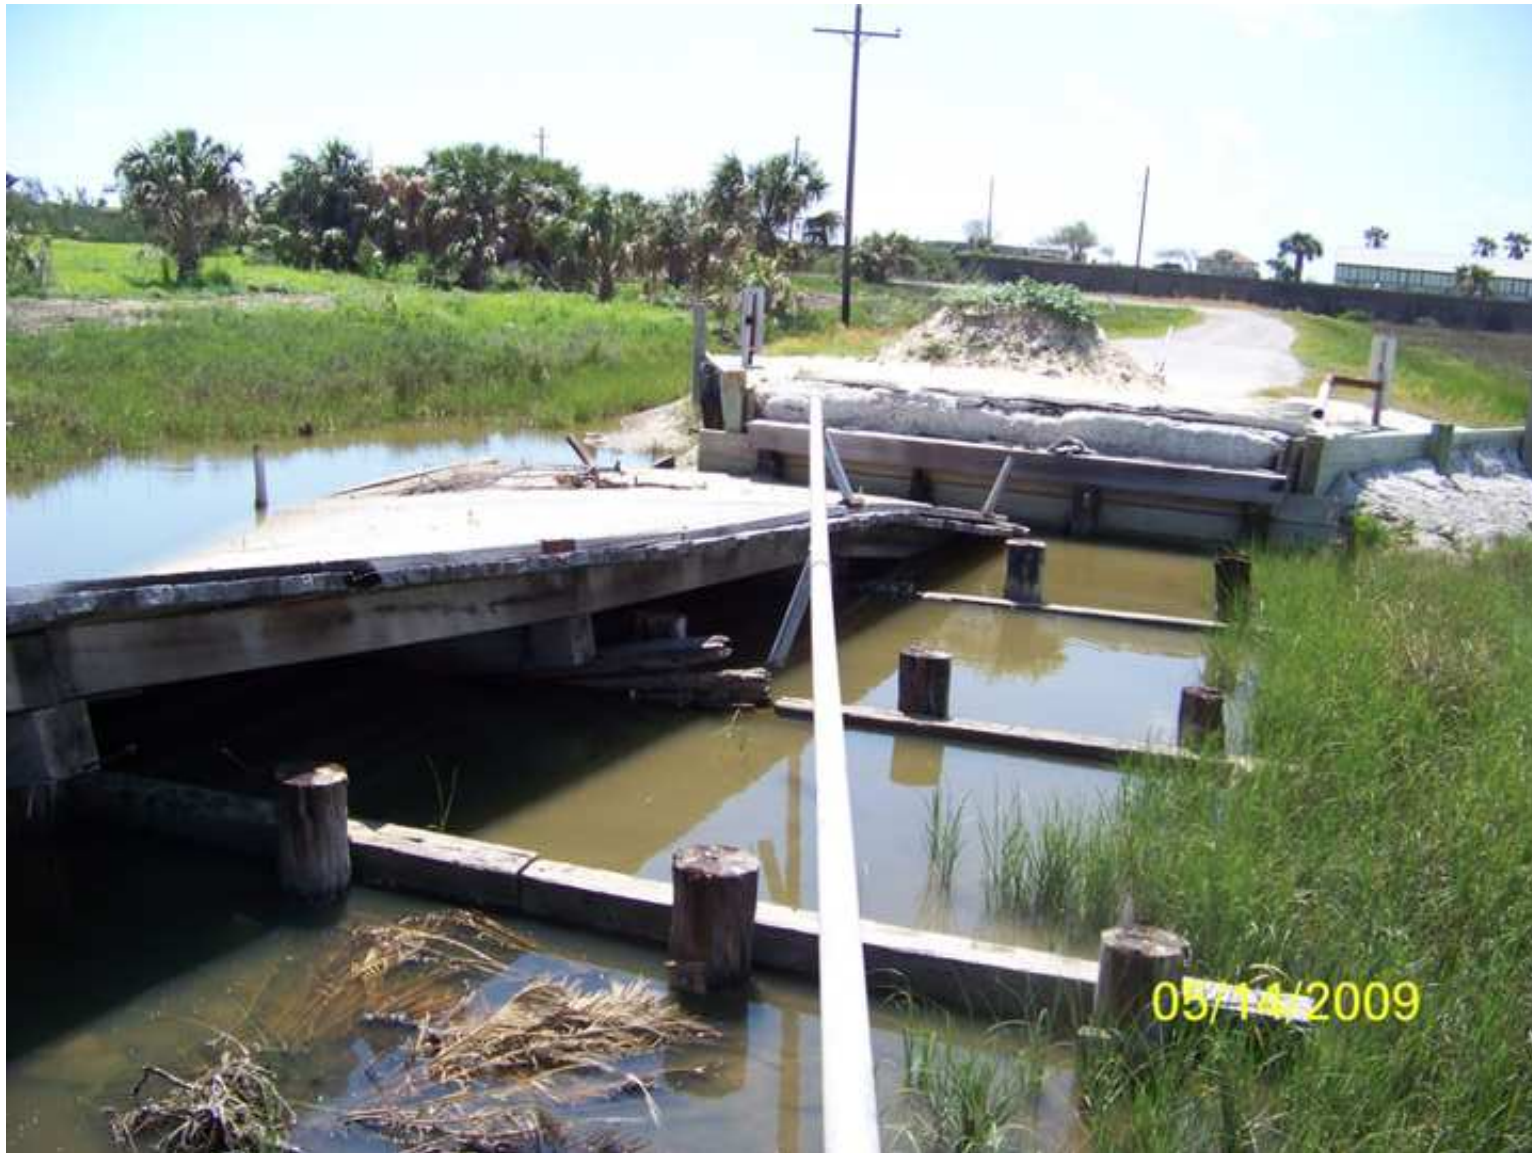
Figure7a

In Galveston Bay near Port Bolivar, the 7th Street Bridge was completely washed away by the storm surge, which at this location was 12.9 feet with 3.1-foot waves based on hindcast storm data (Dawson and Proft, 2010). The timber-supported bridge deck was displaced completely off the timber support structure, as shown in Figure 7. The bridge deck and the support bent connections were inadequate to resist the uplift forces, and they were ripped from the support columns, detailed in Figure 7.

Figure 7. Displaced bridge deck of the 7th Street Bridge at Port Bolivar (left) and detail of the detached support bent from the piers (right) (Courtesy of HNTB).
