Another Failure 20 with measurements and some test mode?

My new MK-312BT is also suffering from "Failure 20".

My PCB is **1.3B**.

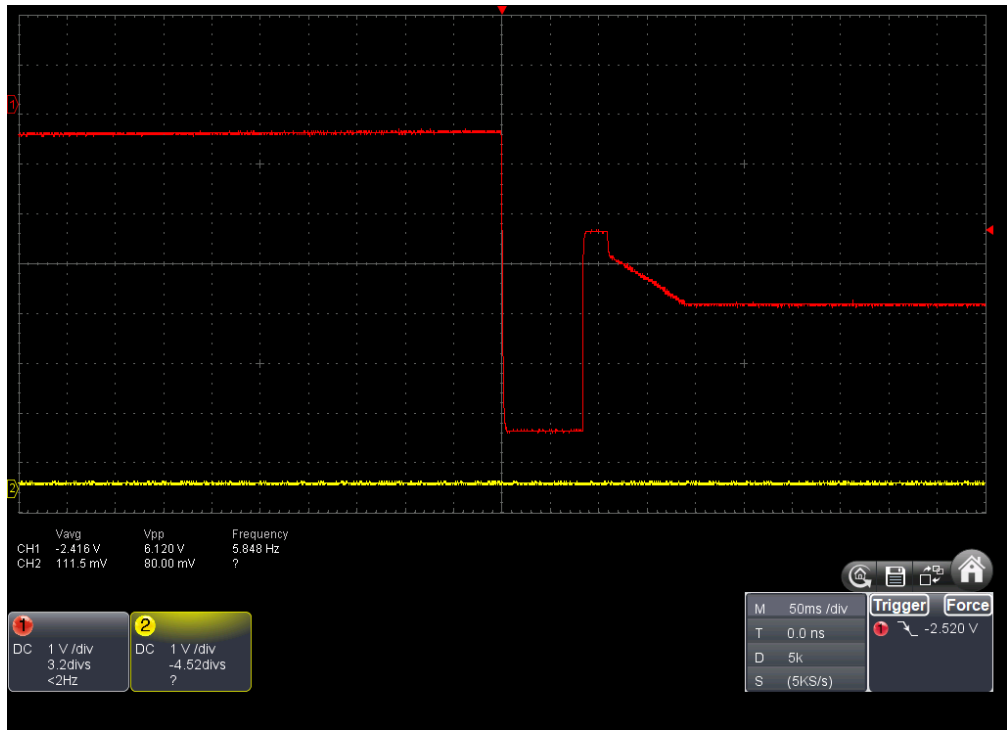
Red = Q3 gate against 9V1 rail (floating scope):

I am unable to measure impulses across transformer coil (floating scope) - it keeps getting into "test mode" - not sure how is this possible.

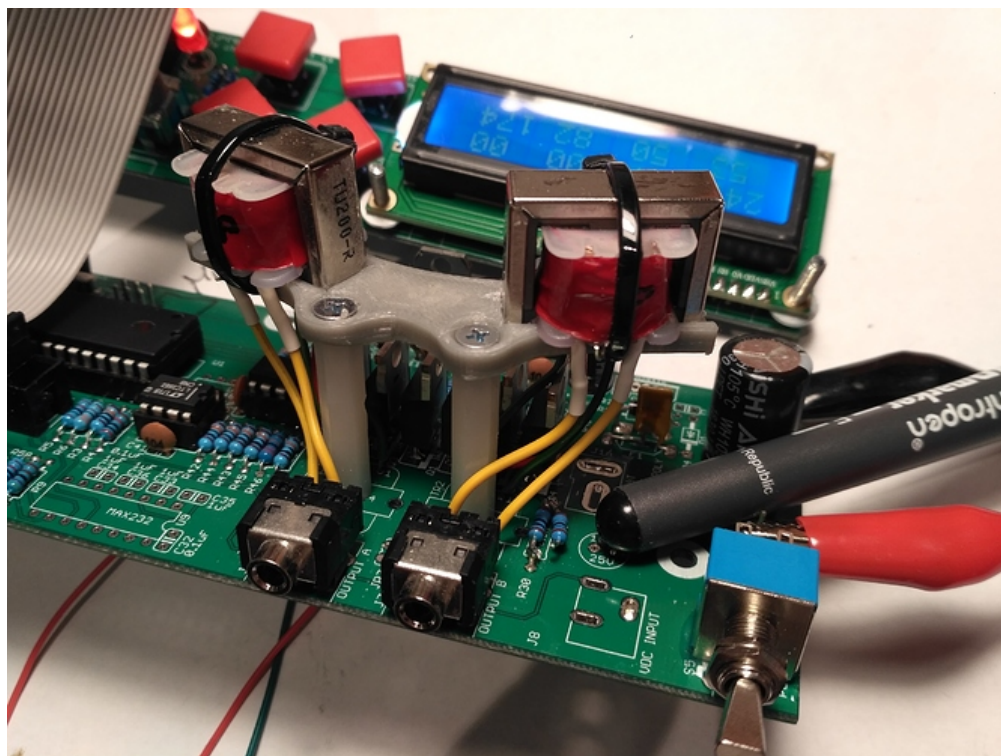
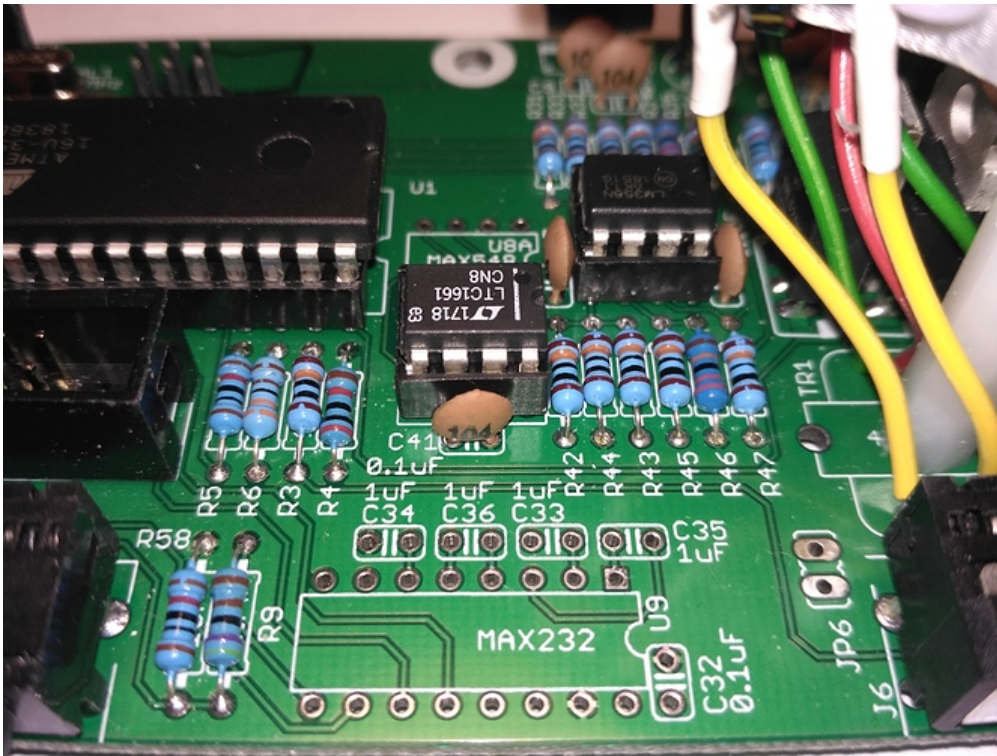
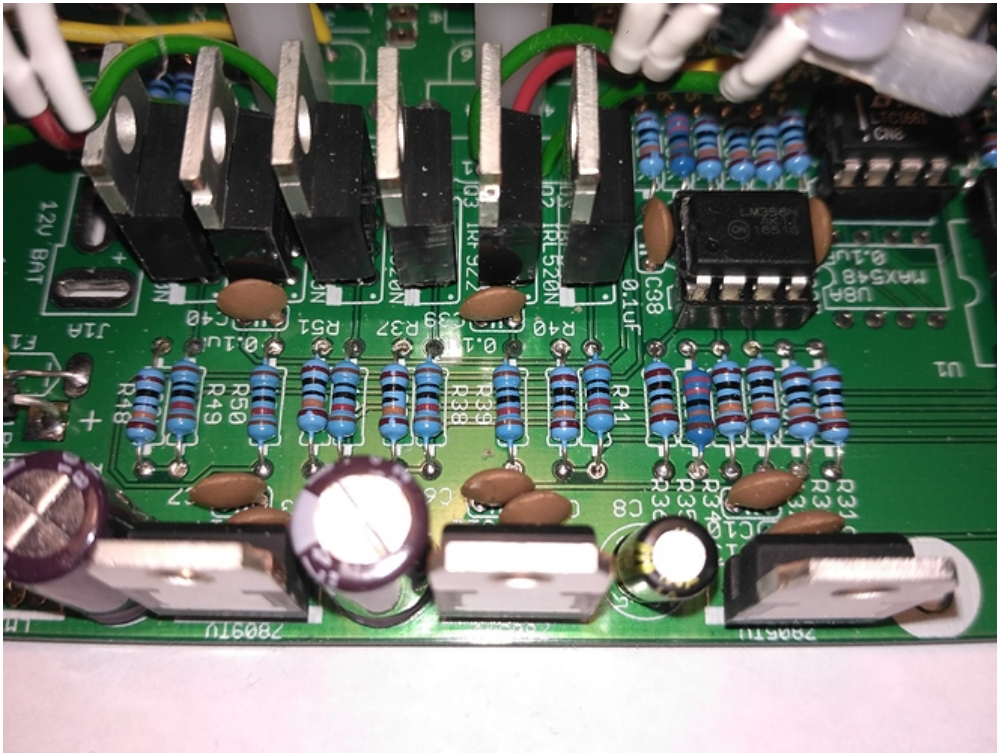
I also managed to enter some kind of a test mode. It happened when I tried to measure signal between ground and Q3 gate (floating scope). It also happens when the R30 value is too high – 1R instead of 0.5R. The MK-312BT then boots into this – see the photo. Buttons pressed change one number, Multi Adjust changes other number, and output intensity pots do nothing.

Test mode? When I disconnected one of two 1R in parallel (R30).

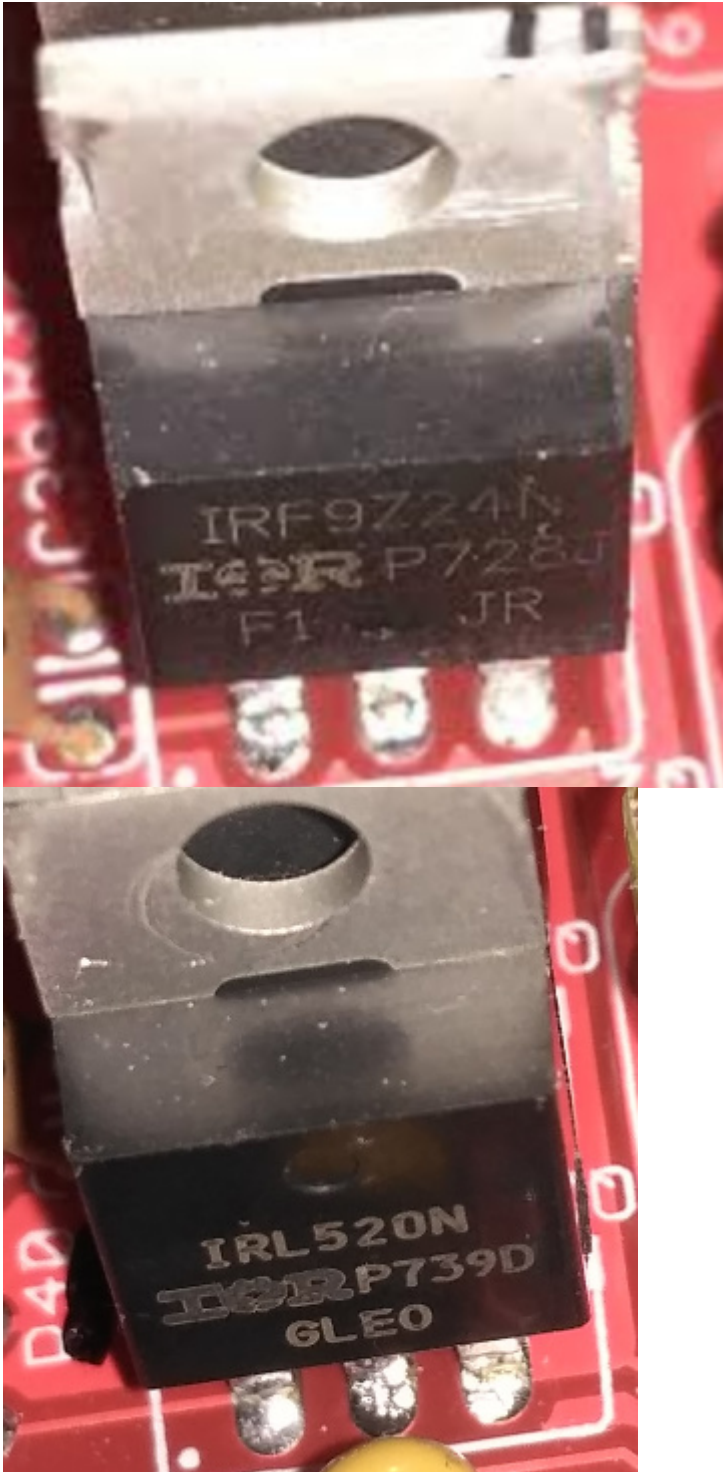
IRF9Z24NPBF (Infineon) purchased from TME has $V_t=2.98V$. I think this might be the problem. There should not be a problem with the IRL520NPBF because they operate in fully saturated mode. Mine has also V_t around 1.8V.

Replaced all of the counterfeit mosfet with genuine one and problem solved. No longer having failure 20.

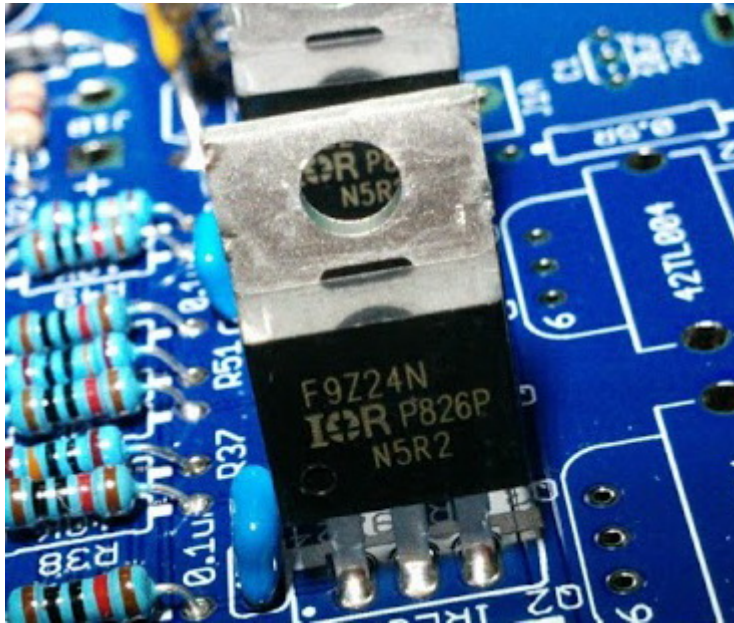
I got this IRF9Z24N from element14. It have a small circle at the bottom left to indicate it's the first PIN, which match with the PCB. Everything looks legit.

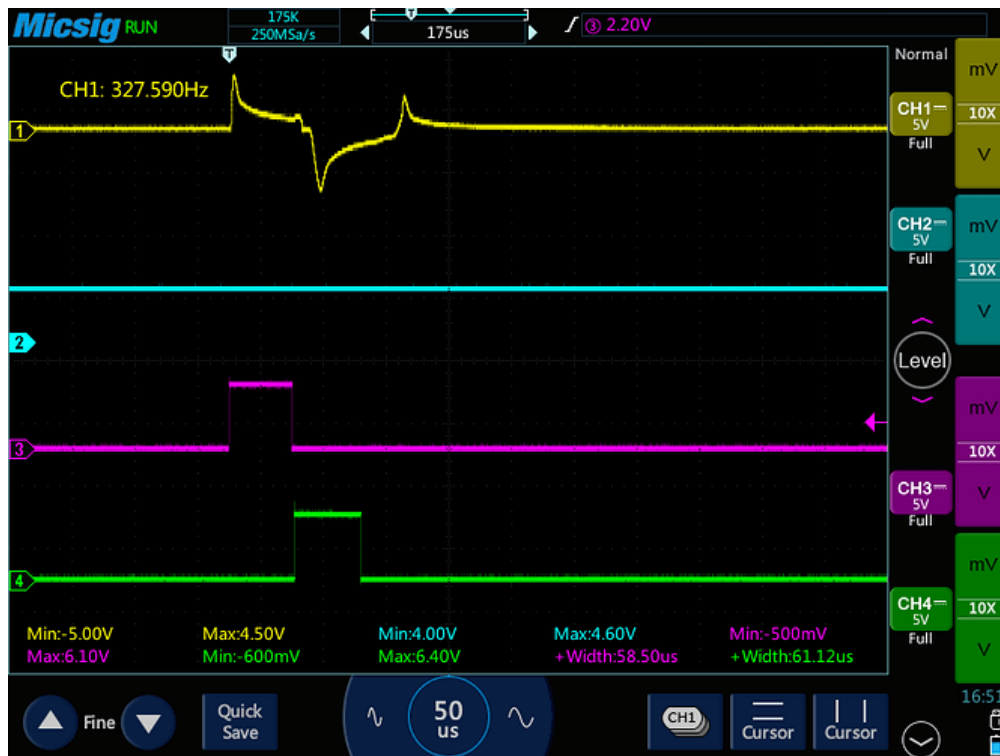
Wave mode.

Yellow - output A terminated by 100K resistor. 0%=6V, 20%=42V, 40%=160V, 50%-100%=195V

Cyan - Q3 control (power channel knob just moves this voltage. all the rest parameters is the same)

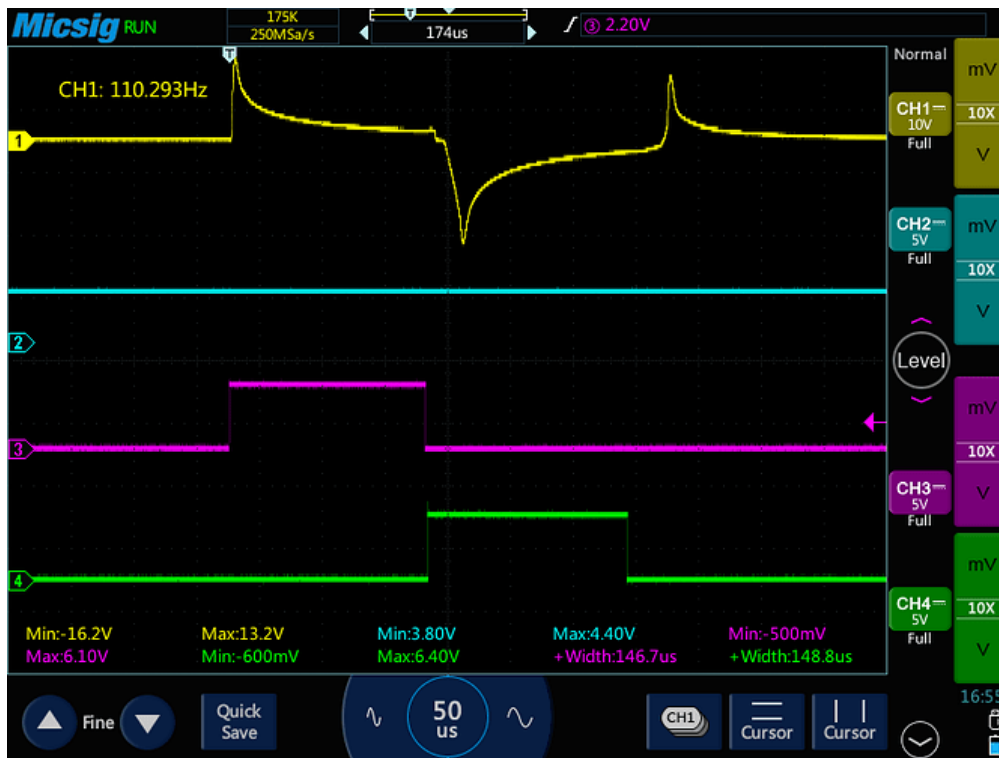
Wave mode slowly changes impulse width. like the maximum here:
